ASBESTOS SURVEY REPORT

LIBRARY/MUSEUM

17283 County Rd 18

31 BUILDING #B25 – LIBRARY / MUSEUM (ST. ANDREWS)

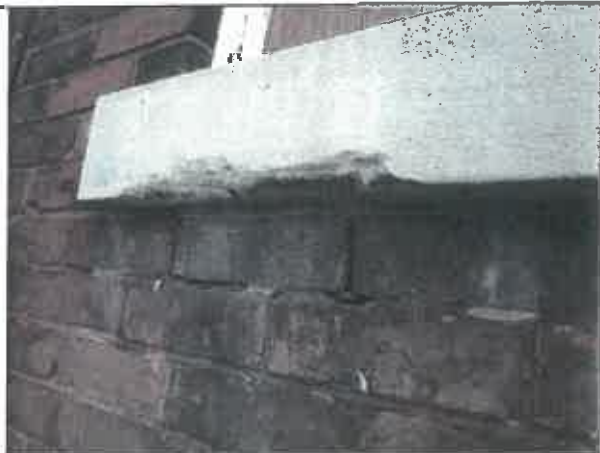
Material	Description	Location	Action
8" Floor tile	Type B – Light grey with black/brown streaks B25-17-64B-A,B,C	Room 17	1 – Manage
8" Floor tile	Type C – White and reddish spotted tile B25-19-64C-A,B,C	Room 19	1 – Manage
8" Floor tile	Type D – White with red/green spots B25-20-64D-A,B,C	Room 20	1 – Manage
8" Floor tile	Type G – Brown with white streaks B25-33-64G-A,B,C	Room 33	1 – Manage
8" Floor tile	Type H – Black tile B25-33-64H – A,B,C	Room 33	1 – Manage
Caulking	Exterior grey window caulking B25-Ext-21-A,B,C	Exterior windows	1 – Manage

Photo 2: Window caulking (Grey) observed on the building's exterior (Asbestos).

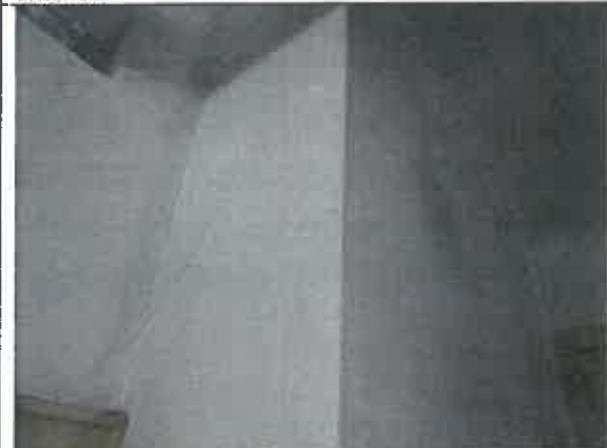
Photo 3: Plaster observed in Room 1 (Asbestos).

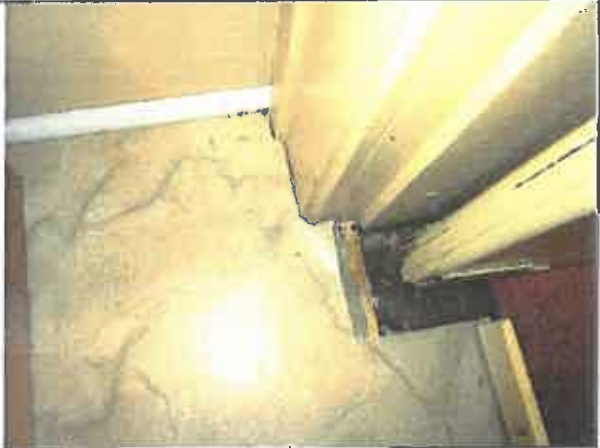
Photo 4: linoleum (Type A – beige marble pattern) observed in Room 2 (Non-Asbestos).

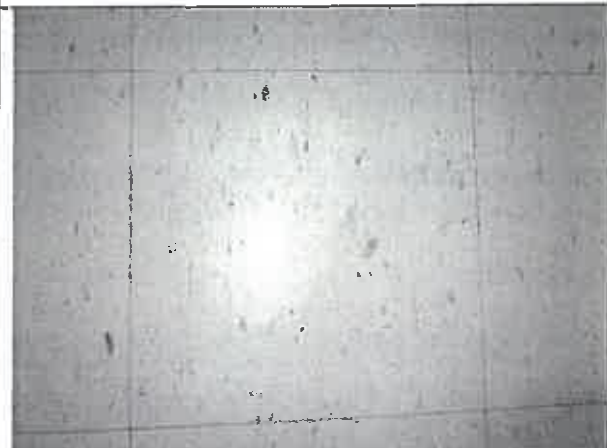
Photo 5: 12" floor tile (Type A – light blue fleck) observed in Room 4 (Non-Asbestos).

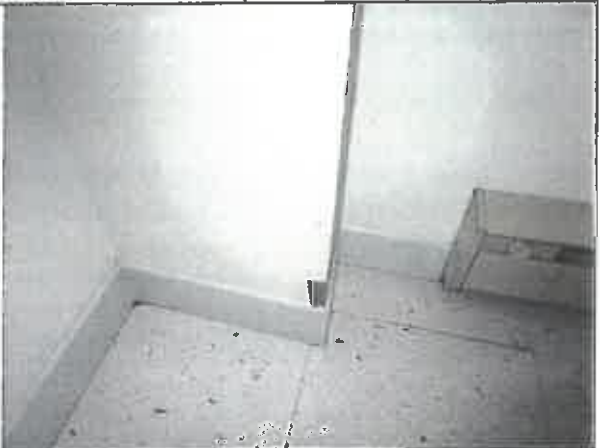
Photo 6: Drywall joint compound observed in Room 5 (Asbestos).

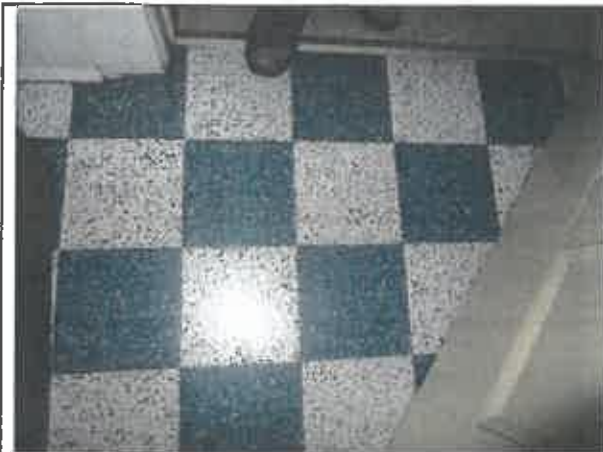
Photo 7: 8" floor tile (Type A – Green and White) observed in Room 10 (Non-Asbestos).

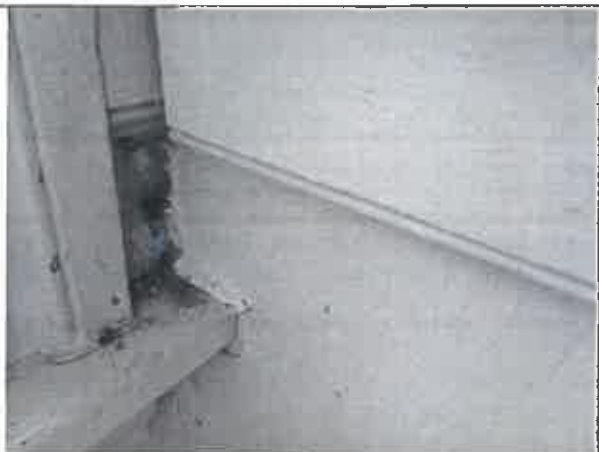
Photo 8: Burlap-like material (Type A) observed on lower wall portion of Room 15 (Non-Asbestos).

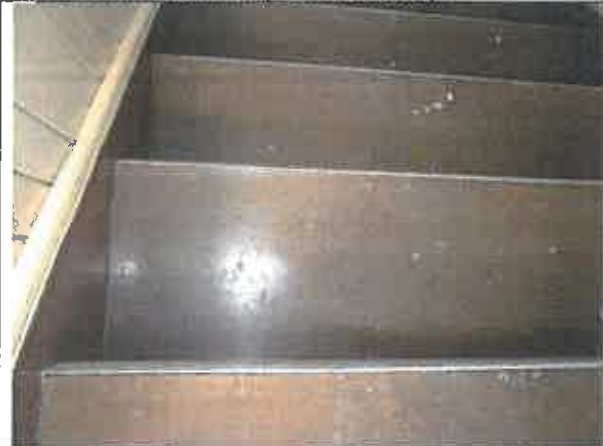
Photo 9: Linoleum (Type A – Brown) observed in Room 15 (Non-Asbestos).

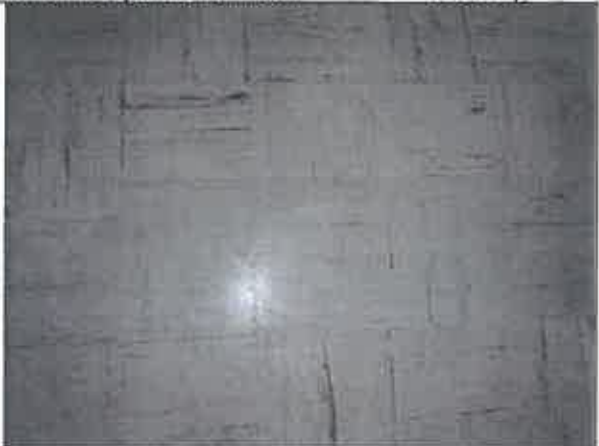
Photo 10: 8" floor tile (Type B – light grey with black and brown streaks) observed in Room 17 (Asbestos).

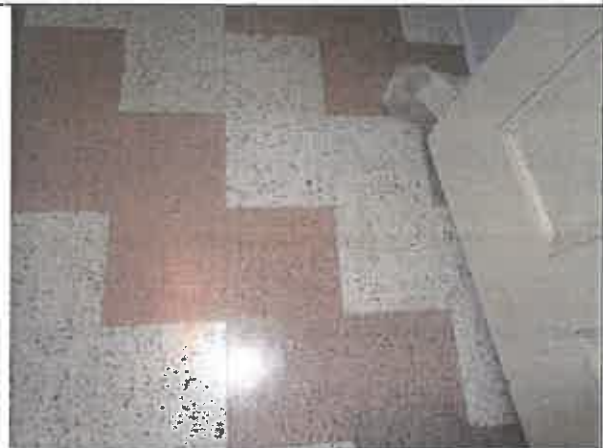
Photo 11: 8" floor tile (Type C– White and reddish tile with spots) observed in Room 19 (Asbestos).

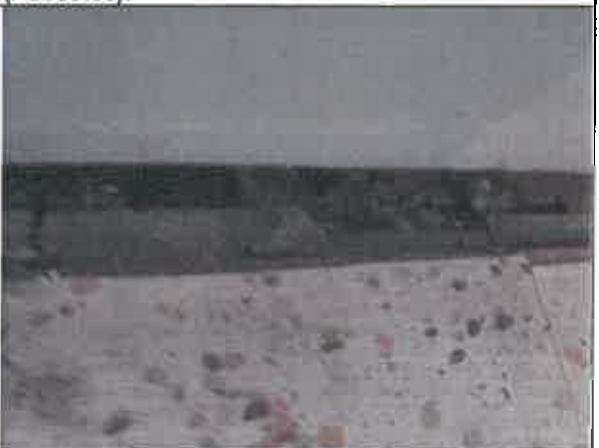
Photo 12: Insulation observed under flooring in Room 19 (Non-Asbestos).

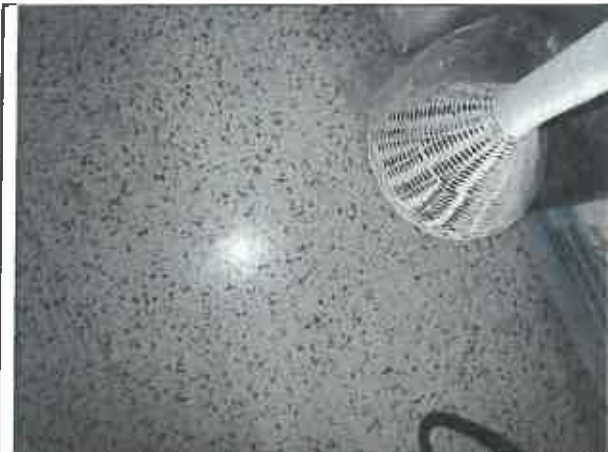
Photo 13: 8" floor tile (Type D— white with red and green spots) observed in Room 20 (Asbestos).

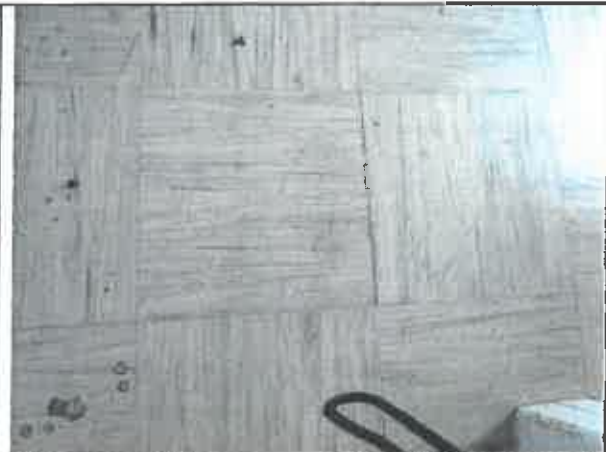
Photo 14: 8" floor tile (Type E— pink and green) observed in Room 20 (Non-Asbestos).

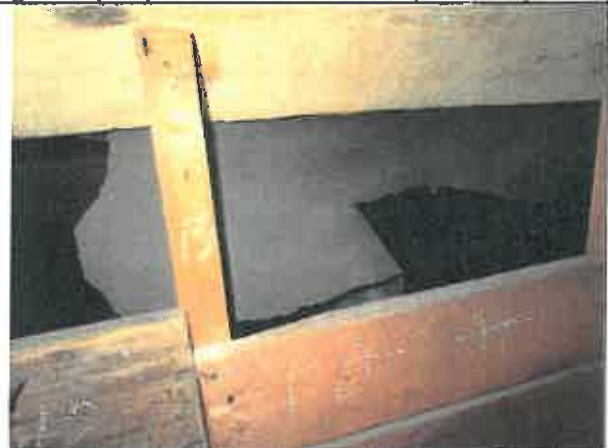
Photo 15: Tar paper observed in Room 28 (Non-Asbestos).

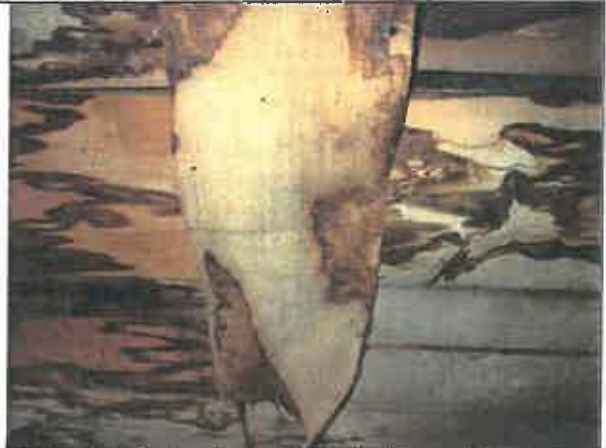
Photo 16: Burlap-like material observed in Room 28 (Non-Asbestos).

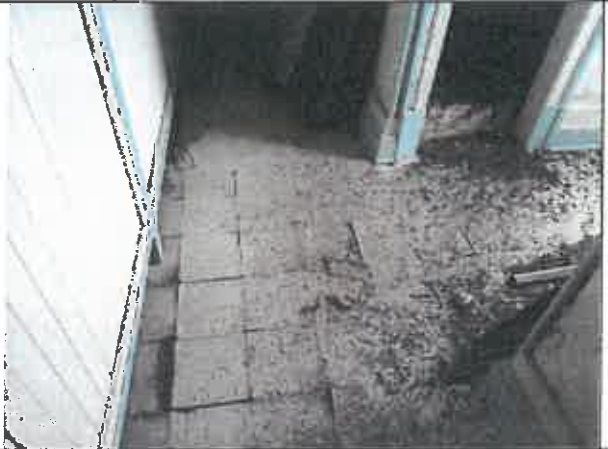
Photo 17: 8" floor tile (Type F— pink and green streaks) observed in Room 27 (Non-Asbestos).

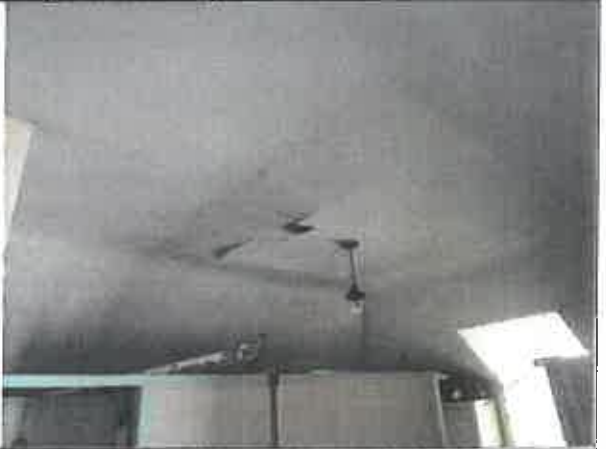
Photo 18: Plaster observed in Room 27 (Asbestos).

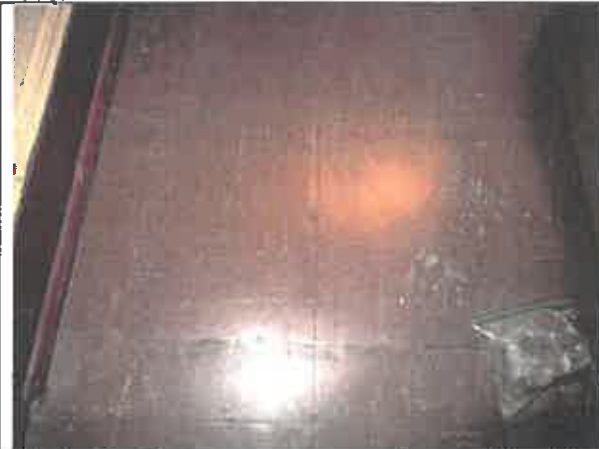
Photo 19: 8" floor tile (Type G— brown with white streaks) observed in Room 33 (Asbestos)

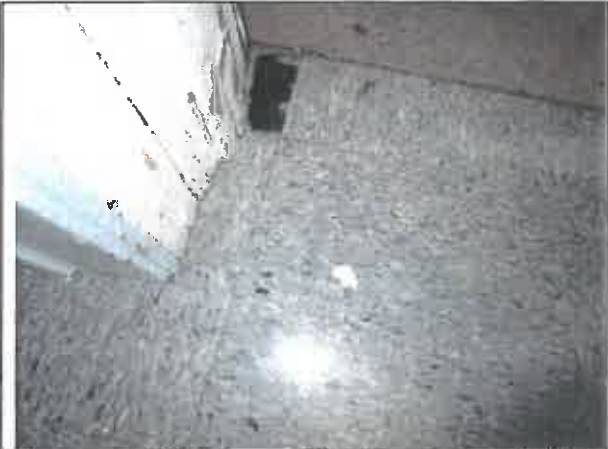
Photo 20: 12" floor tile (Type B – grey and white fleck) observed in Room 4 (Non-Asbestos)

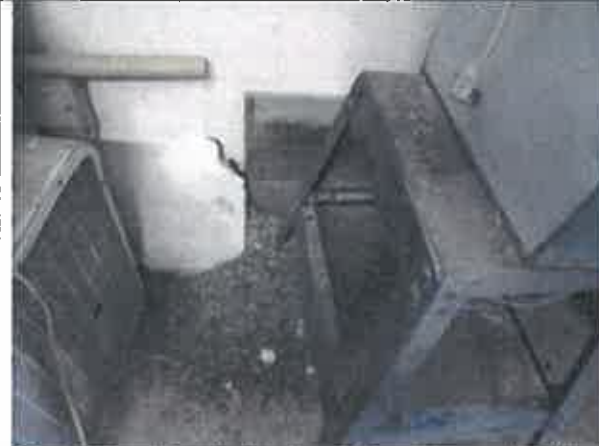
Photo 21: Vermiculite insulation observed within the walls in Room 36 (Asbestos).

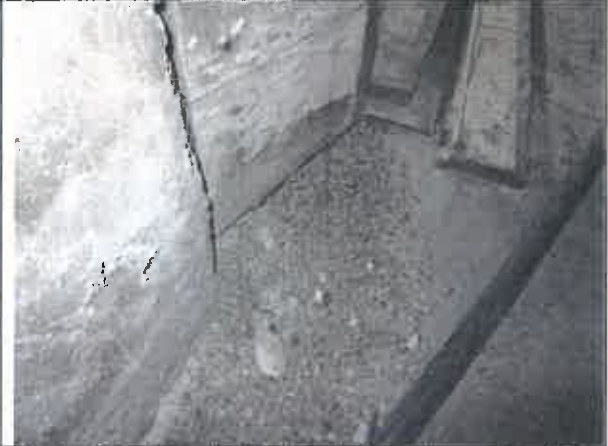
Material	Description	Location	Action
Vermiculite	Loose granular insulation B25-38-14-A,B,C	All exterior walls	5 – Abate vermiculite that has fallen onto the floor (see room sheet)
Insulation	Type B – Boiler insulation B25-38-11B-A,B,C	Room 38	5 – Abate (see room sheet)
Drywall joint compound	White plaster B25-5-59; B25-36-59-A,B; B25-41-59; B25-42-59-A,B; B25-43-59	Rooms 4, 5, 6, 7, 8, 9, 34, 38, 39, 40, 41, 42, and 43	1 – Manage
Plaster	2 phase plaster B25-1-52; B25-10-52; B25-12-25; B25-18-52; B25-22-52; B25-24-52; and B25-27-52-A,B	Throughout building	1 – Manage 2 – Repair (see room sheets for locations)

Photo 22: Vermiculite insulation observed within the walls in Room 38 (Asbestos).

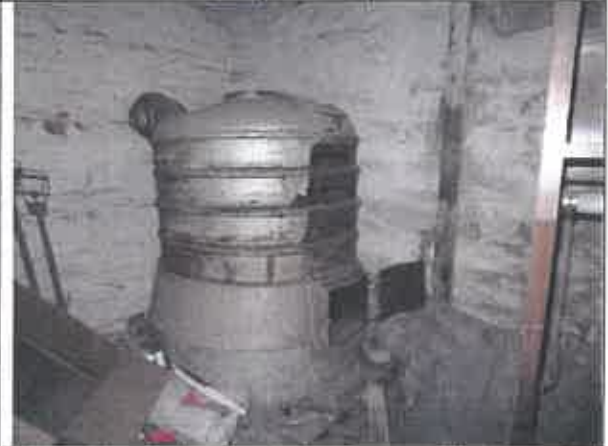
Photo 24: Boiler insulation observed in Room 38 (Asbestos).

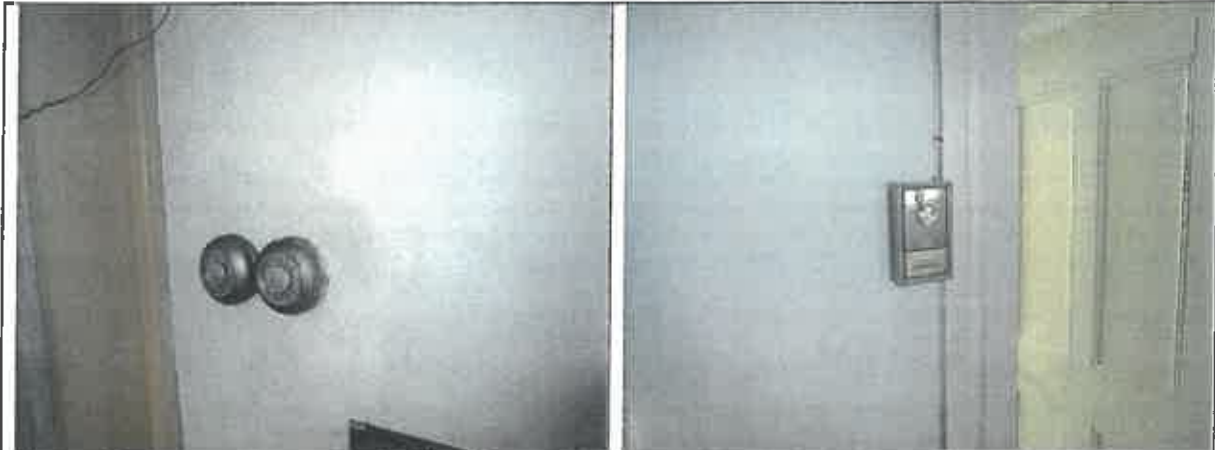
Substance	Description	Location	Action
Mercury	Fluorescent lamps Thermostats	Throughout the building	Removal and disposal of mercury-containing equipment is required prior to activities that may disturb the equipment. The handling, transport, and disposal of mercury containing equipment must follow all applicable provincial and federal regulations and guidelines pertaining to Mercury, including the requirements of O. Reg. 490/09 and the requirements of Reg. 347 – <i>General – Waste Management</i> .
Silica	Cement, masonry, glass etc.	Throughout the building.	Work that may disturb silica-containing materials should follow all applicable provincial and federal regulations and guidelines pertaining to Silica including the requirements of O. Reg. 490/09 and the MOL Guideline - Lead on Construction Sites.
Isocyanates		Not suspected	No Action Required
Vinyl Chloride Monomer		Not suspected	No Action Required

Photo 25: Typical mercury containing thermostat observed in throughout the building.

Photo 26: Typical mercury containing thermostat observed in throughout the building.
