Raisin River Heritage Centre Architectural Analysis & Updated Report

Project Number:
209-00187-00

DATE
December 7, 2020

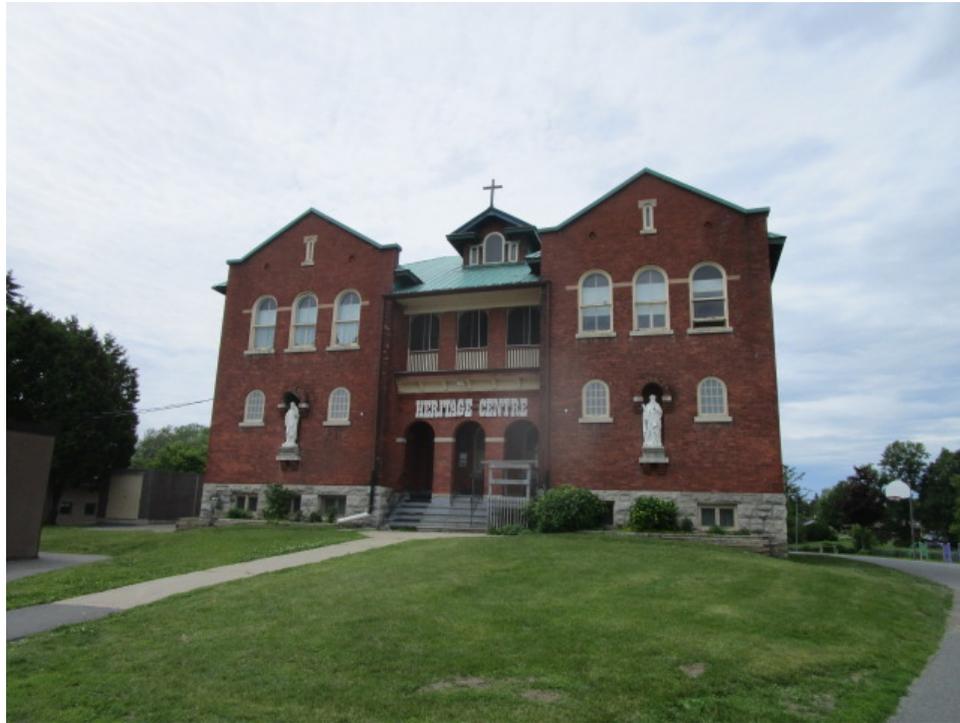
Photo 1 – South Elevation, 2017

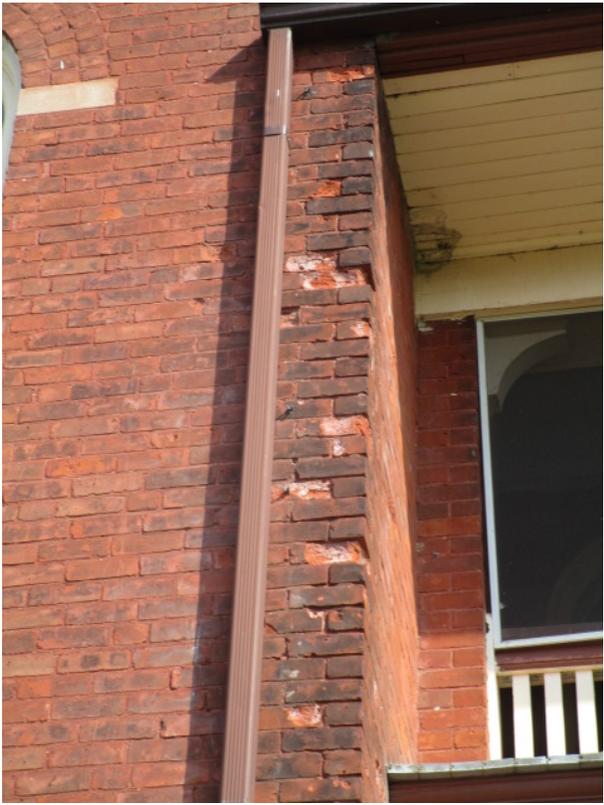
14. **Building Exterior:**
 - a. **Masonry:** the stone masonry foundation walls appear to be in fair condition – assume some repair work. The brick exterior requires repairs in several locations which will involve the replacement of broken bricks and repointing, including the chimney; Note that the deterioration of the exterior brick masonry has progressed further particularly visible on the south side of the building at the main entrance, since the 2017 report.

Photo 5 – Brick Masonry Deterioration, 2017

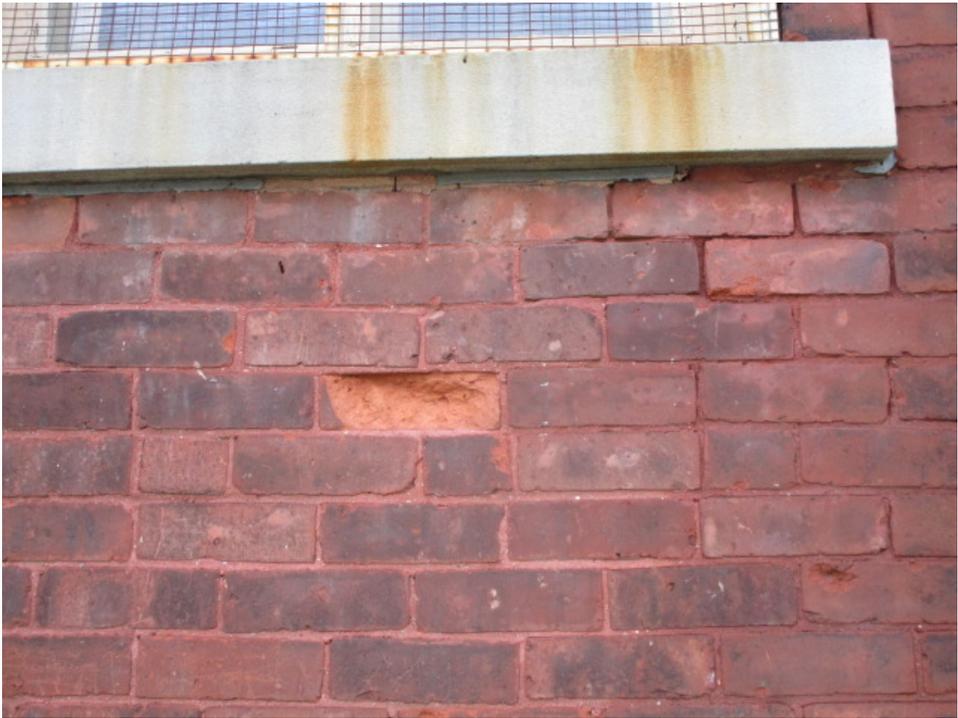
Photo 6 – Brick Masonry Deterioration, 2017

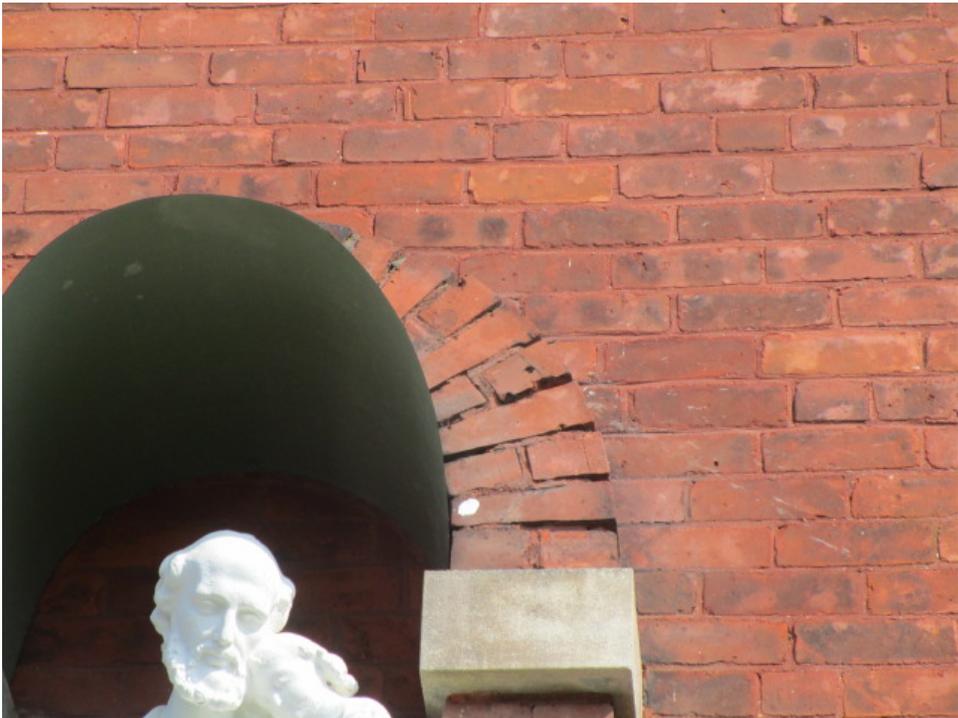
Photo 7 – Brick Masonry Deterioration, 2017

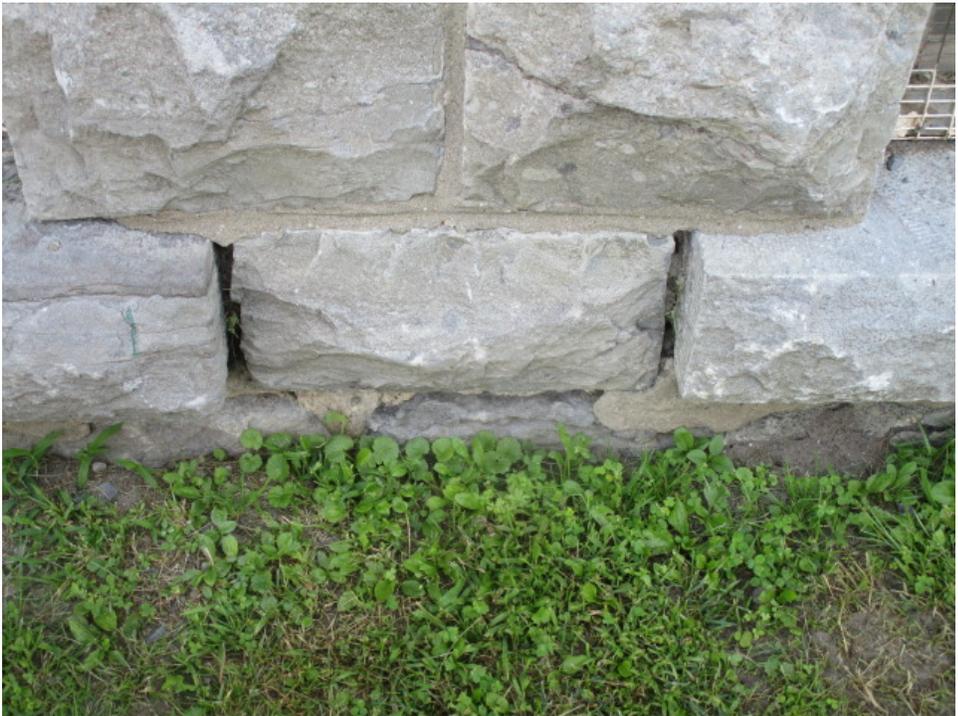
Photo 8 – Stone Masonry Deterioration, 2017

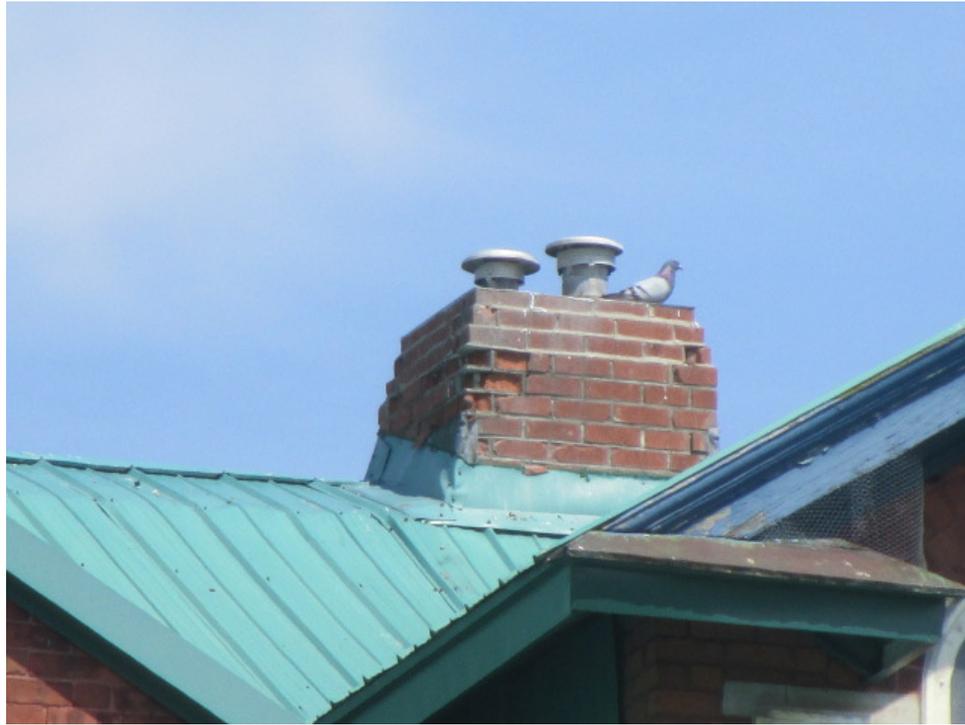
Photo 9 – Chimney Masonry Deterioration, 2017

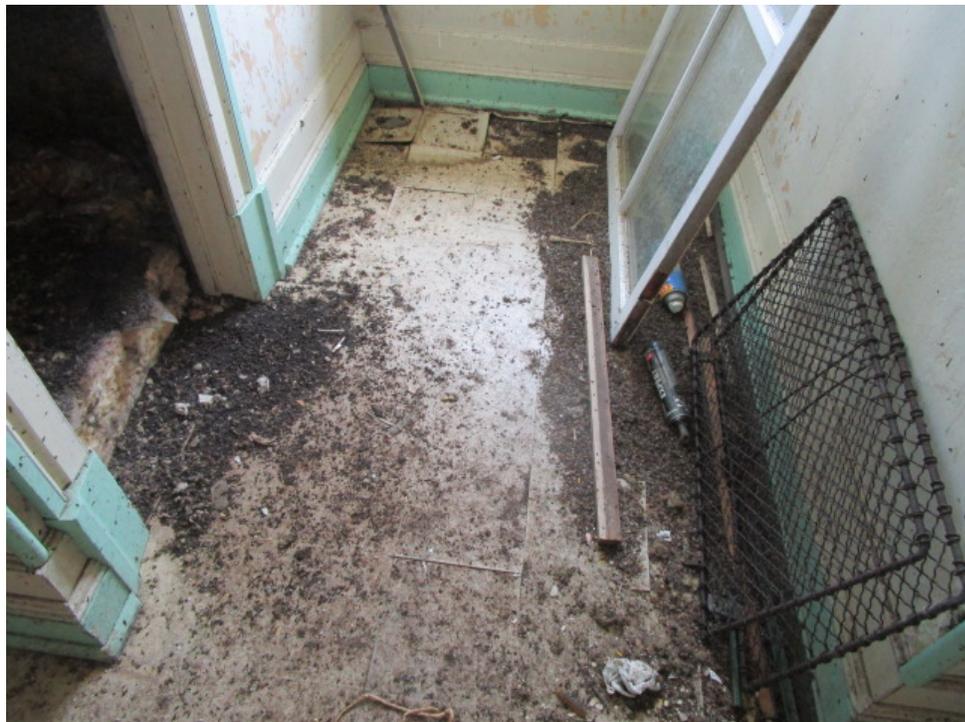
Note: no destructive exploratory openings were made. Nor were detailed roofing inspections made or review of 3rd floor – where extensive bird and bat guano droppings existed (dangerous health issue without special PPE).

Photo 10 – Third Floor Batt Droppings, 2017

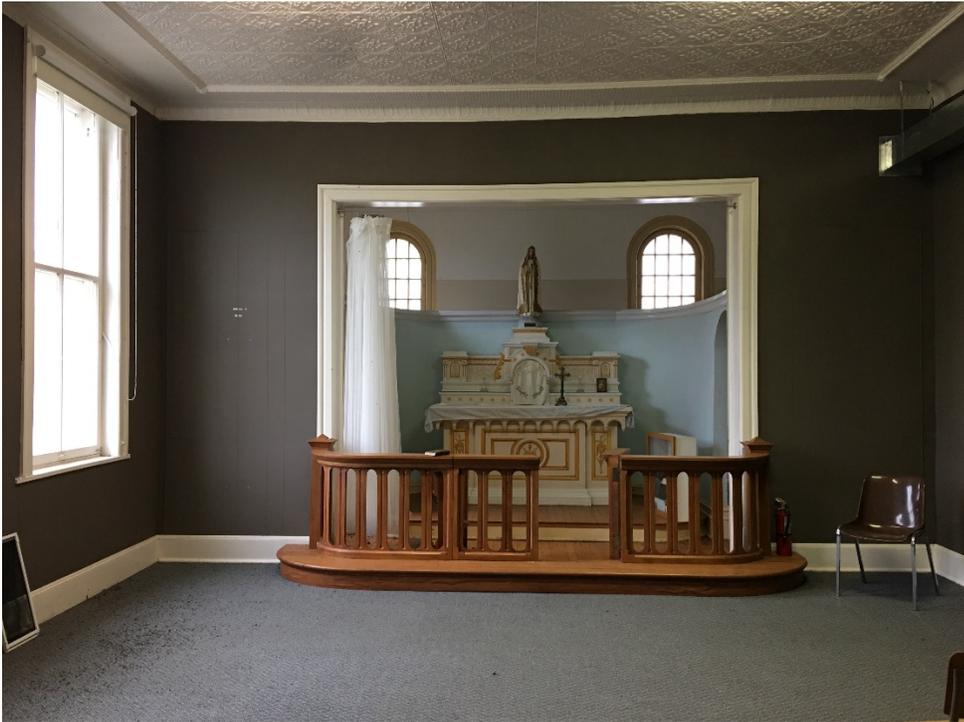
4. **Main Floor:** the main floor is spacious with high ceilings and could be well suited for clerical / administrative / archival uses, there is a religious component where an altar is built-in, essentially dedicating the ground floor as a chapel. The altar most likely has historical and heritage significance and need to remain in place;

Ground Floor Alter, 2020

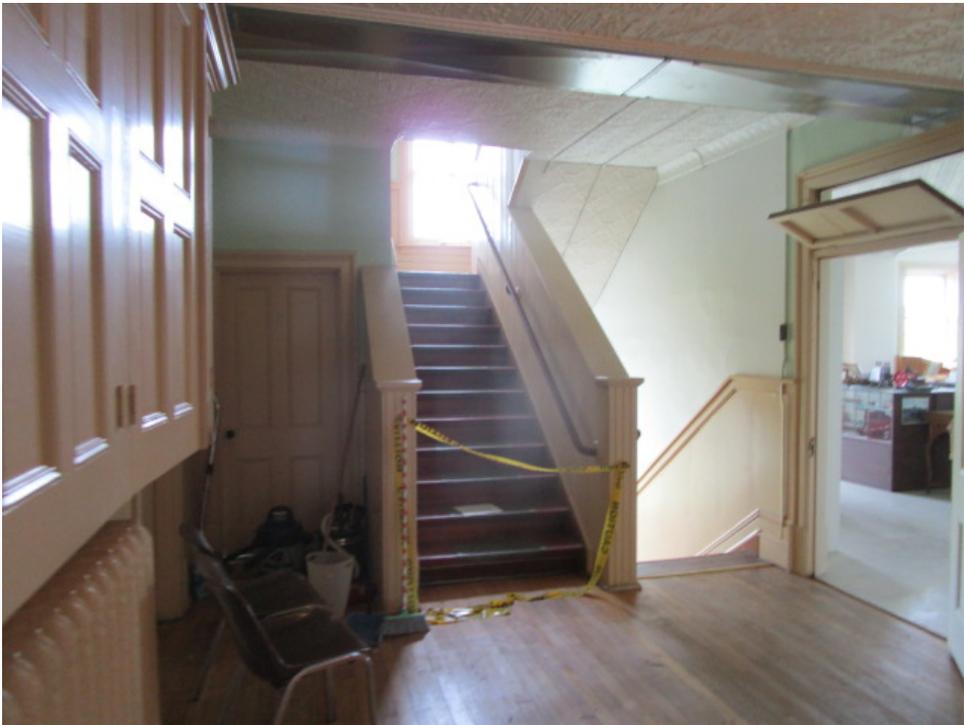
3.2.2.53 or 3.2.2.54 of the OBC requires that this **Group 'D' building of 3 storeys** can be combustibile construction however fire separations at floors are required to be $\frac{3}{4}$ hr., thus sprinklers may also be employed as a safety measure.
The central circulation stairway does not provide a fire separated egress and its lack of separation at the floors creates a situation where all floors are interconnected. A new fire stair is required, and floors must be fire separated at each level. Related to issues of fire separations is safety compliance regarding building egress, door hardware, emergency lighting and exit signage;

Open Circulating Stair, 2017

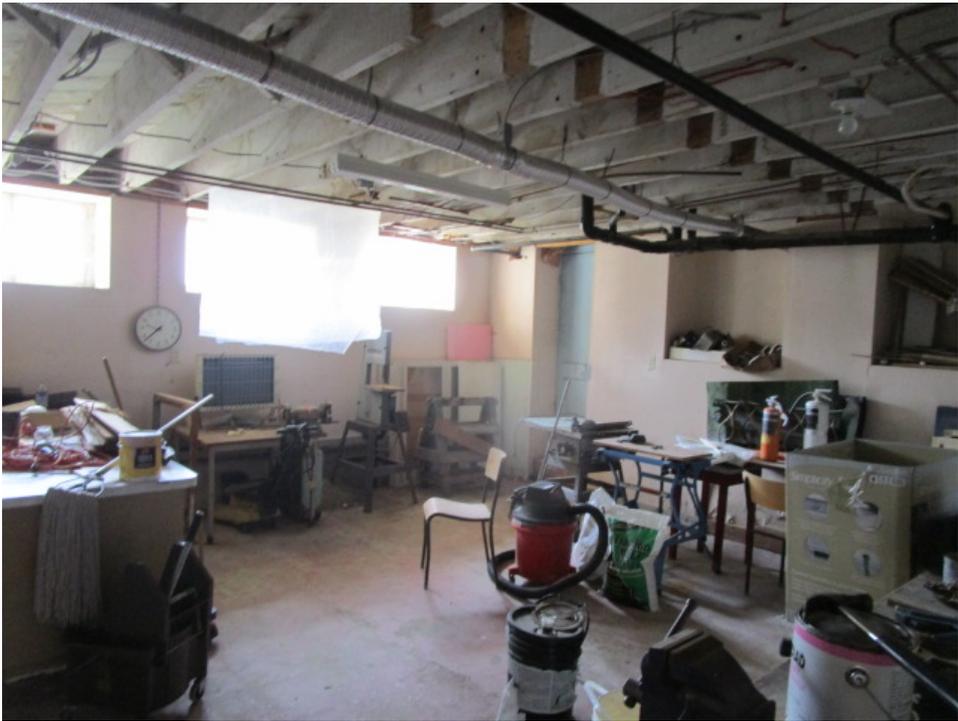
12. **Two single storey additions:** on the north sides of the building do not provide much value except to provide vestibule type of space when exiting from the stairwell and addition to basement work area - likely repairs would be necessary with potential building retrofit;

Basement addition 2017
