2021 BIENNIAL STRUCTURE INSPECTION PROGRAM

Township of South Stormont – October 2021

Keystone Bridge Management Corp.

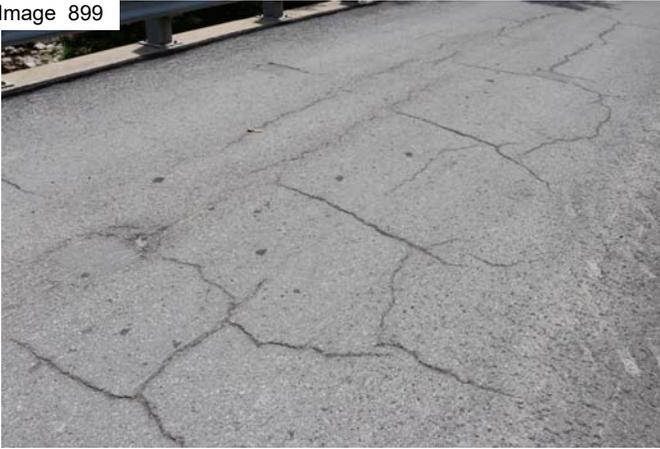
Image 899

Asphalt on deck with random cracking (typical)

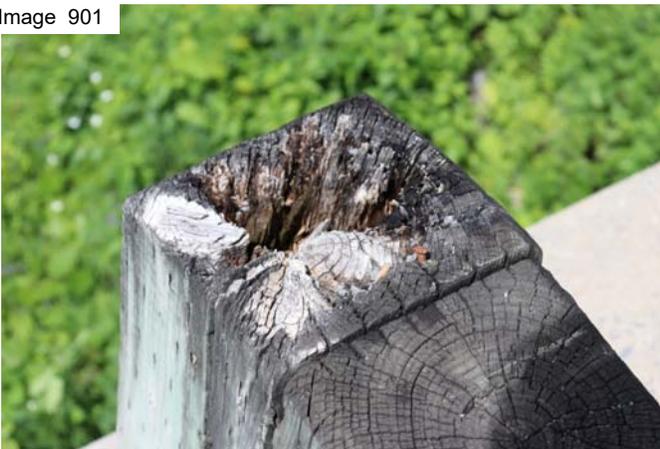
Image 901

Post rot (typical)

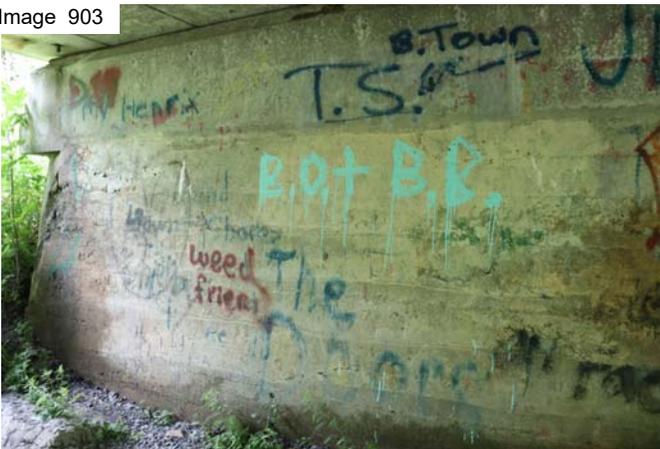
Image 903

North abutment

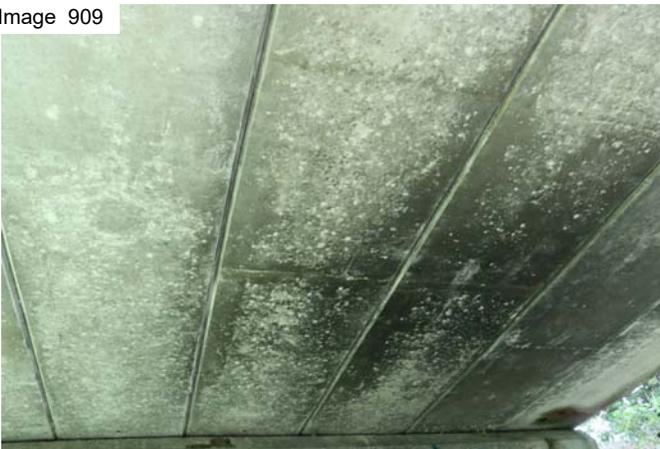
Image 909

Soot stains in north soffit

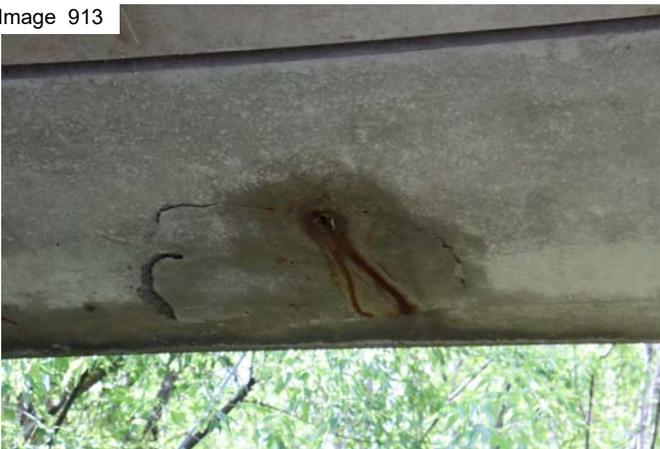
Image 913

Soffit delamination at west

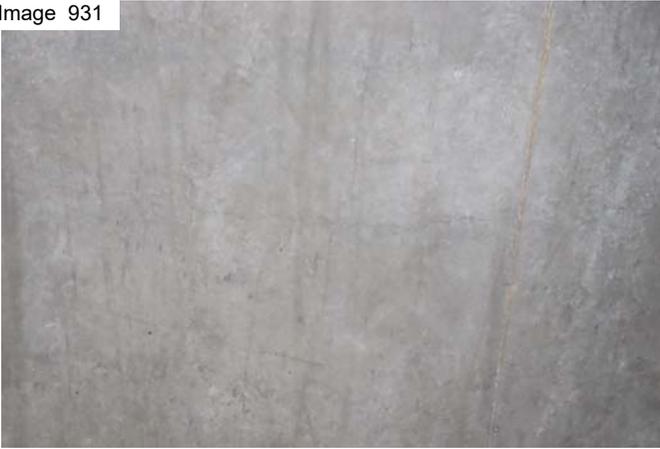
Image 931

Hairline transverse crack in soffit

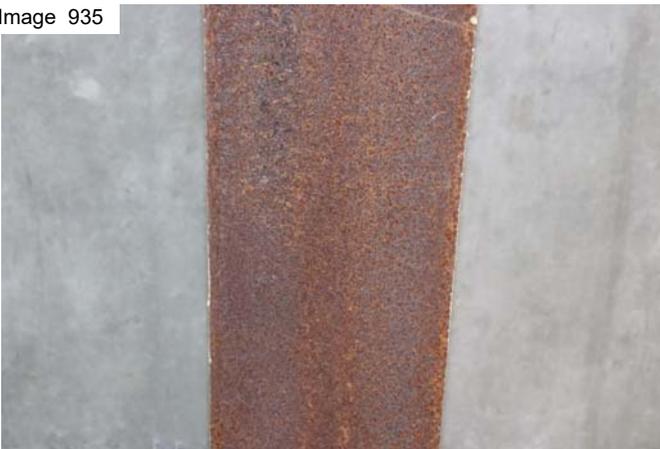
Image 935

Girder bottom condition (typical)

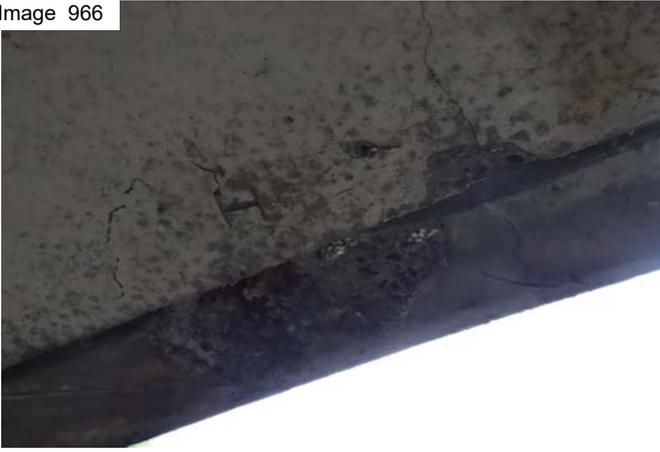
Image 966

Spalling in south soffit

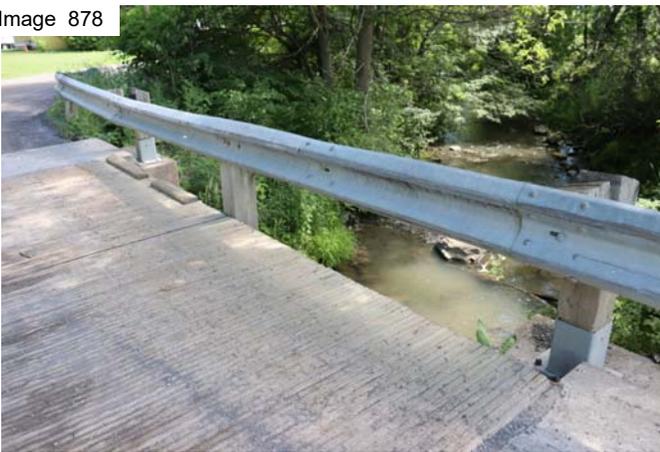
Image 878

East guide rail with missing curb

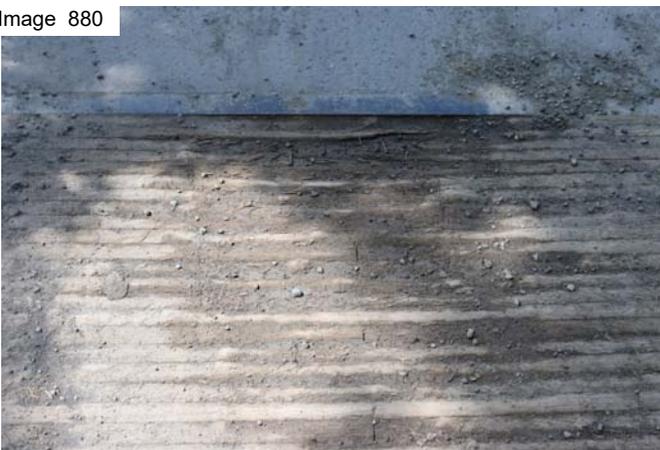
Image 880

Wheel path wearing in deck

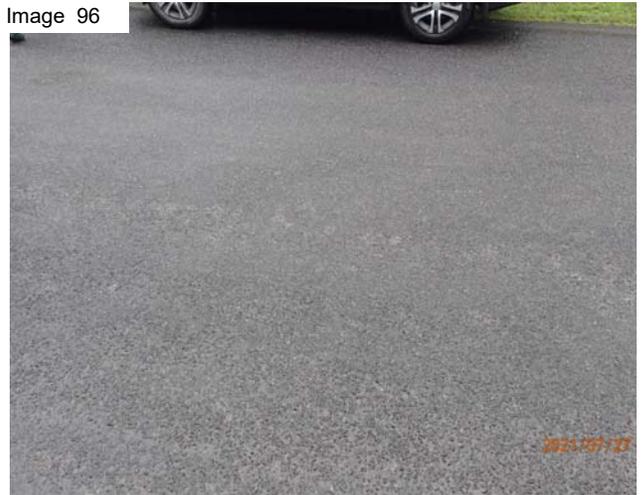
Image 96

Wearing surface overtop

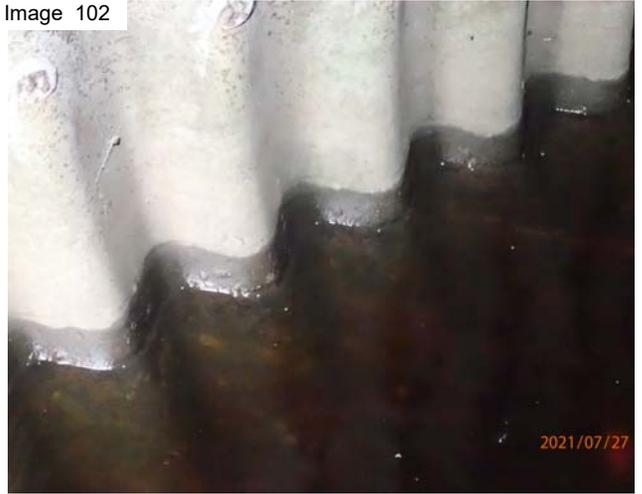
Image 102

Waterline condition

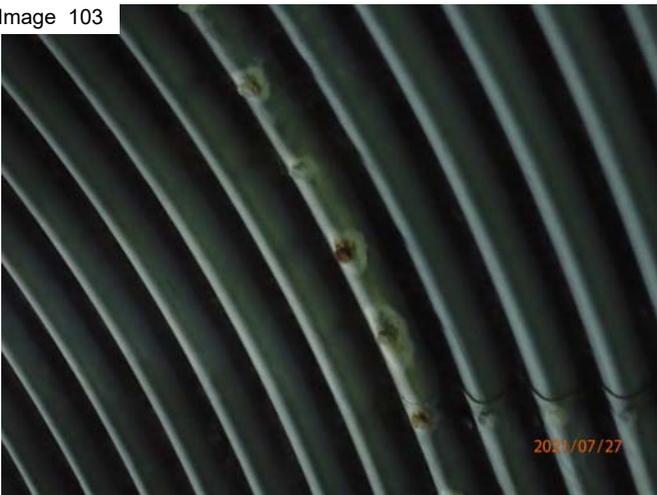
Image 103

Leaching and rust at bolts

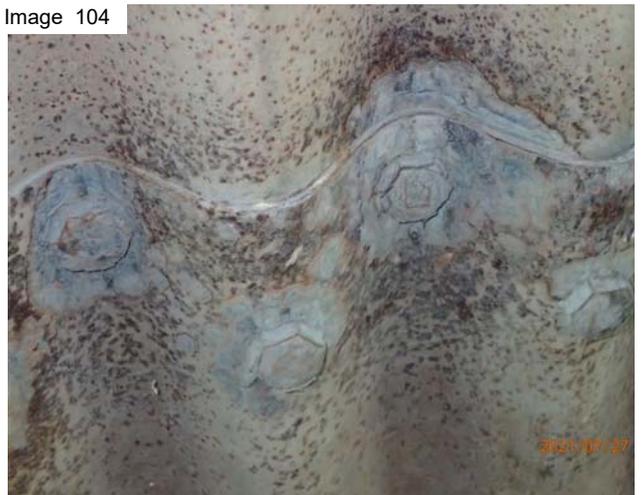
Image 104

Corrosion near waterline

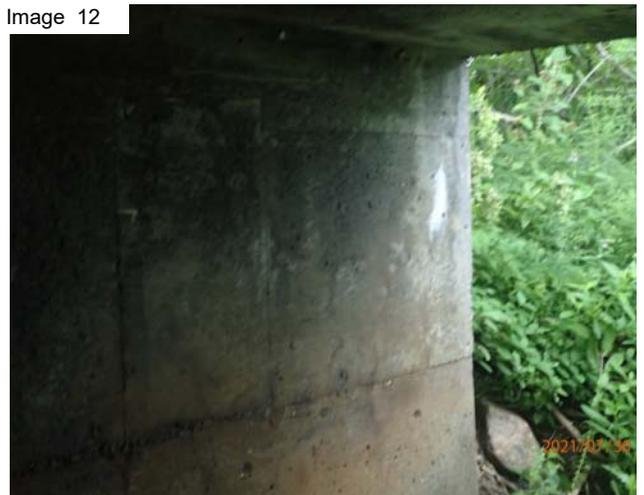
Image 12

Leaching crack wall in the SE

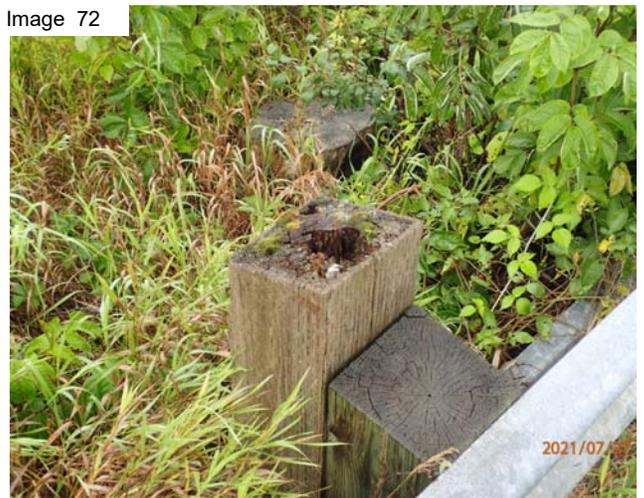
Image 72

Typical post decay

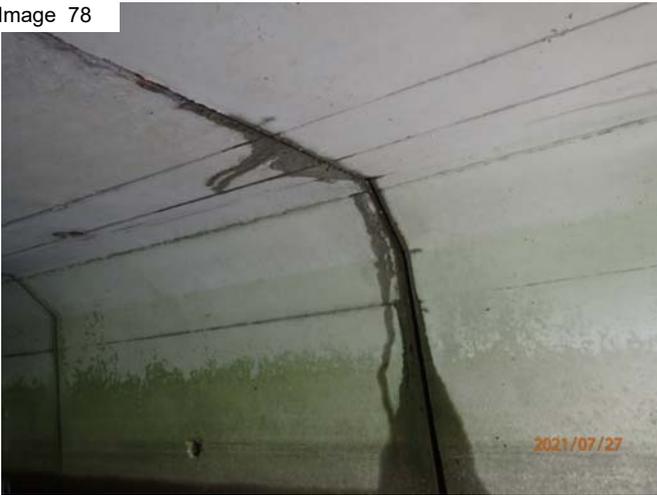
Image 78

Leaky joint at north

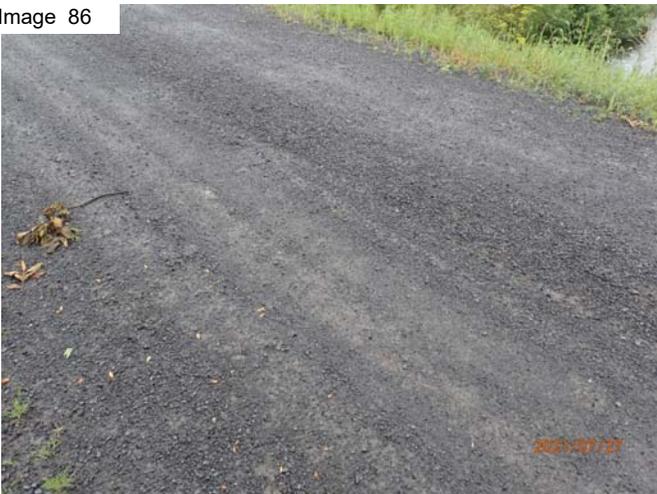
Image 86

Gravel wearing surface overtop

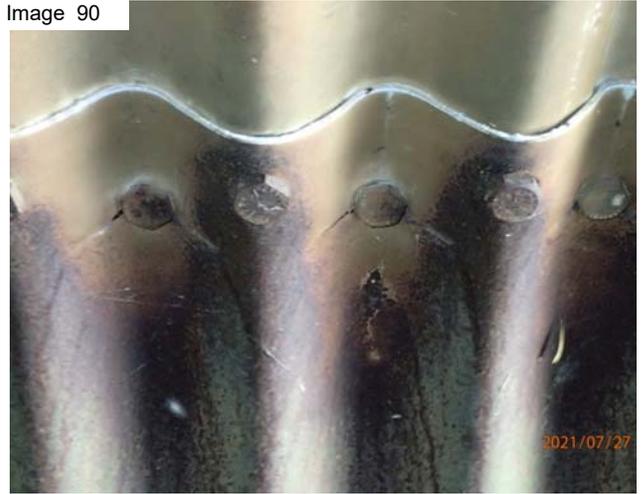
Image 90

Boltline cracking

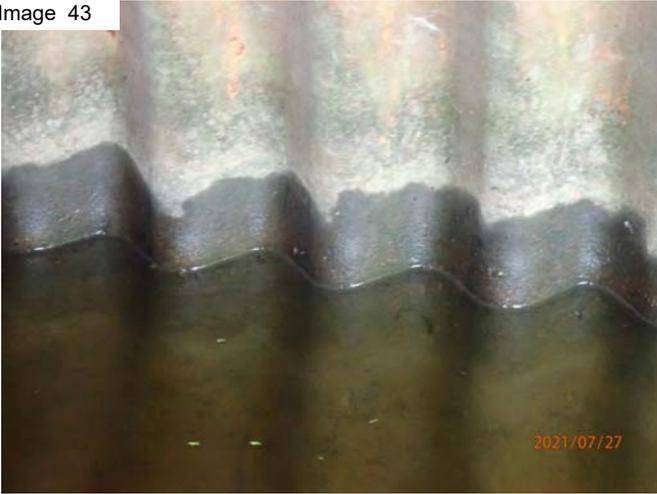
Image 43

Condition of wall at waterline

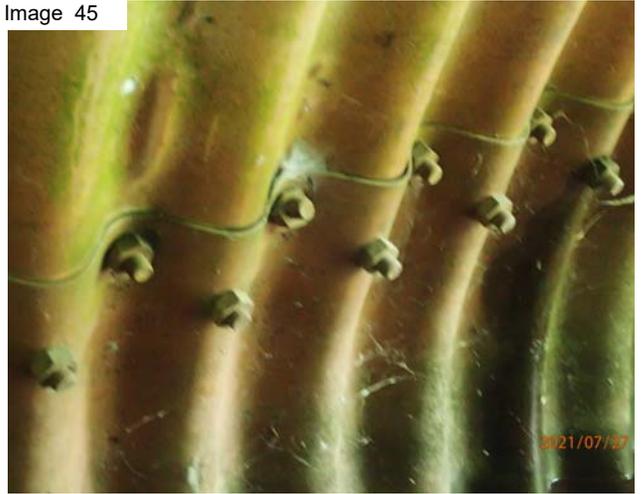
Image 45

Bent bolt in NE
