2019 BIENNIAL STRUCTURE INSPECTION PROGRAM

Township of South Stormont – September 2019

Keystone Bridge Management Corp.

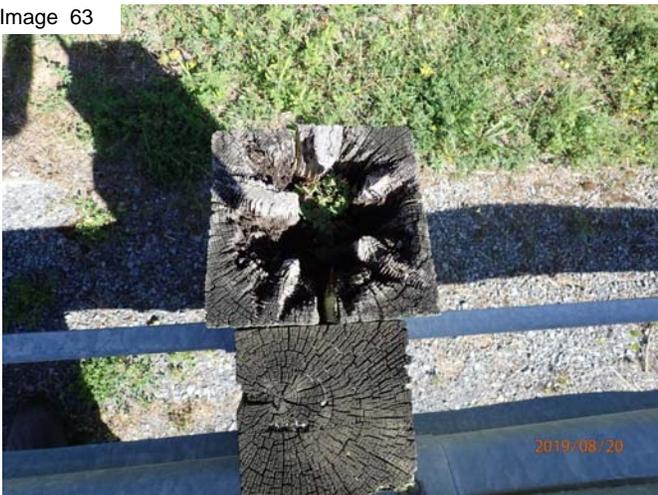
Image 63

NE guide rail post decay

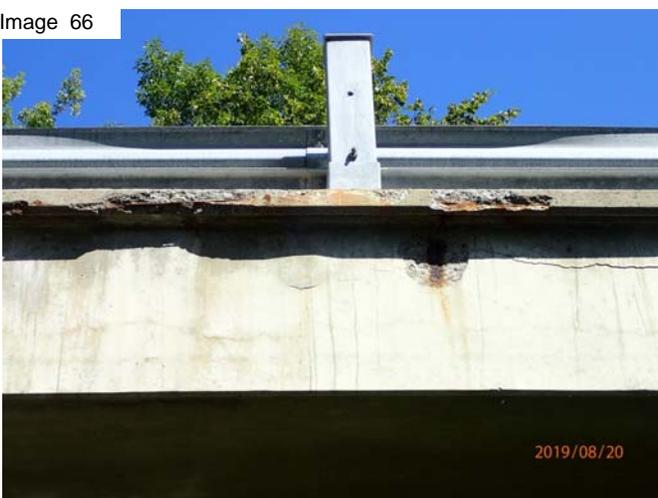
Image 66

South exterior spalling

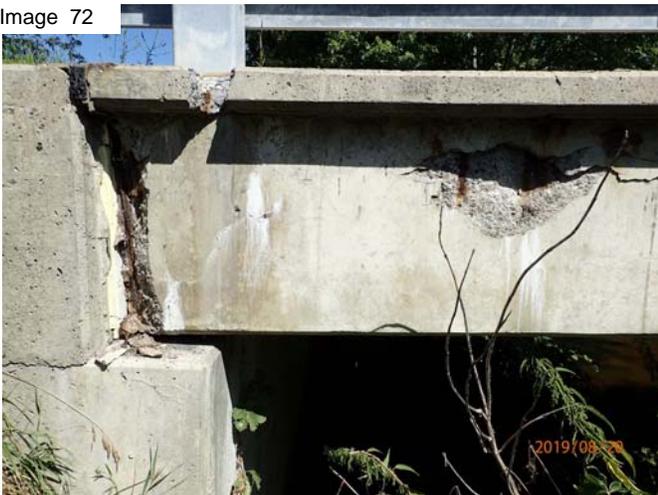
Image 72

SW exterior spalling

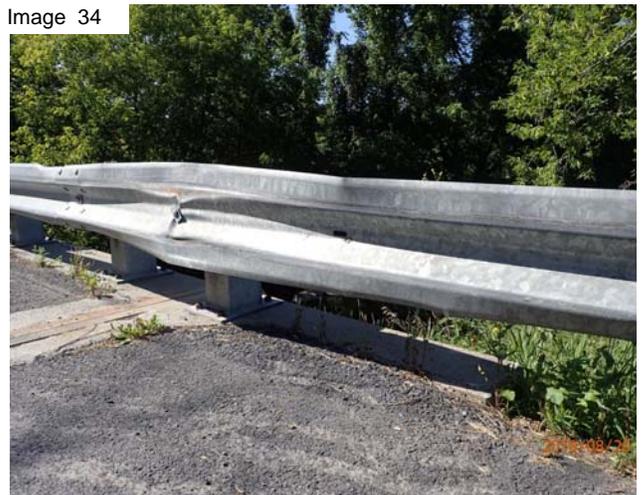
Image 34

NW guide rail impact damage

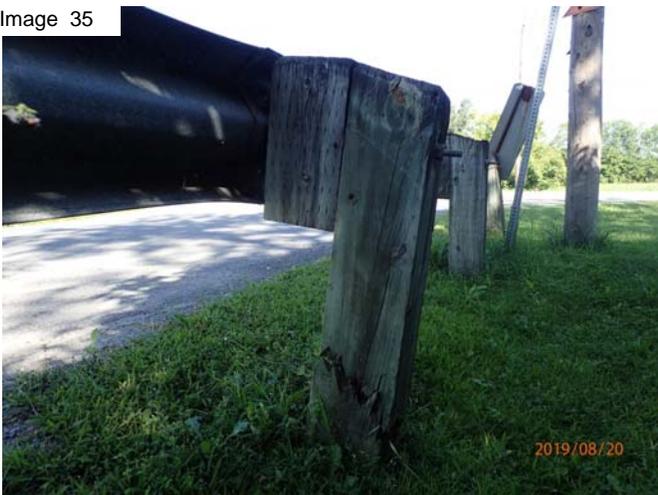
Image 35

NE guide rail post severed

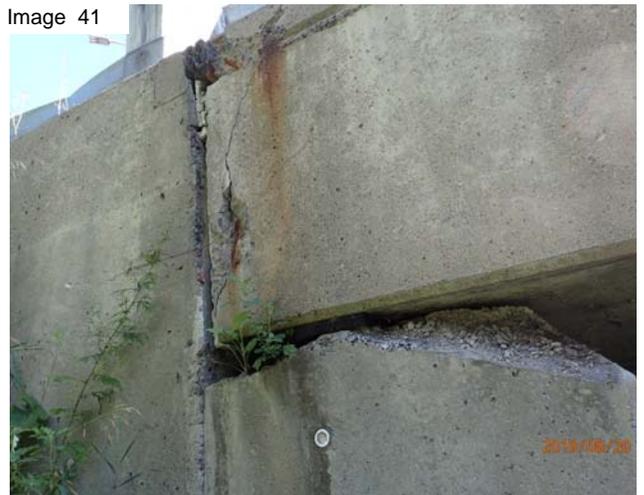
Image 41

NW corner typ damage at corners

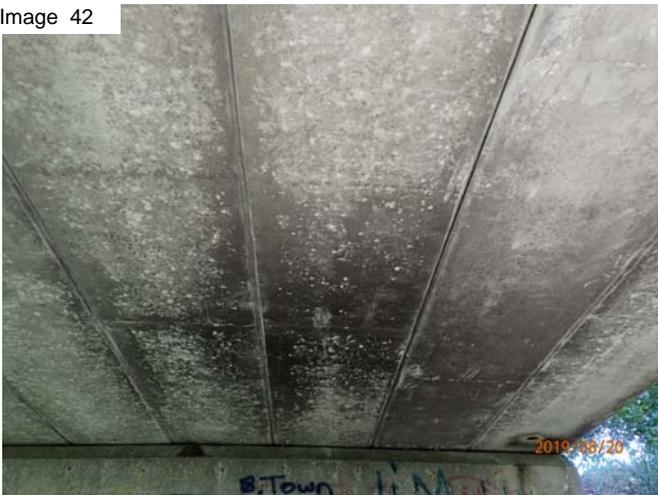
Image 42

North soffit fire damage

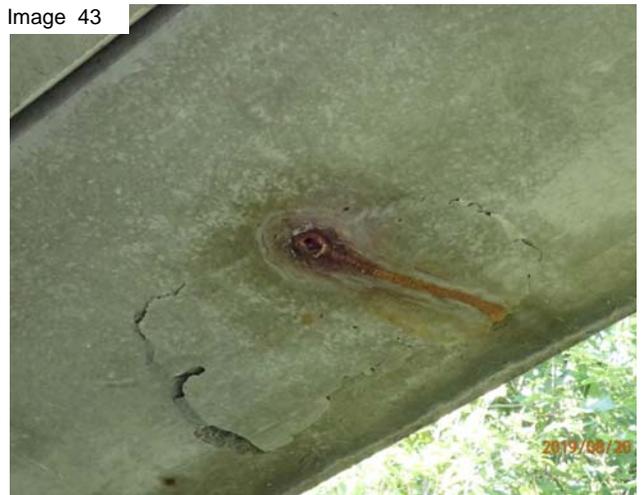
Image 43

West exterior girder delamination

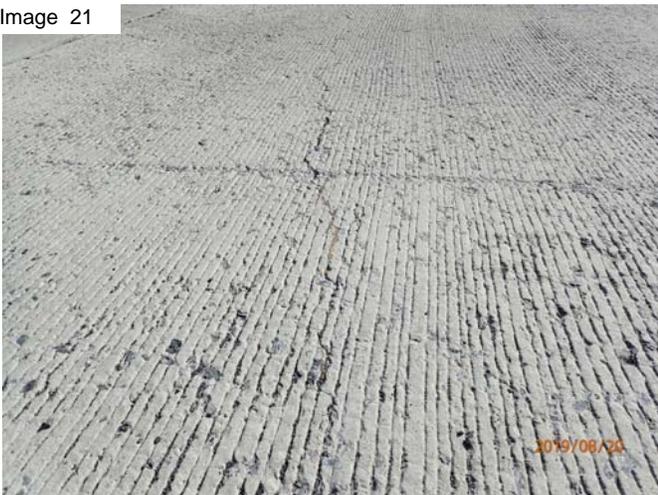
Image 21

North end deck cracking

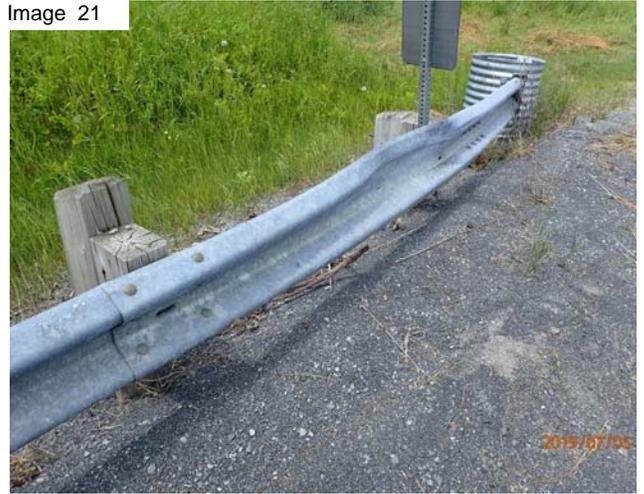
Image 21

Impact damage NW end

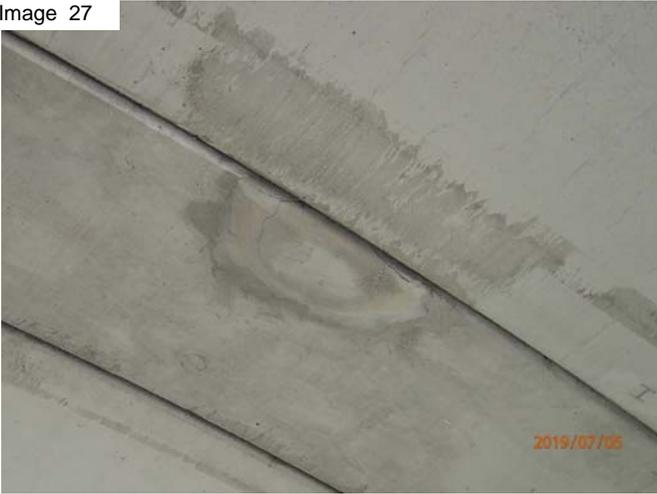
Image 27

Small repaired area in soffit

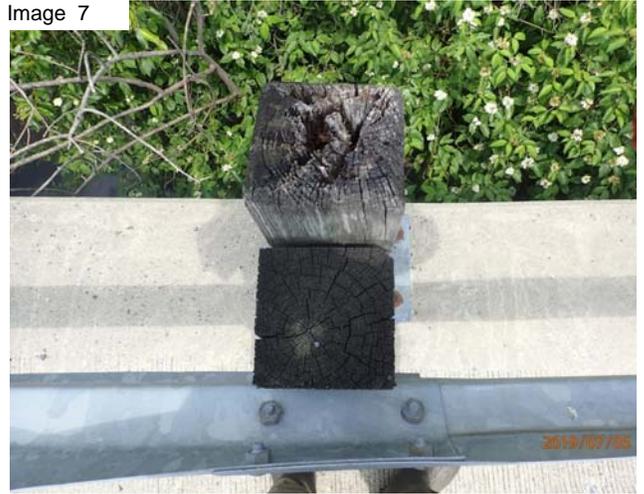
Image 7

Typ decay in post tops

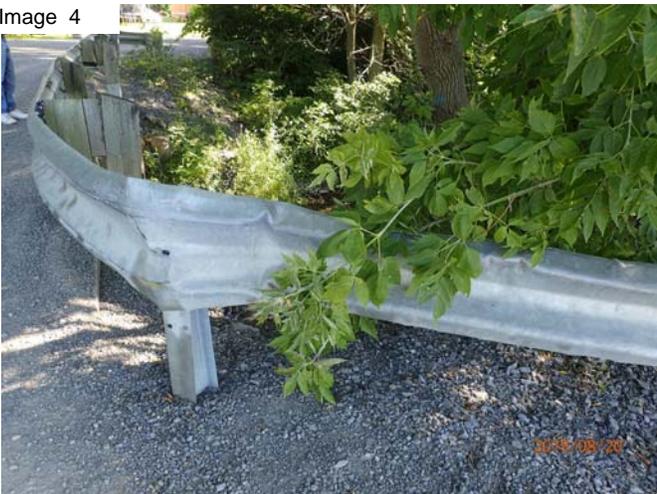
Image 4

SE guide rail impact damage

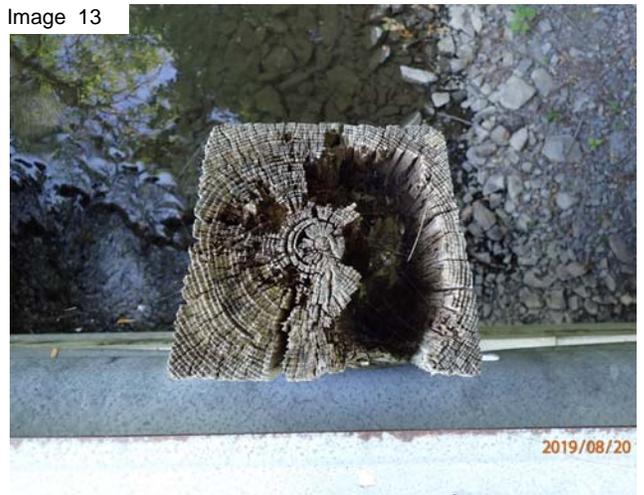
Image 13

West guide post decay

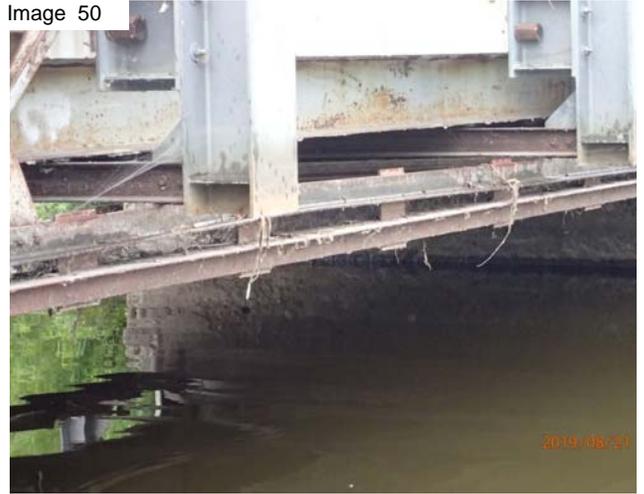
Image 50

Damaged bottom chord east side

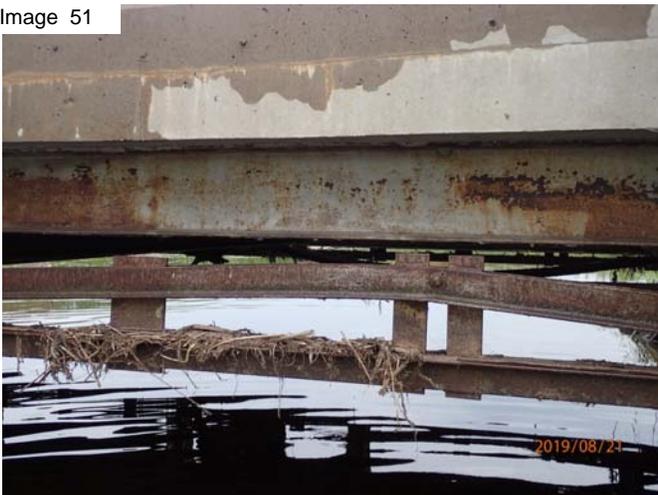
Image 51

Damaged bottom chord west side

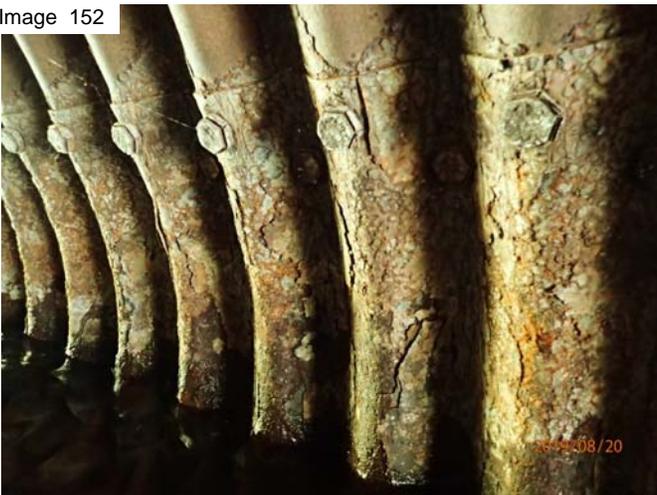
Image 152

East wall close up corrosion

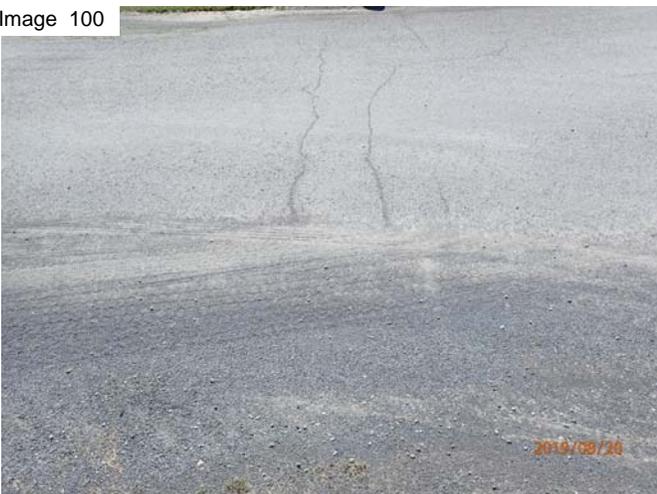
Image 100

Asphalt over culvert with flexural cracking

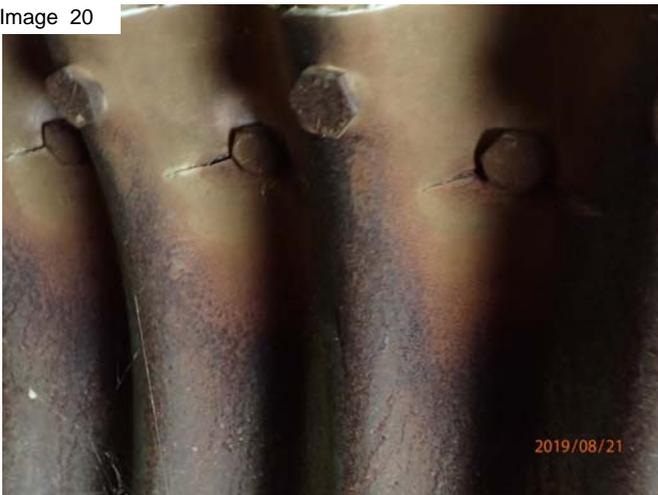
Image 20

Bolt line cracks west wall

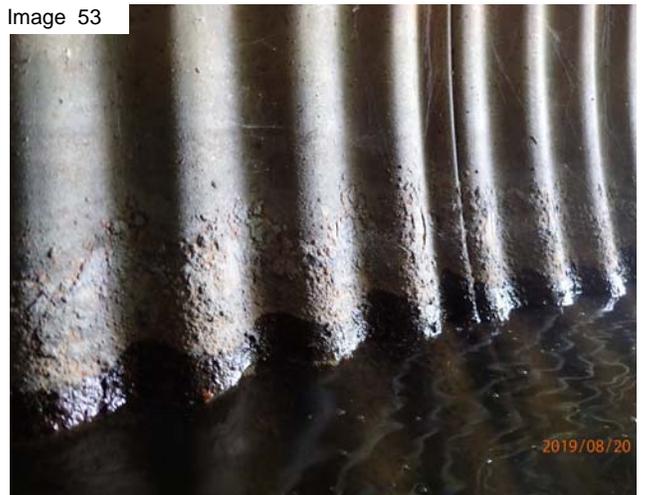
Image 53

North wall corrosion at water line
