2021 BIENNIAL STRUCTURE INSPECTION PROGRAM

Township of South Stormont – October 2021

Keystone Bridge Management Corp.

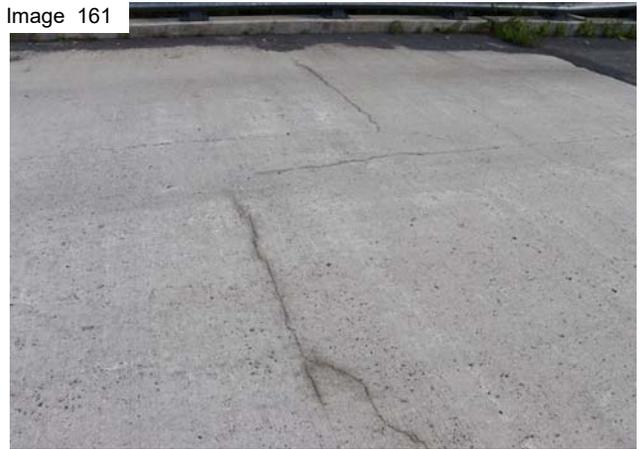
Image 161

Deck surface

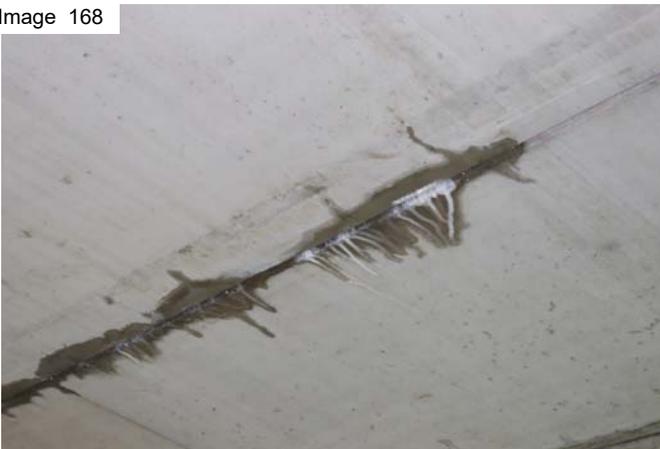
Image 168

Soffit joint leaching and saturation

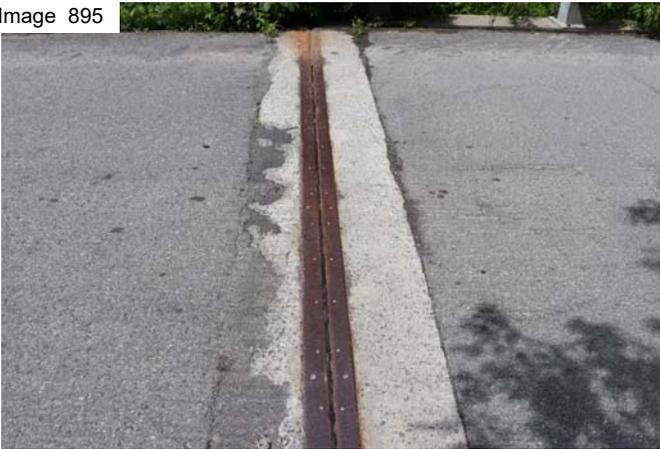
Image 895

South expansion joint

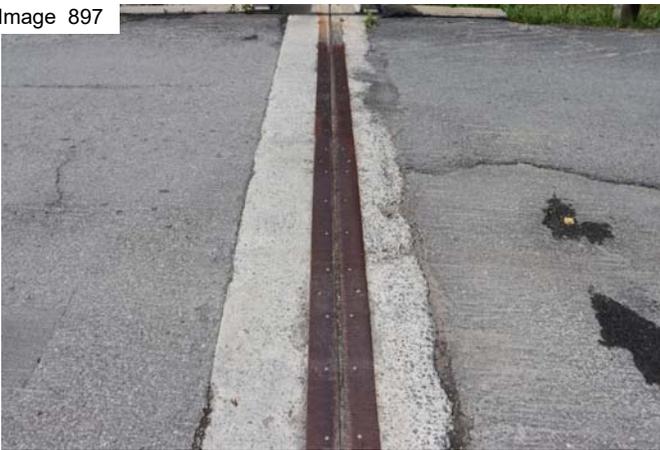
Image 897

North expansion joint

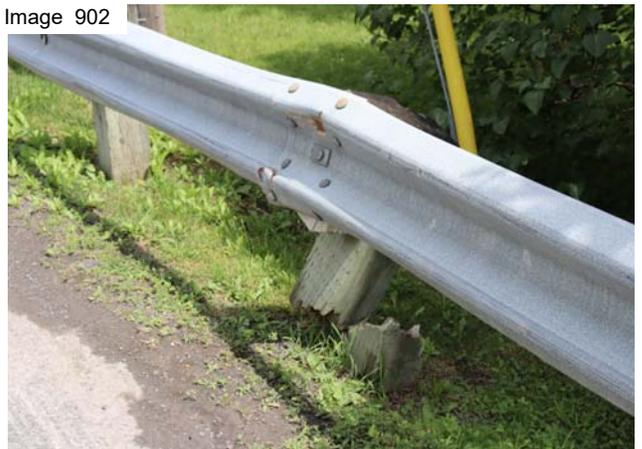
Image 902

NE guide rail damage

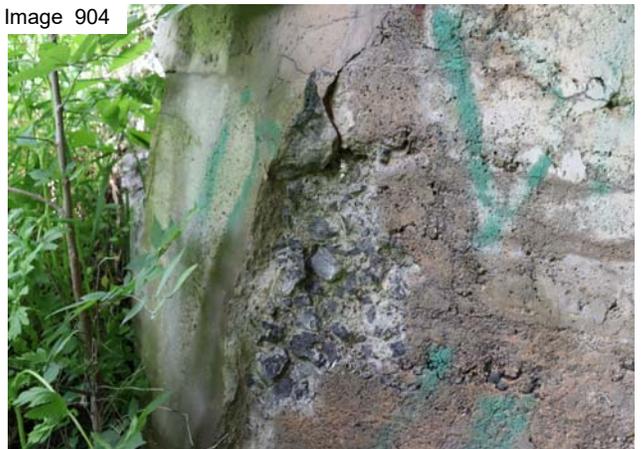
Image 904

Large spall NW corner

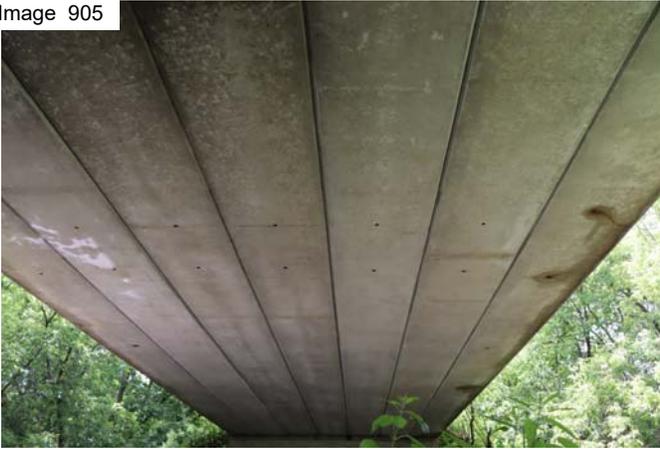
Image 905

Soffit

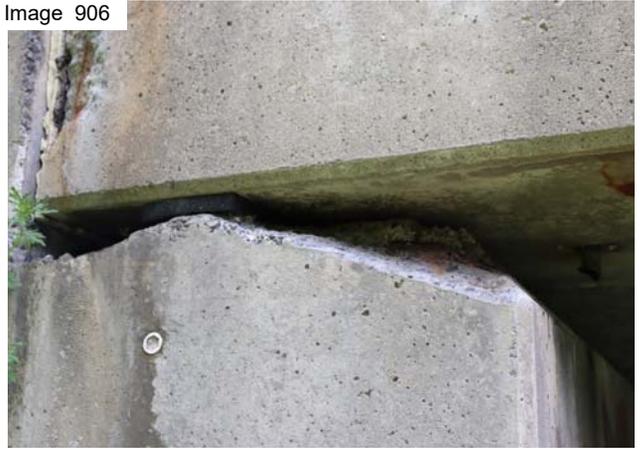
Image 906

NW bearing seat disintegration

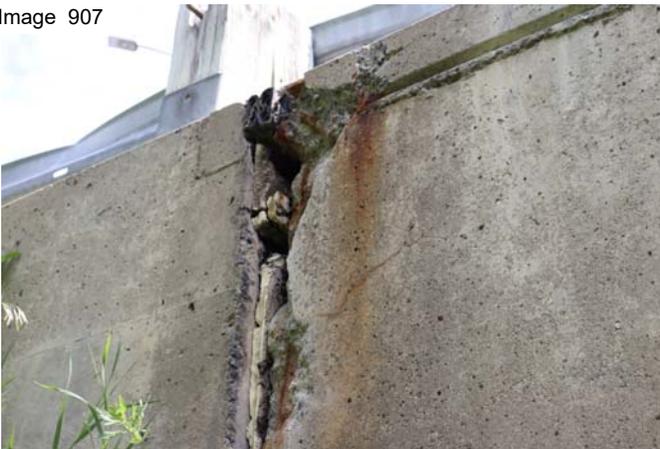
Image 907

NW corner disintegration under expansion joint

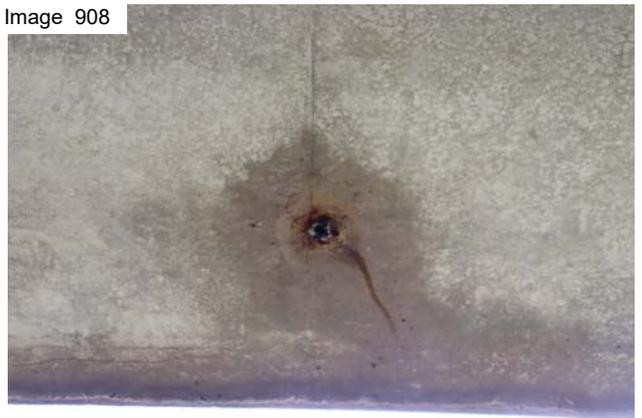
Image 908

Deck drain end with saturation and rust (typical)

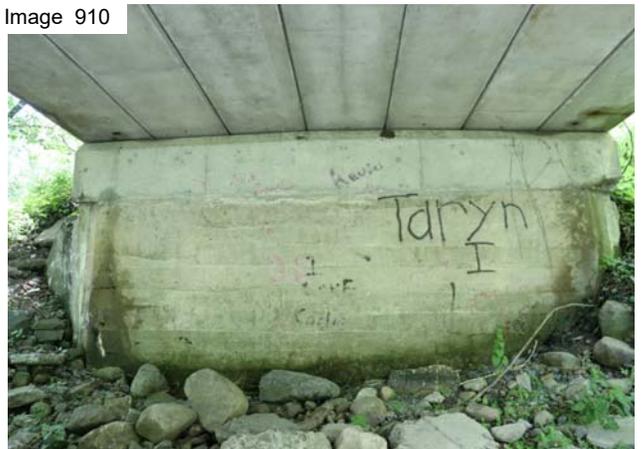
Image 910

South abutment

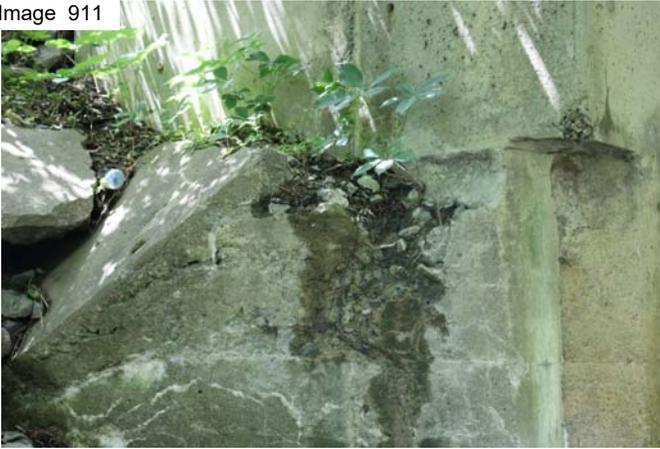
Image 911

SE wing wall disintegration

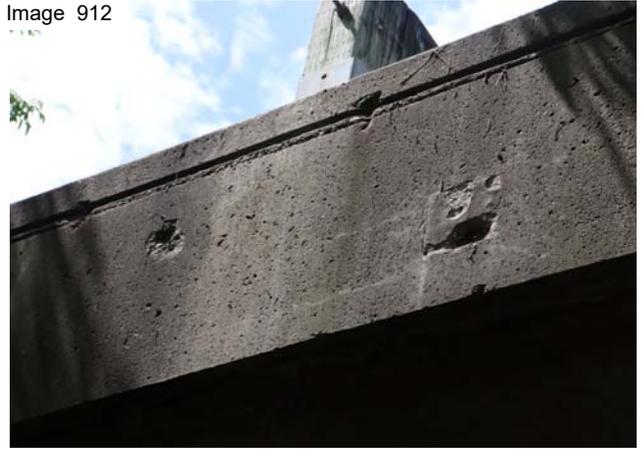
Image 912

Spalls on east fascia

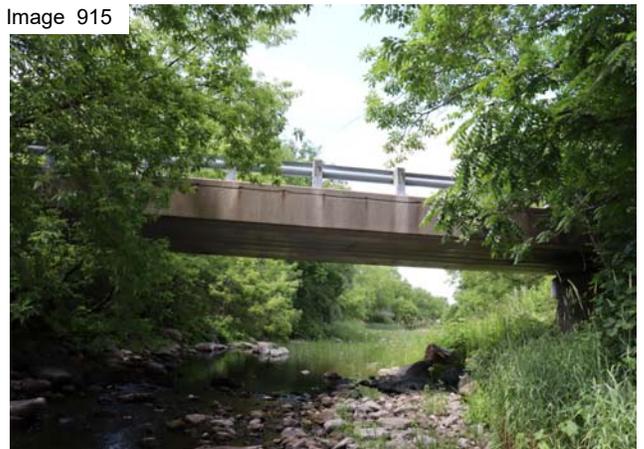
Image 915

East elevation

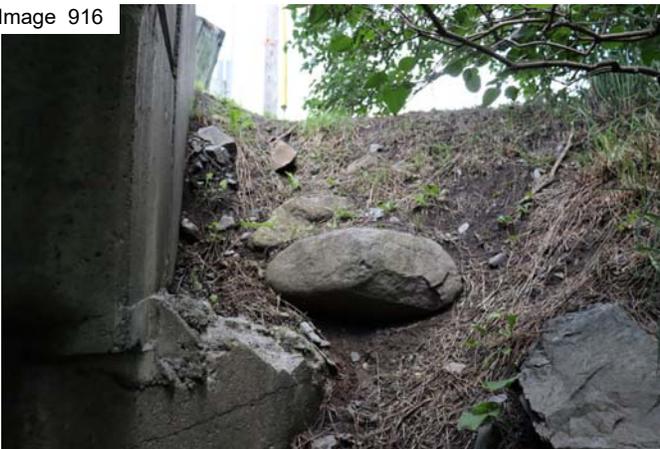
Image 916

Erosion NE corner

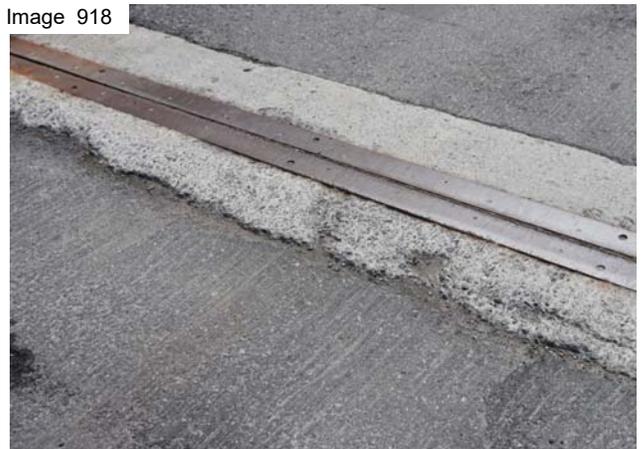
Image 918

North expansion joint end dam damage

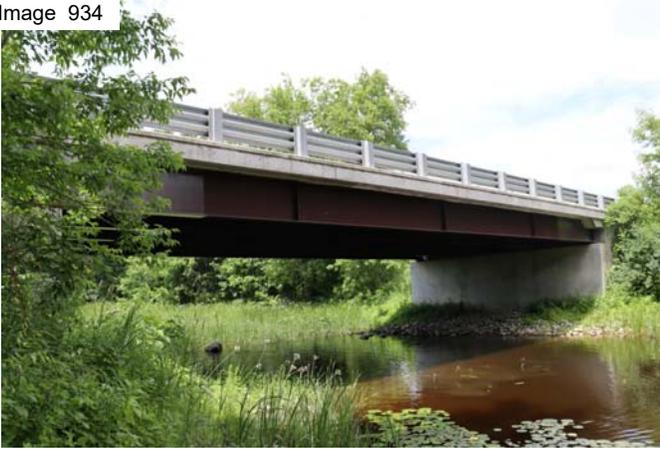
Image 934

East elevation

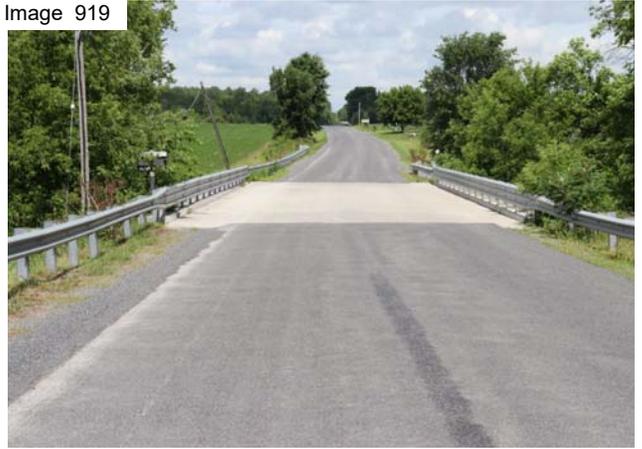
Image 919

South approach

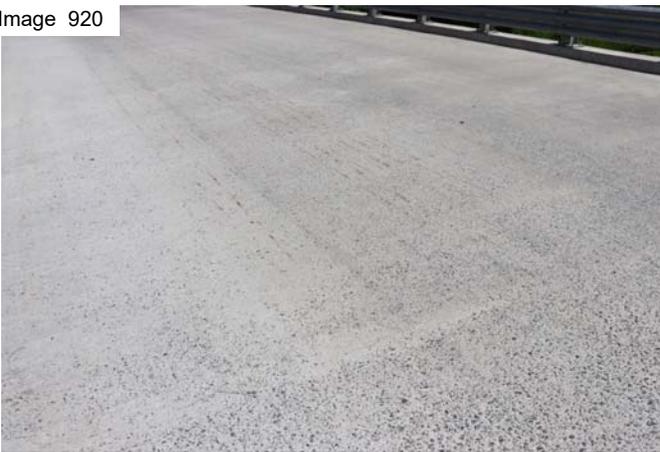
Image 920

Concrete deck surface

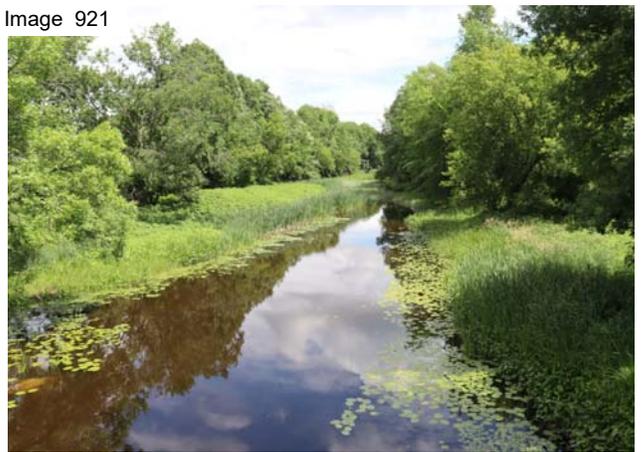
Image 921

East channel

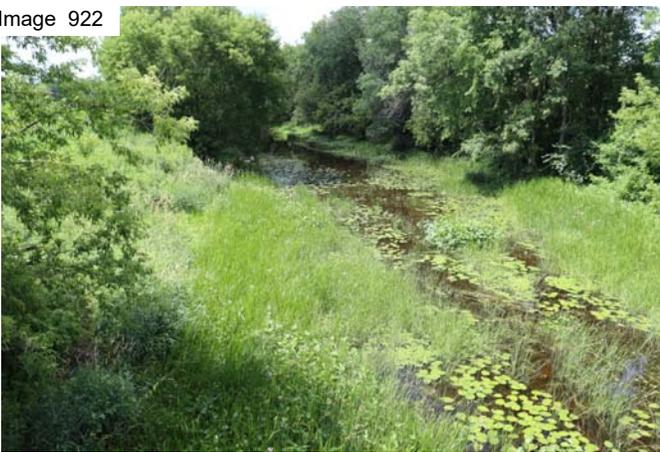
Image 922

West channel

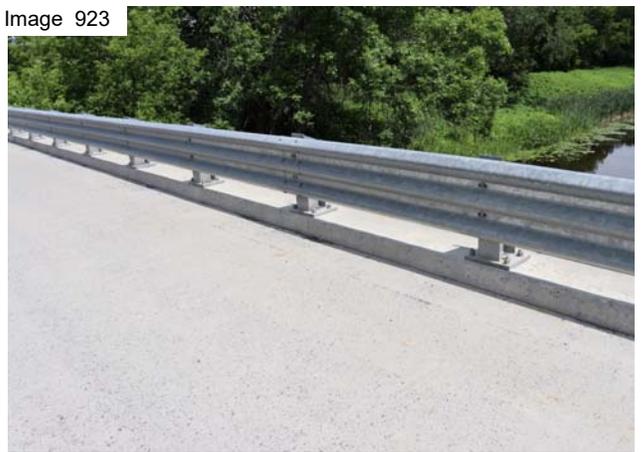
Image 923

East railing and curb

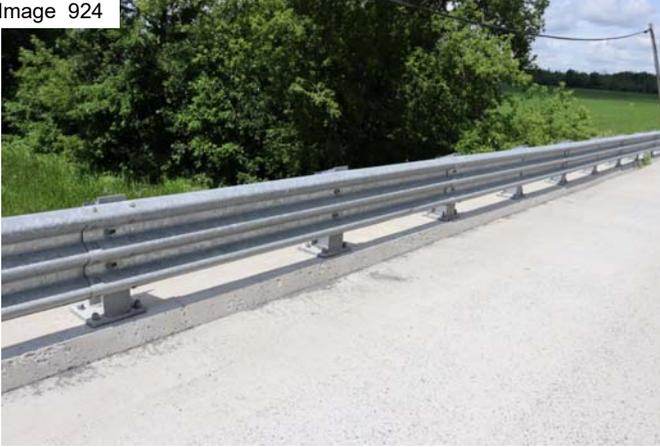
Image 924

West railing and curb

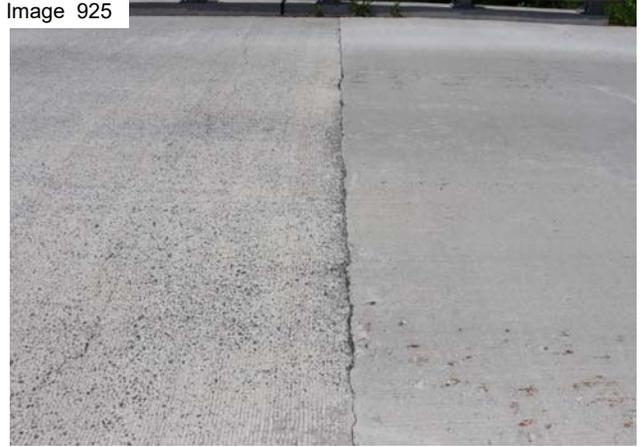
Image 925

North deck end

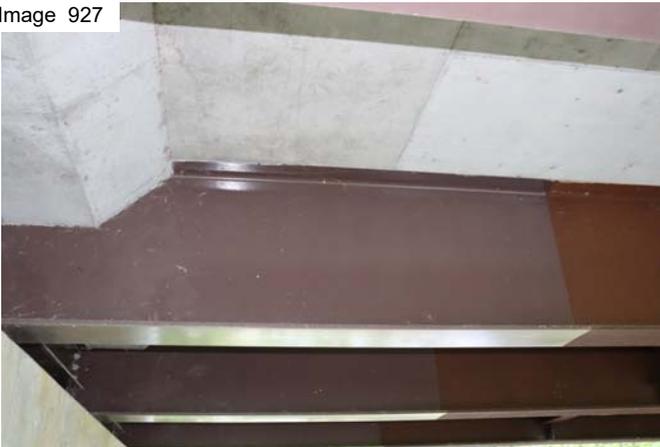
Image 927

Coated girder ends (typical)

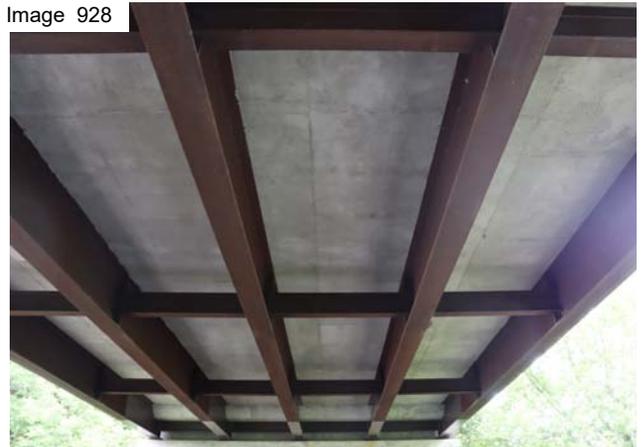
Image 928

Soffit

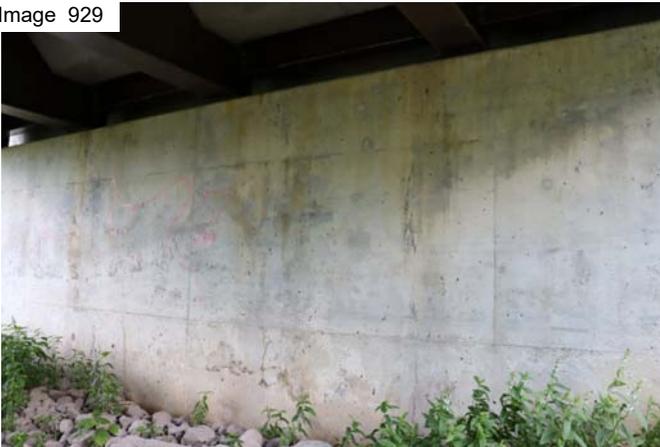
Image 929

North abutment

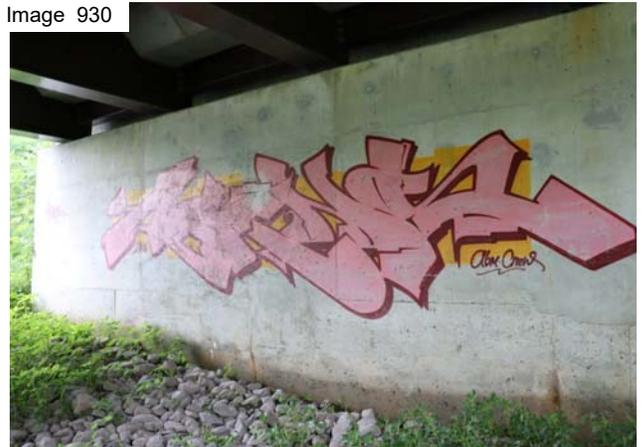
Image 930

South abutment

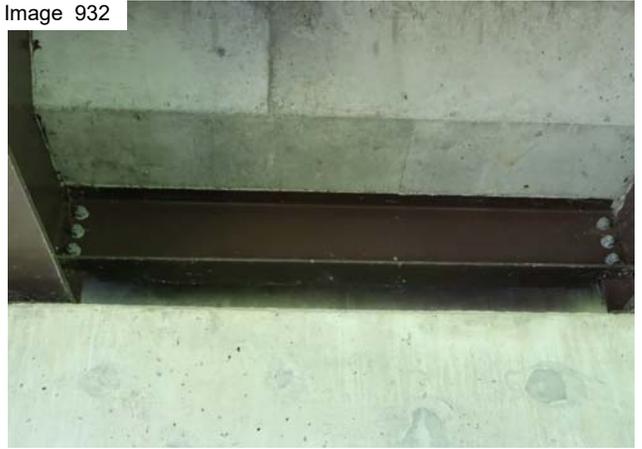
Image 932

Typical diaphragm in south

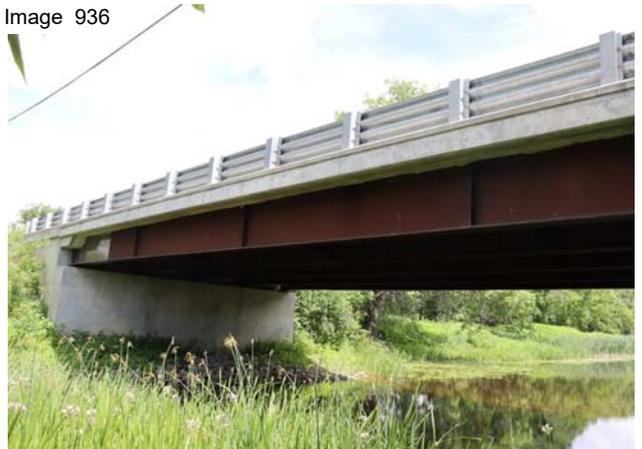
Image 936

West elevation

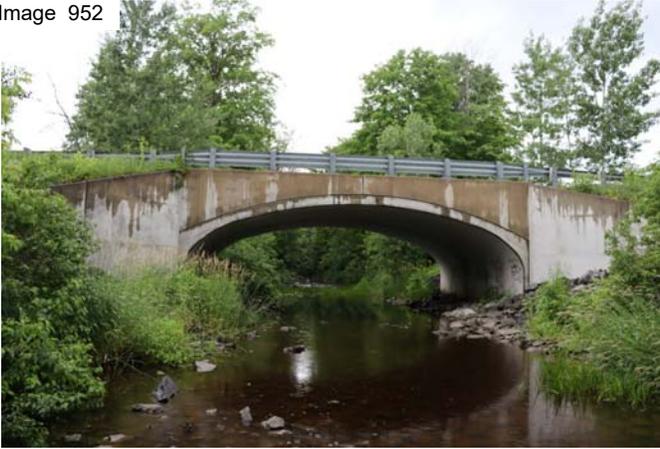
Image 952

East elevation

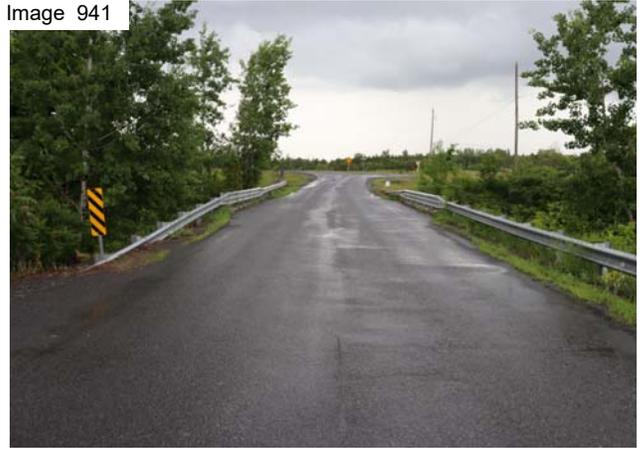
Image 941

South approach

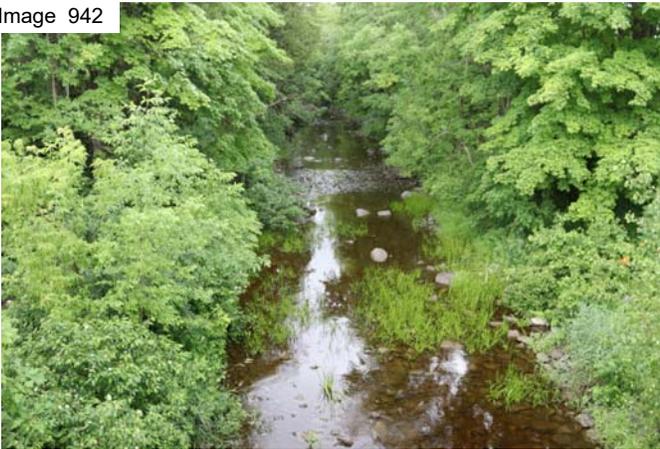
Image 942

West channel

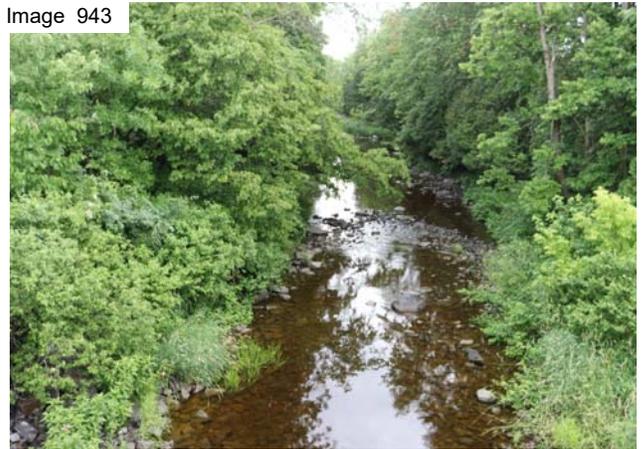
Image 943

East channel

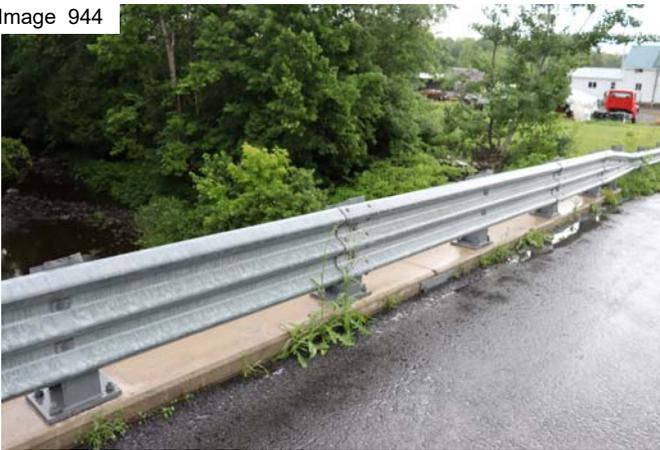
Image 944

East railing and curb

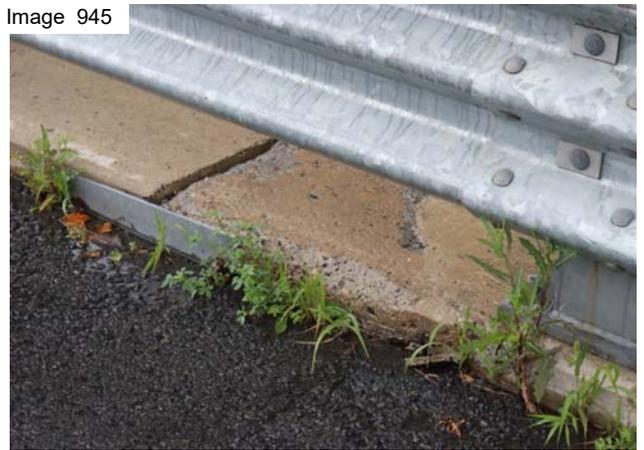
Image 945

West curb joint and plate

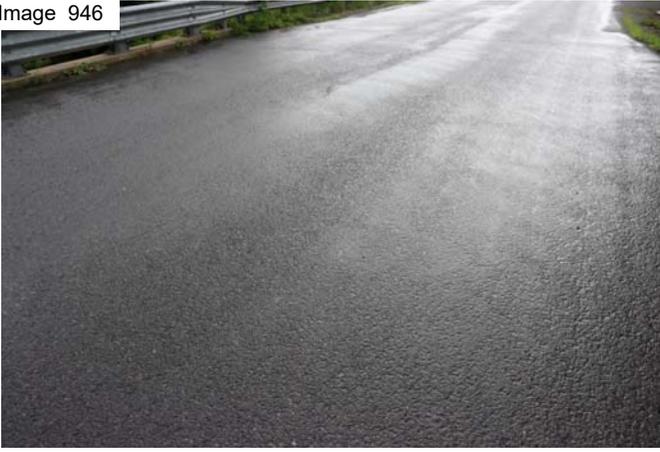
Image 946

Asphalt on deck

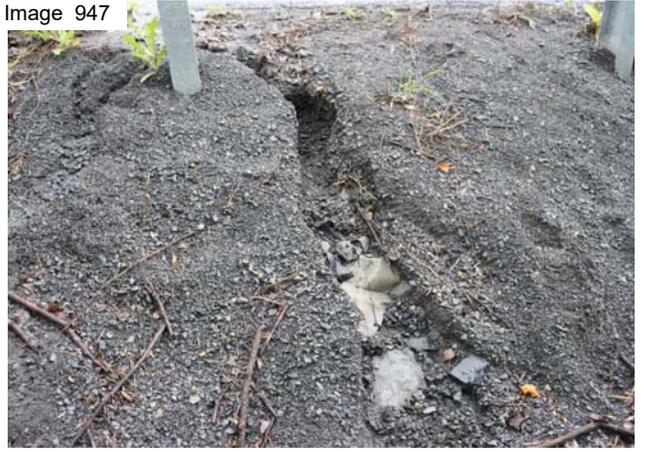
Image 947

Gullying NW

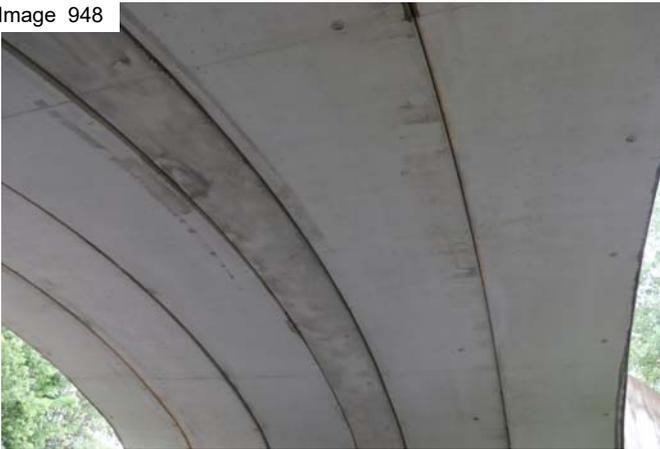
Image 948

Soffit

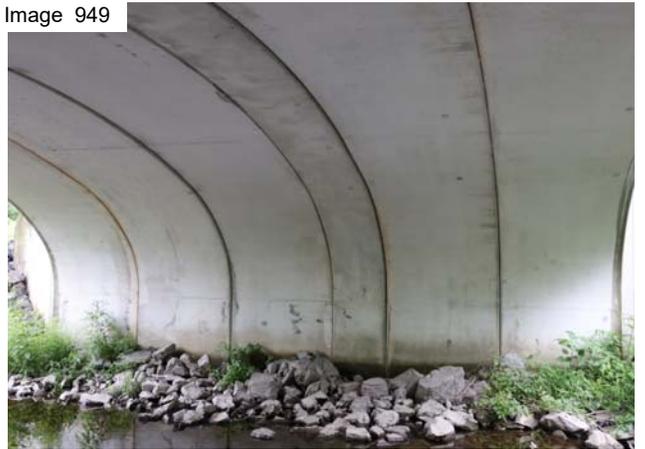
Image 949

South wall

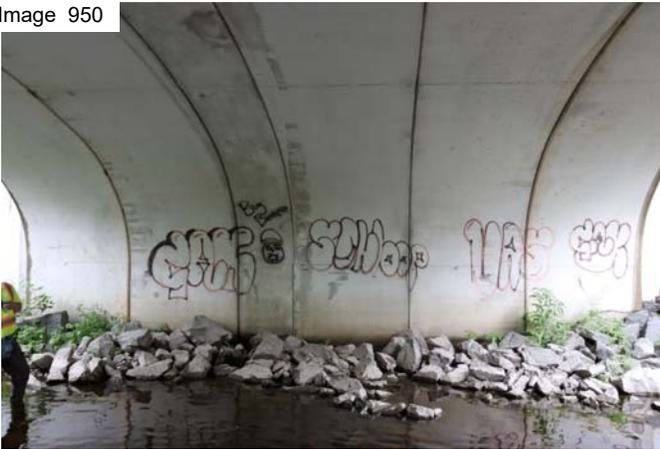
Image 950

North wall

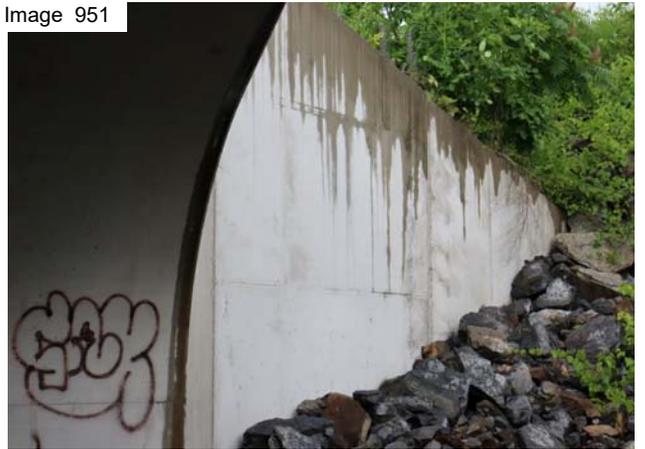
Image 951

NE wing wall (typical)

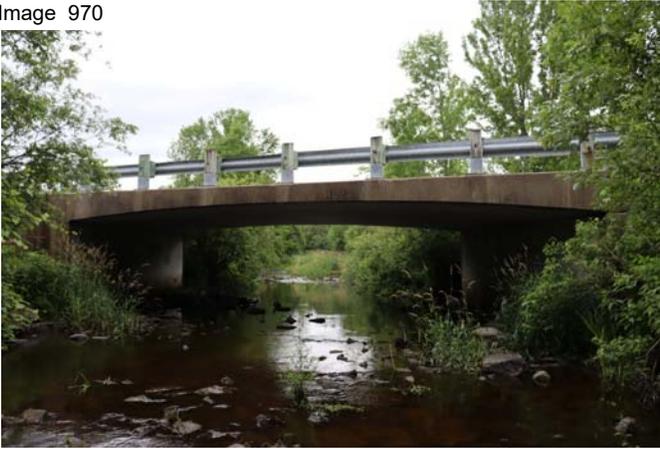
Image 970

South elevation

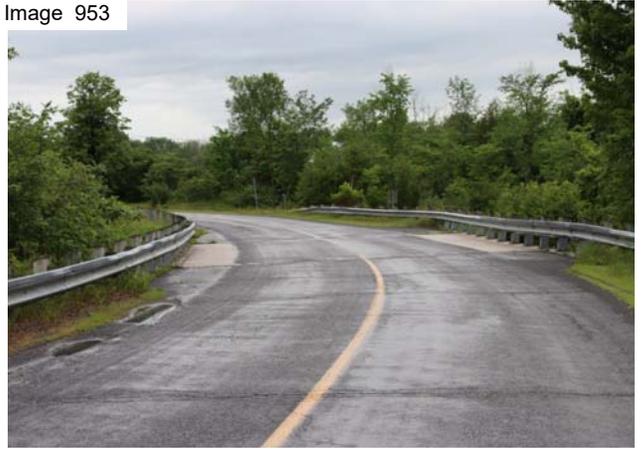
Image 953

East approach

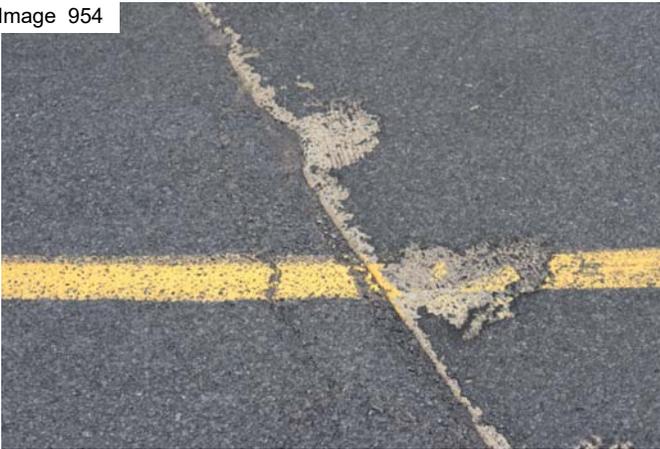
Image 954

East deck end

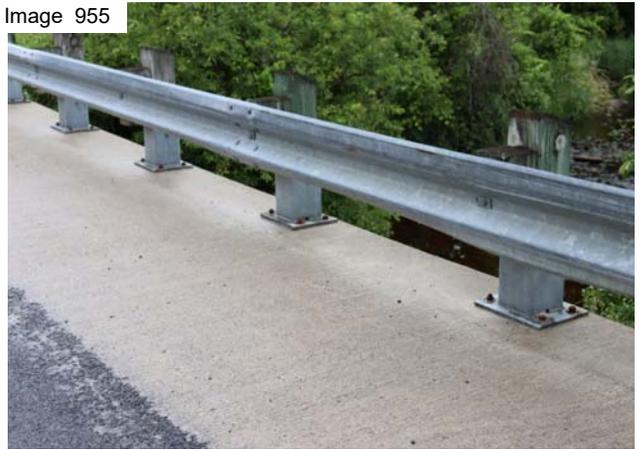
Image 955

North railing

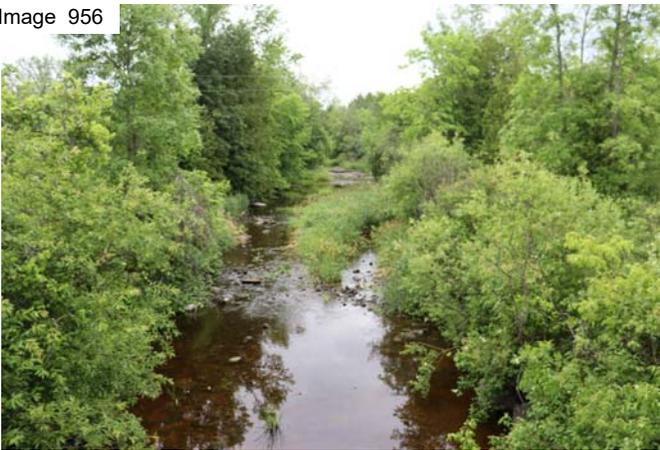
Image 956

North channel upstream

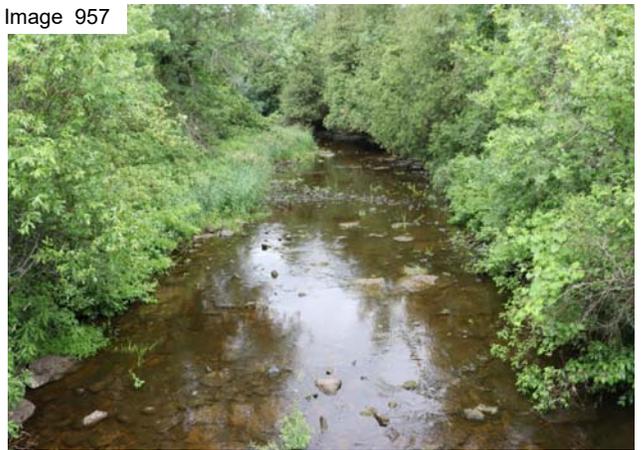
Image 957

South channel downstream

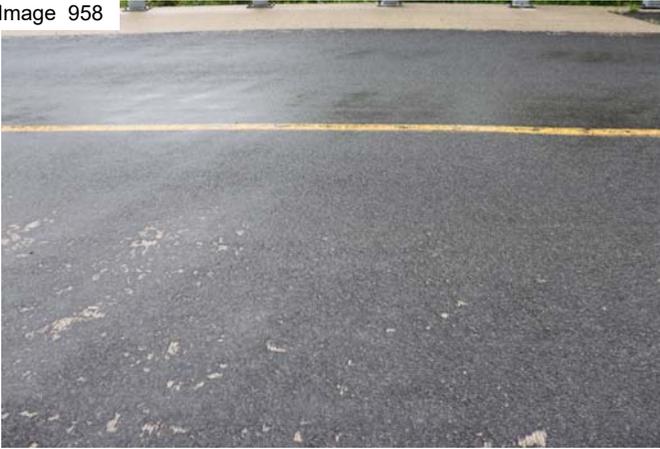
Image 958

Asphalt on deck (typical)

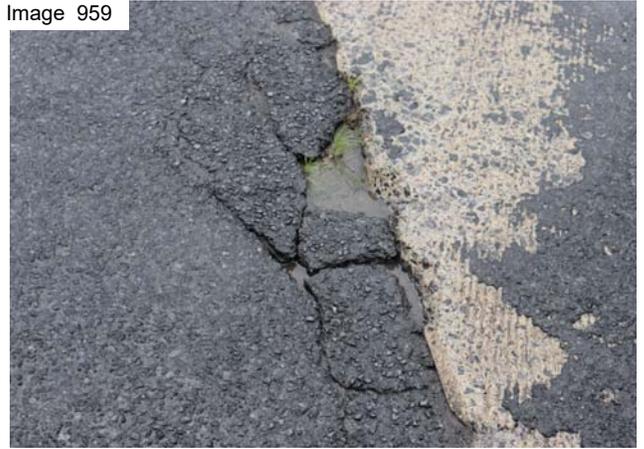
Image 959

Damage at west deck end

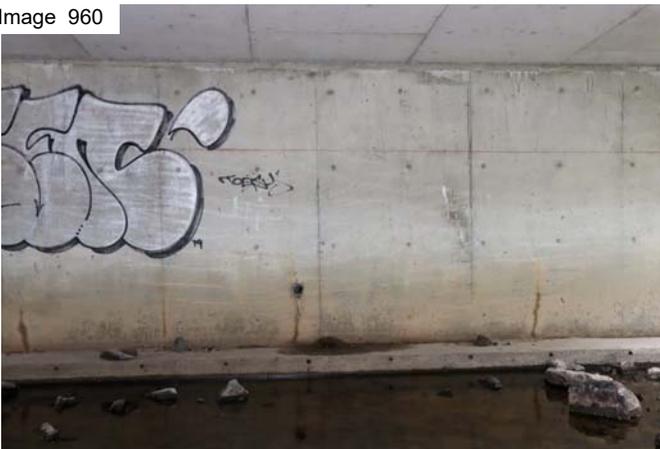
Image 960

East abutment

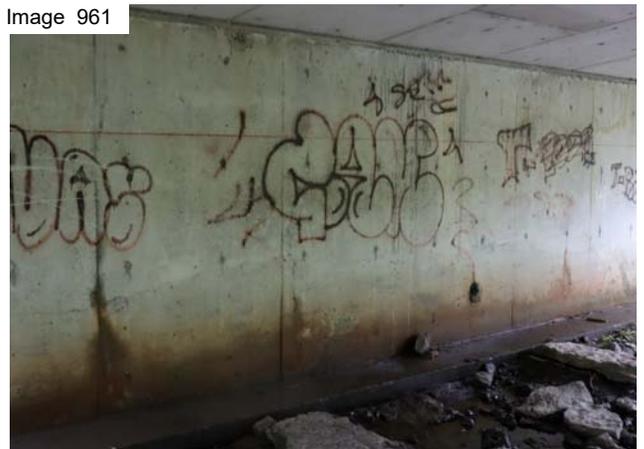
Image 961

West abutment

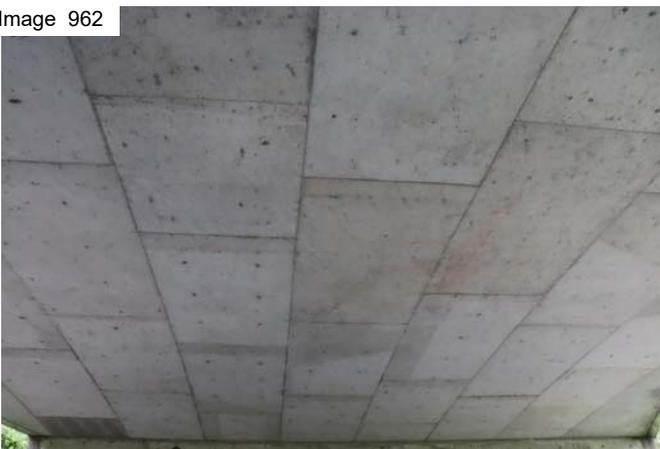
Image 962

Soffit

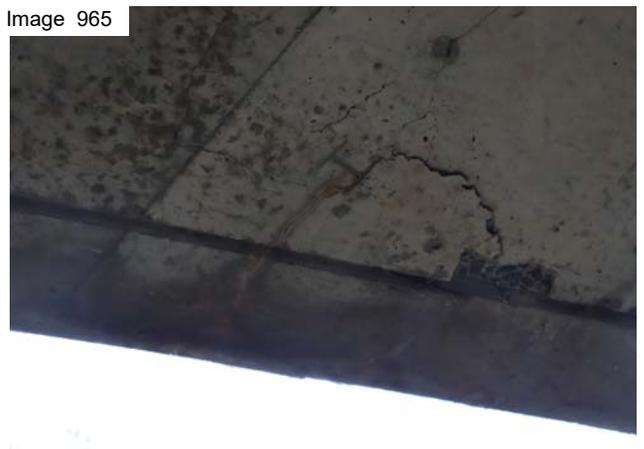
Image 965

Bridge is in good condition. Lack of proper drainage control on bridge is causing damage to soffit on the south side and will eventually damage abutment walls if left in current condition. The guide rail has many areas of collision damage due to the curved road alignment at the bridge. Buried end treatments do not meet the current standards. Due to the damage and performance deficiencies recommend the guide rail be replaced within two years. This may be a good time to add curbs to the bridge, the improved drainage from deck top would greatly benefit this bridge and prevent damage from water runoff.

Delamination in south soffit

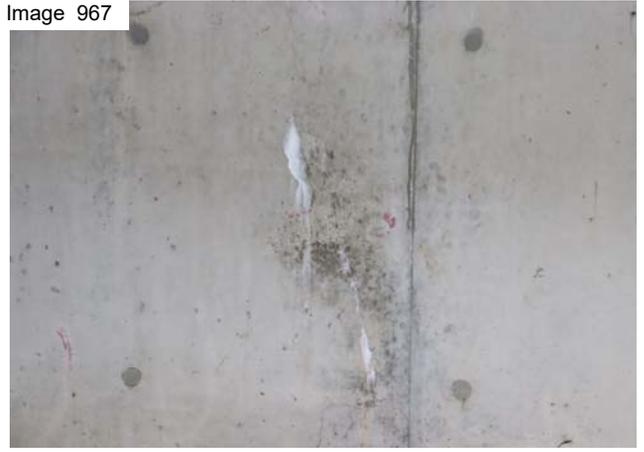
Image 967

Leaching east abutment

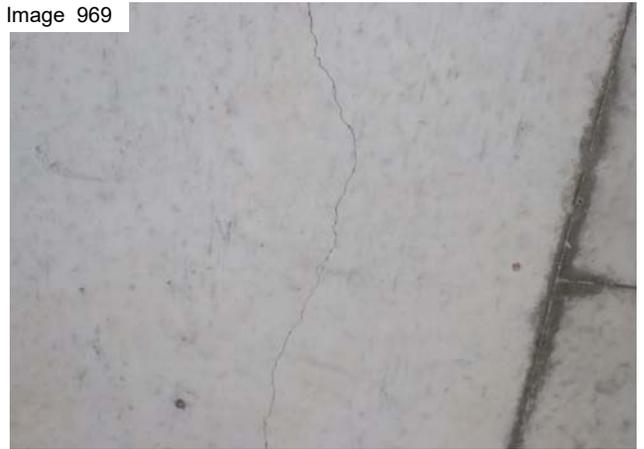
Image 969

Small soffit crack

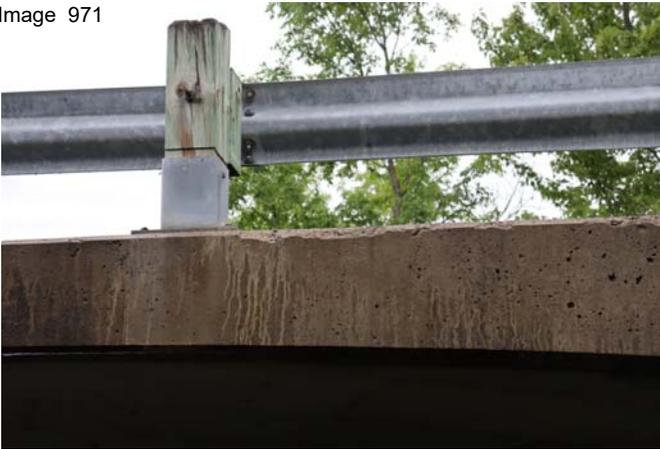
Image 971

South curb spall

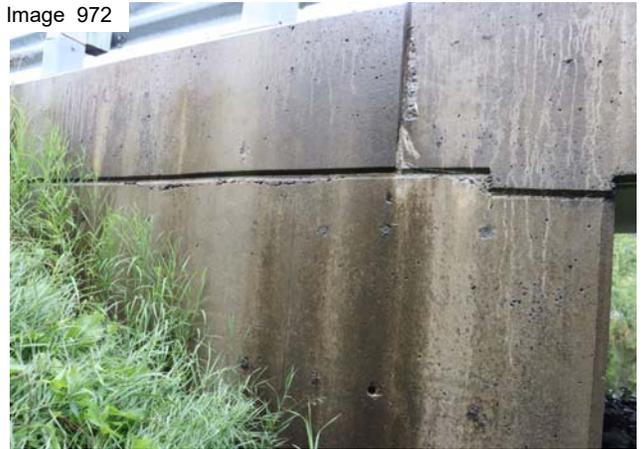
Image 972

SW wing wall (typical)

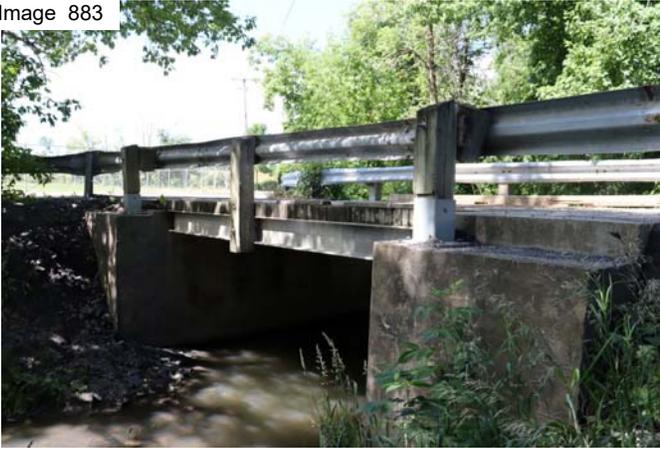
Image 883

East elevation

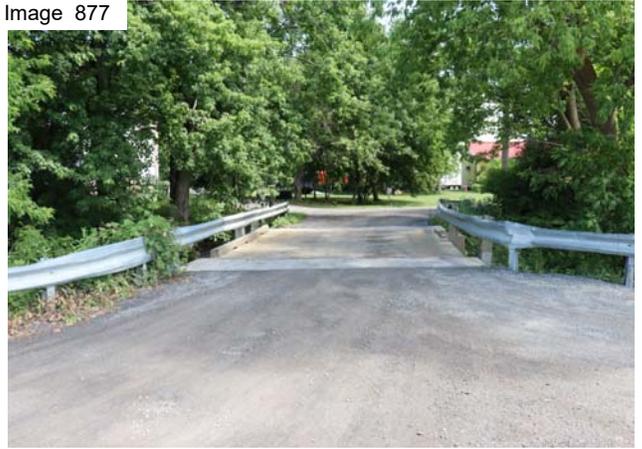
Image 877

South approach

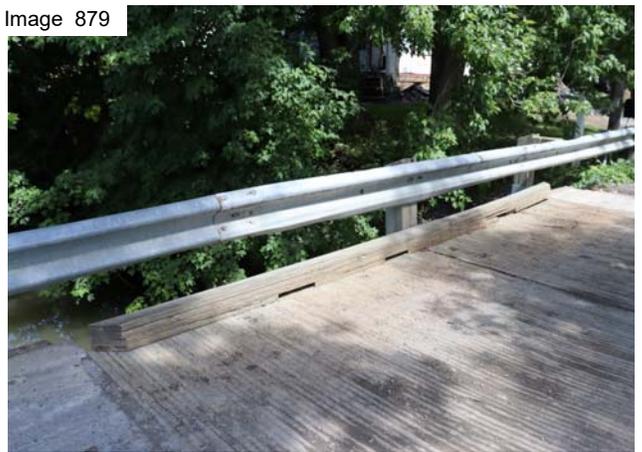
Image 879

Height: 0.16 m	<i>Curb on east side is mostly missing. West side is comprised of 3 2x8 boards. Boards have pulled up at north end. Similar conditions in 2021.</i>	
Steel Post & Guide Rail (4)	Defects 0.0%	
Approach Barrier	Damage 35.0%	Moderate Impact
Length: 15.6 m	Maintenance None	
Width:	Capital Rec. Replace in 1 year	Perf Def: Weakened
Height: 0.72 m	<i>Many impact strikes on flex beam. Post spacing not up to standard. 15.2 m (N) + 16.0 m (S).</i>	
Steel Beam on Wood Post (Defects 0.0%	
Guide Rail	Damage 25.0%	Moderate Impact, Major Decay
Length: 5.6 m	Maintenance None	
Width:	Capital Rec. Replace in 1 year	
Height: 0.72 m	<i>Major collision damage to both sides of guide rail barrier. Timber posts have major decay in top surface. Post spacing is not up to standard.</i>

West guide rail and curb

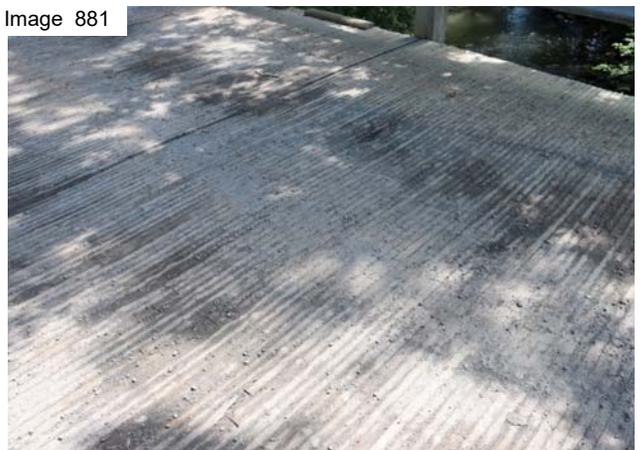
Image 881

The timber deck is showing moderate wear in the wheel paths and the bridge barrier system is in need of replacement. Bridge is low priority but barrier system is due for replacement. Consider replacing entire structure with new culvert instead of deck replacement.

Timber deck surface (typical)

Replace Deck, B/Wall

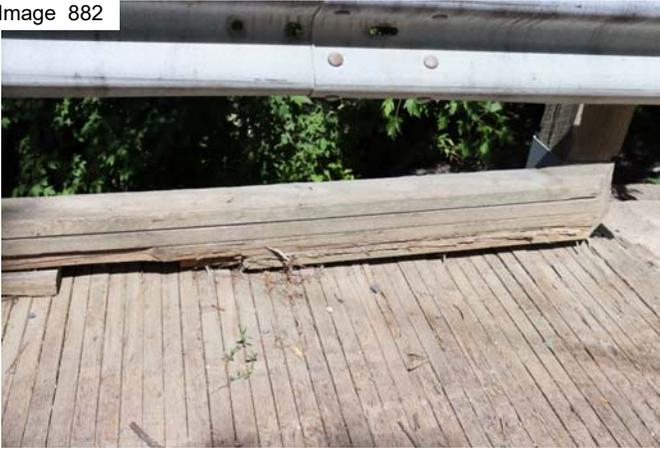
Image 882

Curb disconnected in NW

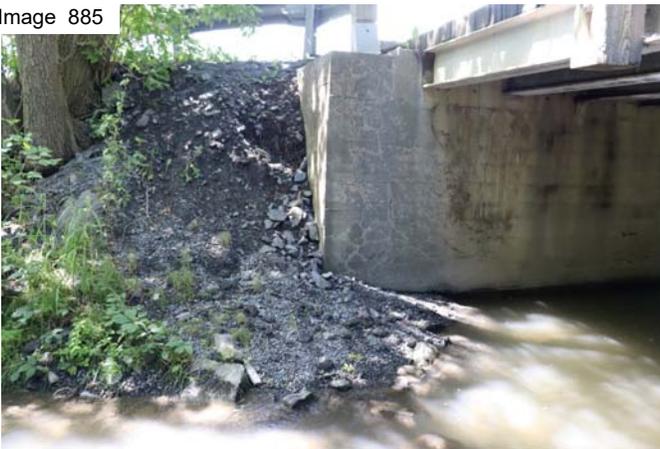
Image 885

Embankment (4) Embankment	Defects 5.0% Minor Erosion Damage 0.0% Maintenance None Capital Rec. None <i>Embankments at the corners of the bridge are slipping down into channel.</i>

Erosion in SE embankment

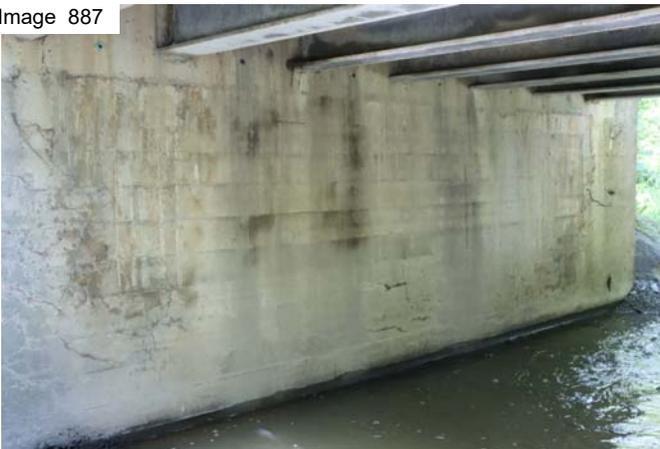
Image 887

South abutment

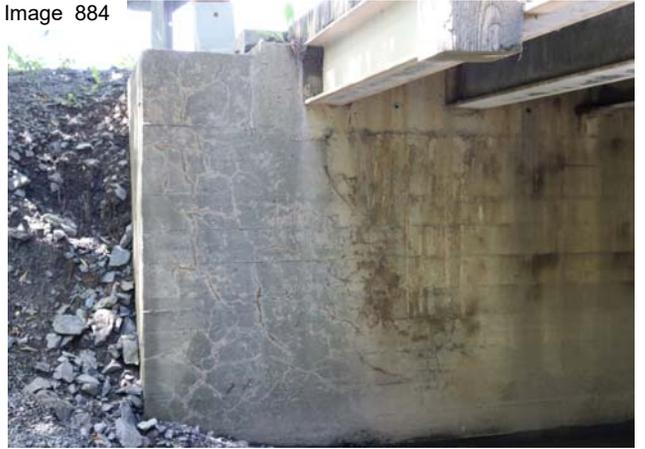
Image 884

SE abutment AAR

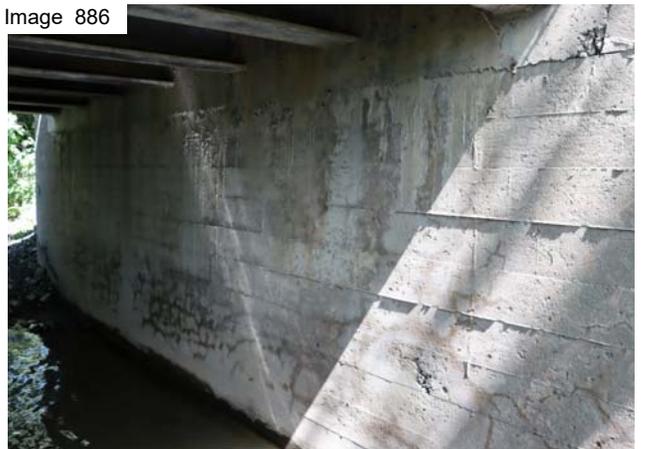
Image 886

North abutment

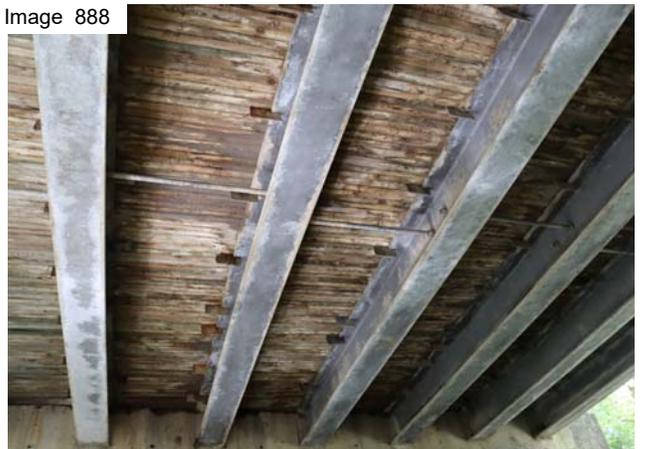
Image 888

Soffit and girders

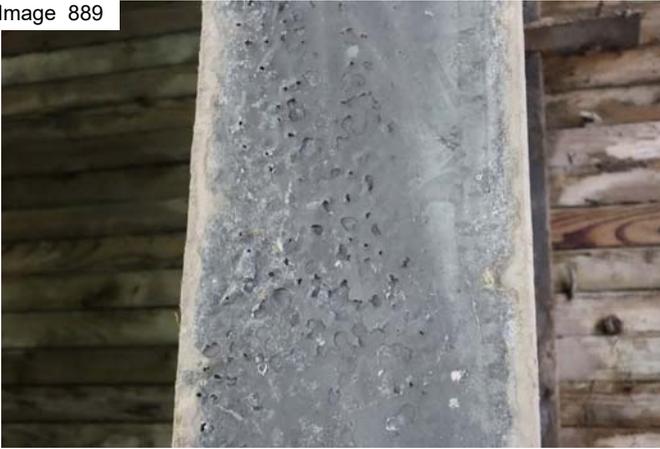
Image 889

Girder 3 bottom

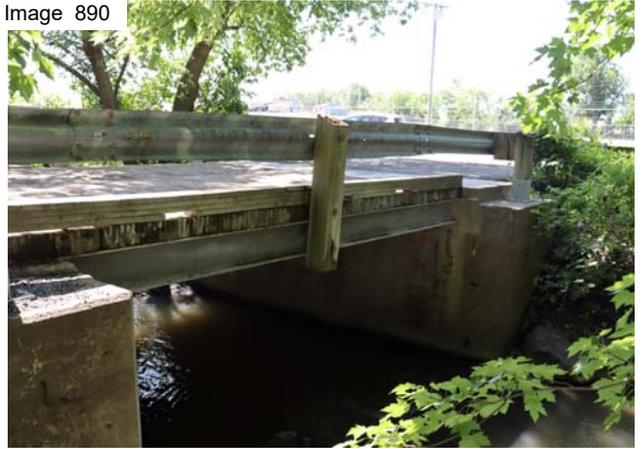
Image 890

West elevation

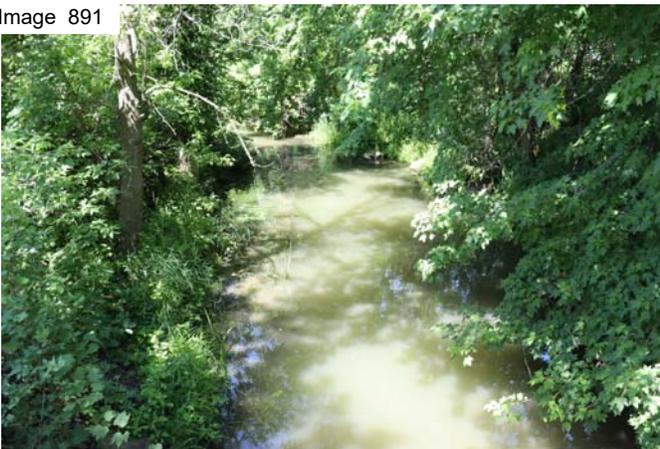
Image 891

West channel

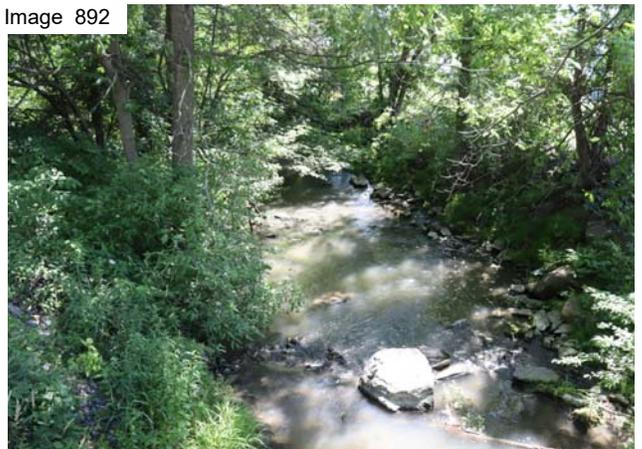
Image 892

East channel

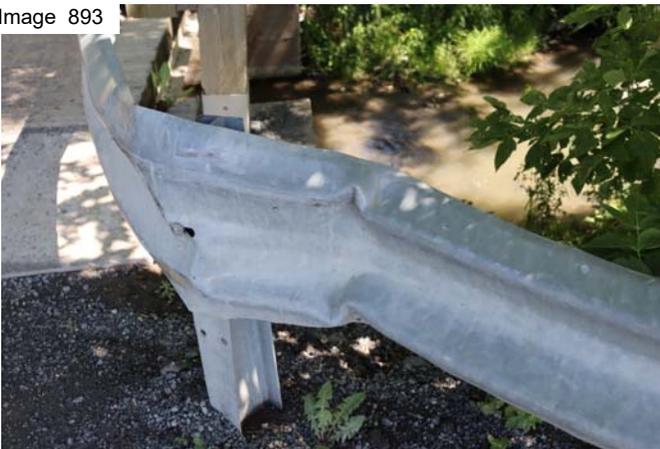
Image 893

Guide rail damage SE

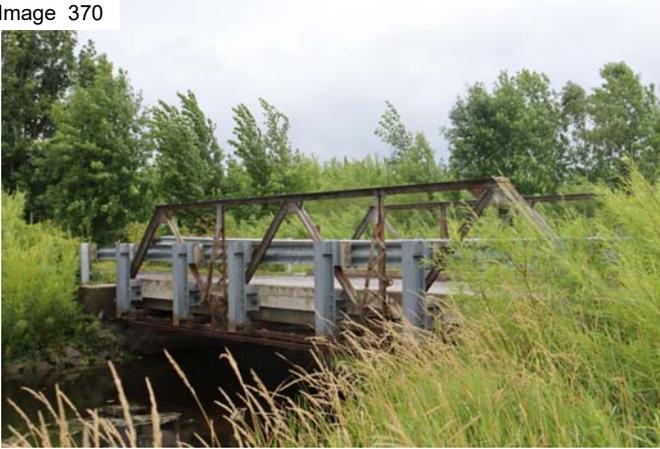
Image 370

East elevation

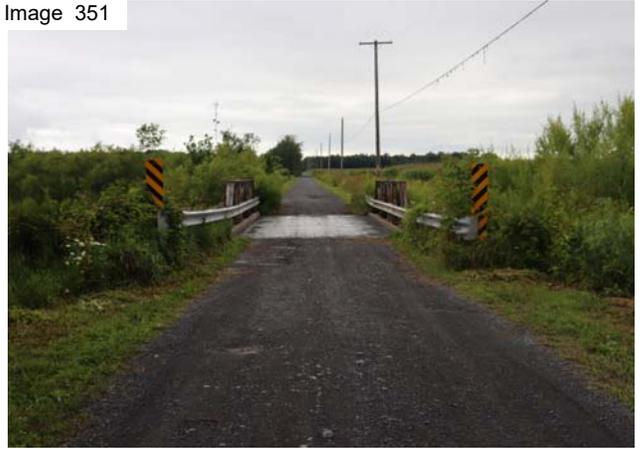
Image 351

South approach

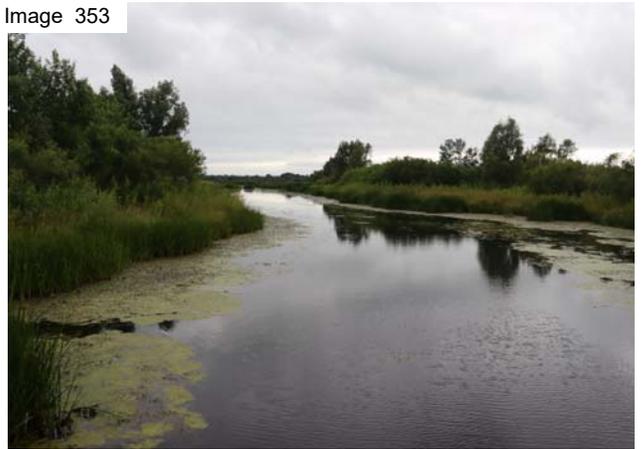
Image 353

West channel
