2021 BIENNIAL STRUCTURE INSPECTION PROGRAM

Township of South Stormont – October 2021

Keystone Bridge Management Corp.

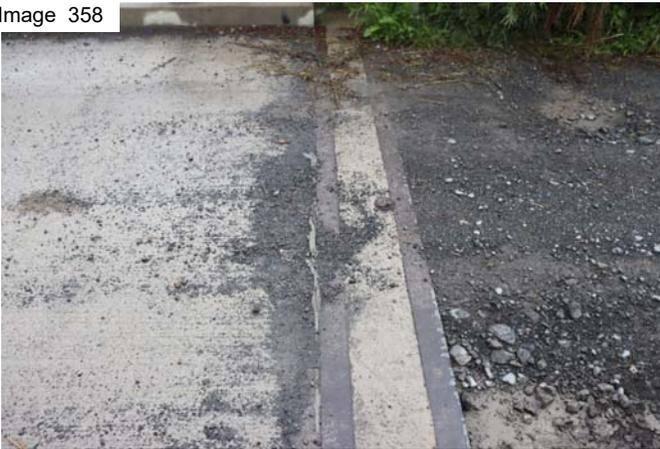
Image 358

North expansion joint

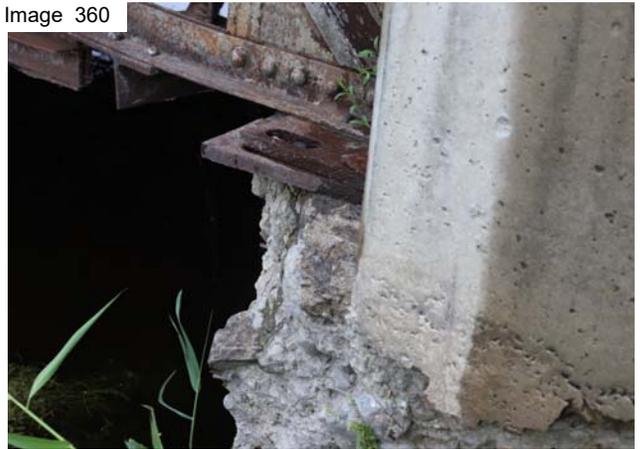
Image 360

Construction year was estimated at 1950. However abutments are thought to be 1920's construction. This bridge is unsafe due to the loss of support under the south bearings. Bridge bearing in SE corner is of major concern, loss of concrete in SE corner has left bearing unstable, SW similar but not quite as bad. Condition of this bridge was brought to owners attention 2019, immediate repairs are needed. Load limit signs missing at 2021 site visit.

SW bearing disintegrating abutment

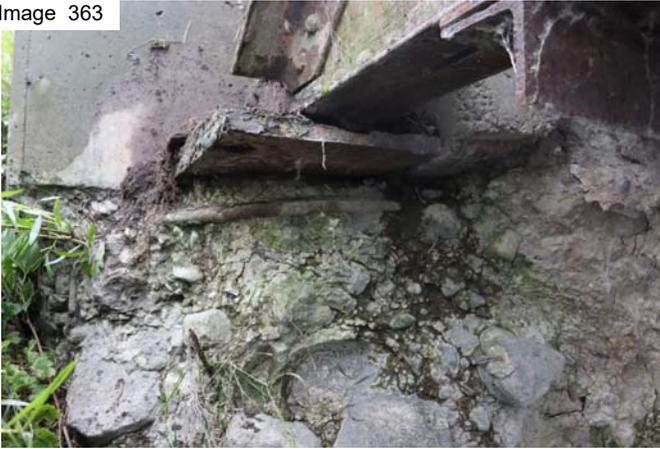
Image 363

SE bearing abutment disintegration

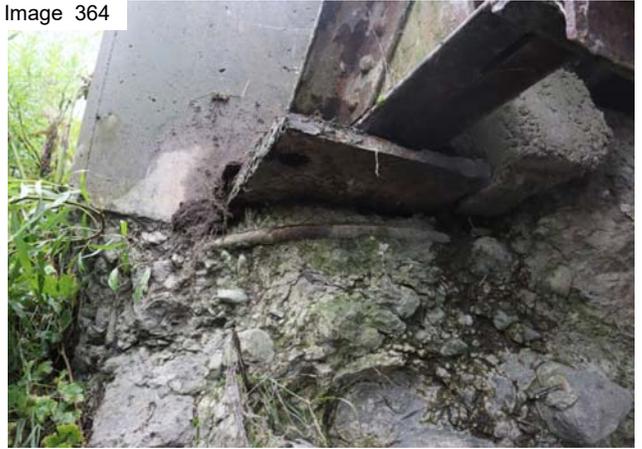
Image 364

SE bearing

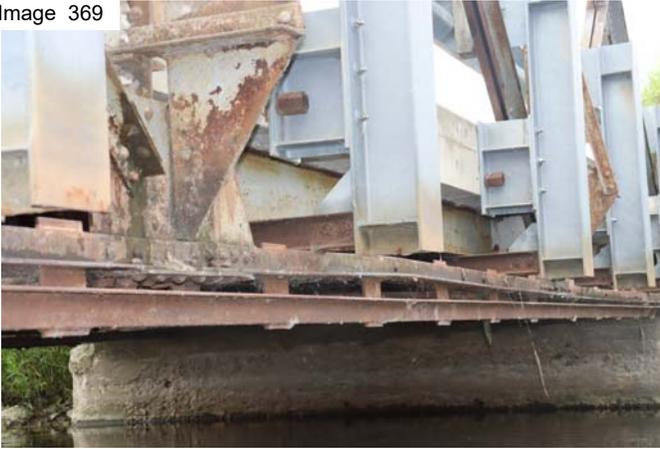
Image 369

Bottom chord deformed east side

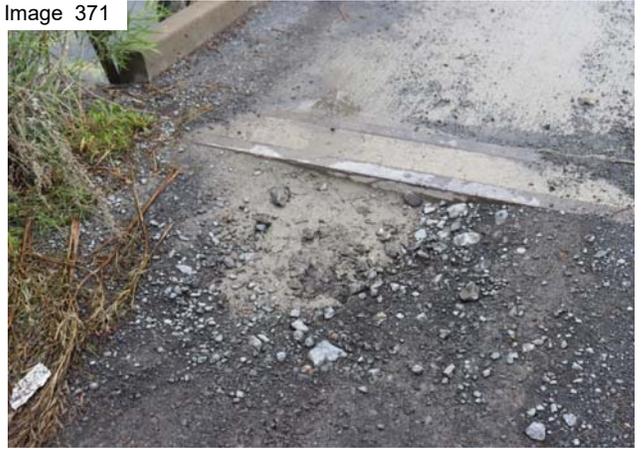
Image 371

Potholes gravel approach north

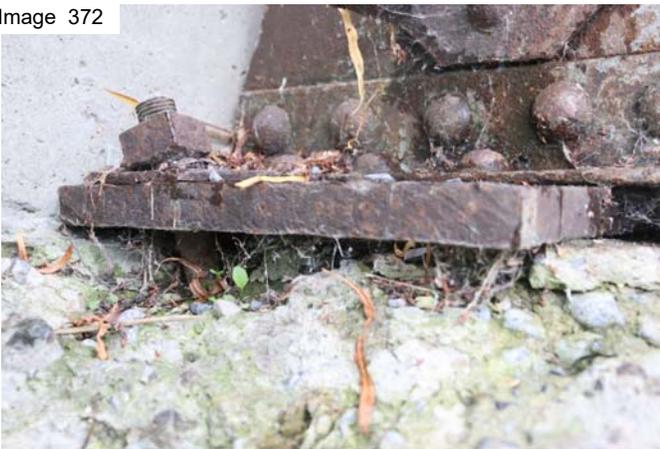
Image 372

NW bearing missing bolt

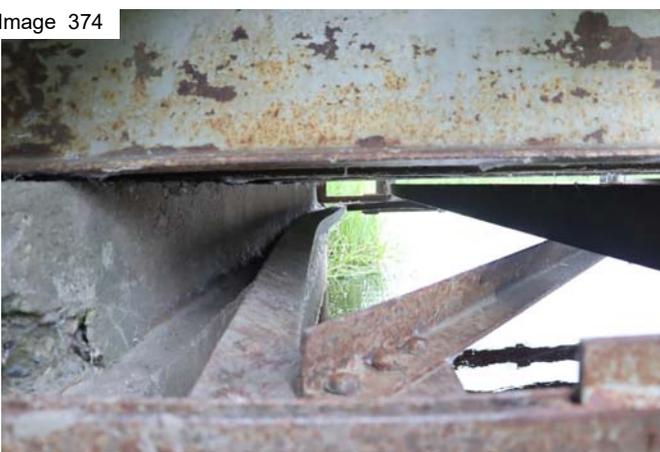
Image 374

Bent lateral brace north abutment

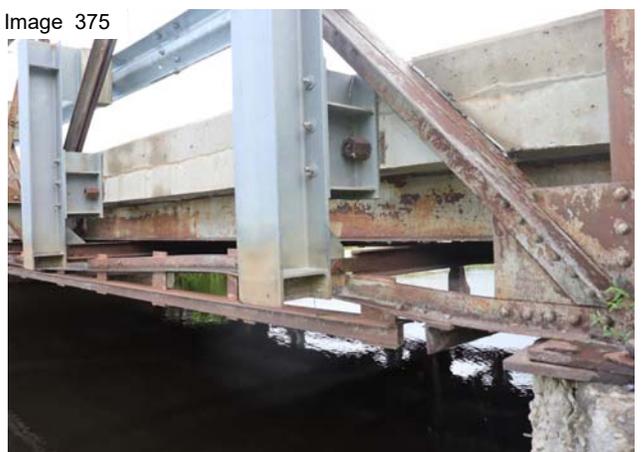
Image 375

Deformed bottom chord in the SW

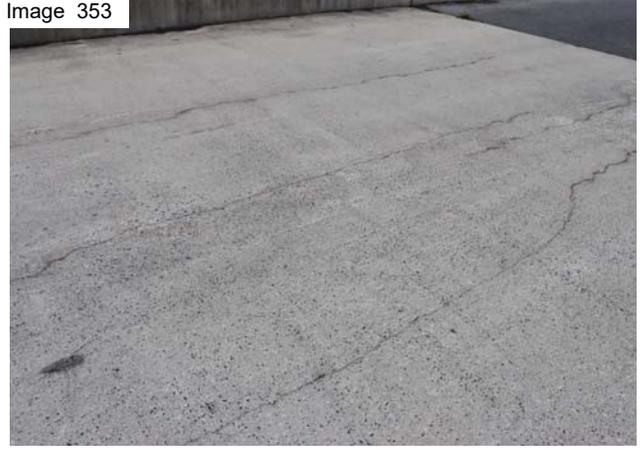
Image 353

Nice small bridge in very good condition. Deck is polished and has wide longitudinal cracks, no delaminations at this time. Topping slab needs to be made stiffer to control reflection cracking from girder joints. Consider overlay, waterproofing and paving subject to capacity of bridge.

Concrete deck surface

O'Lay, WP&P

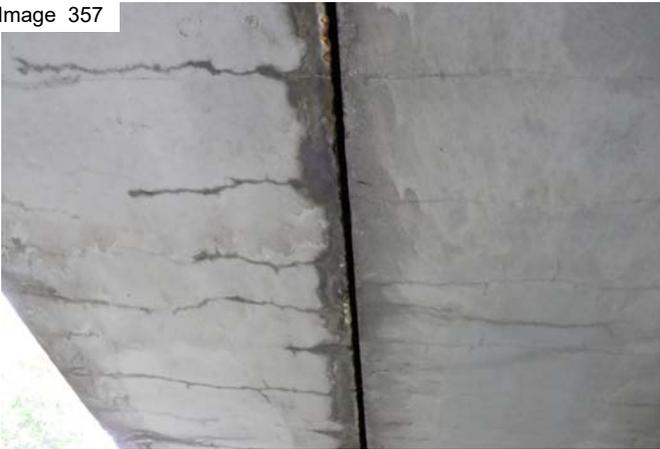
Image 357

West joint leaking

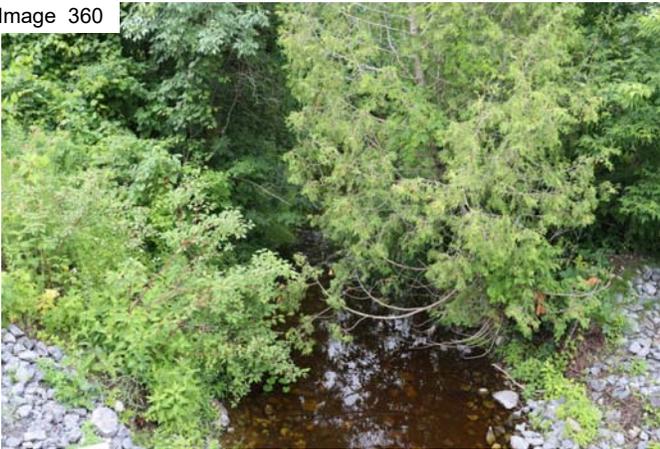
Image 360

South channel

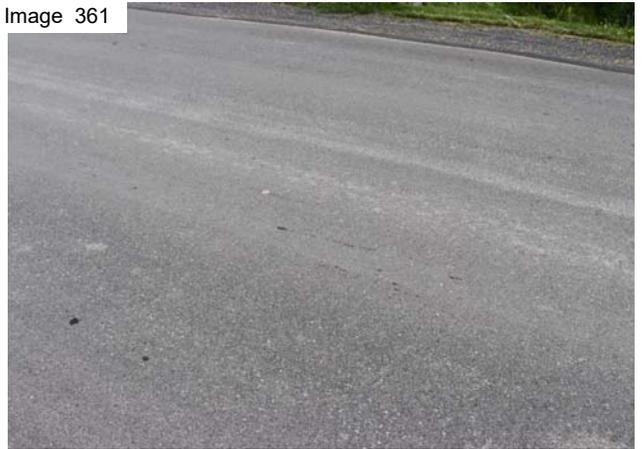
Image 361

Asphalt overtop

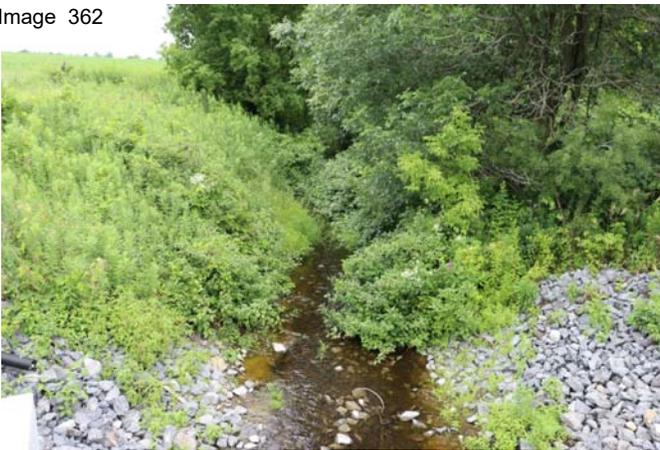
Image 362

North channel upstream

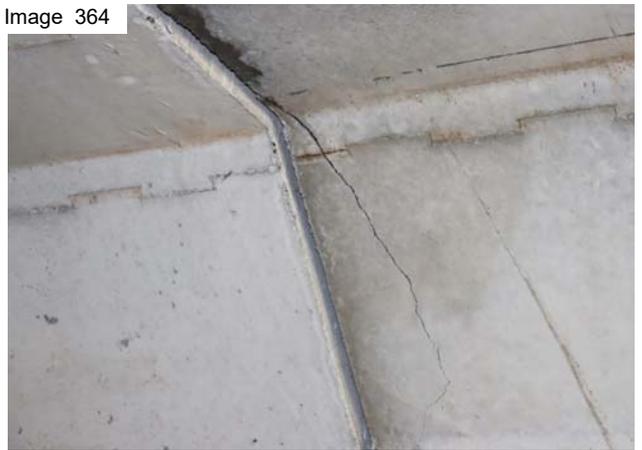
Image 364

Crack in west wall

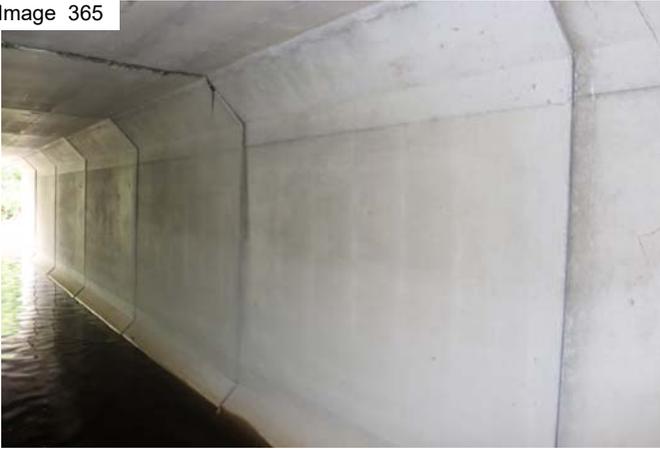
Image 365

West wall

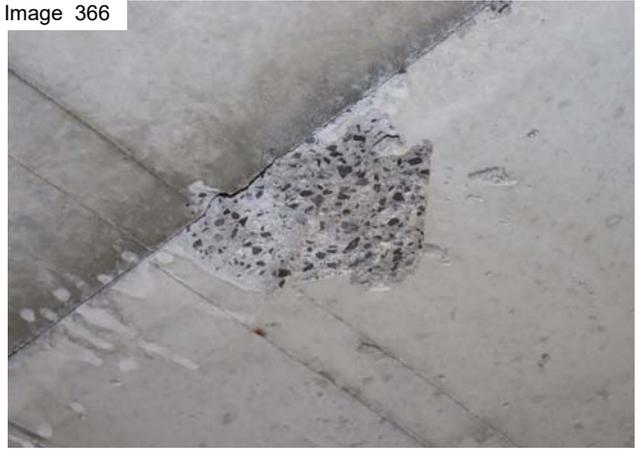
Image 366

Soffit spall

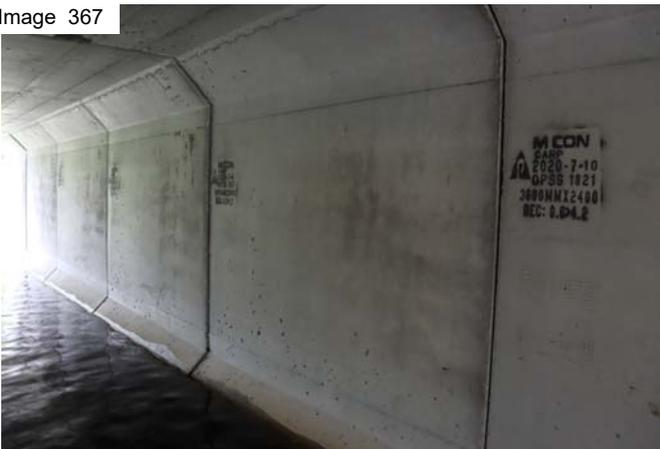
Image 367

East wall

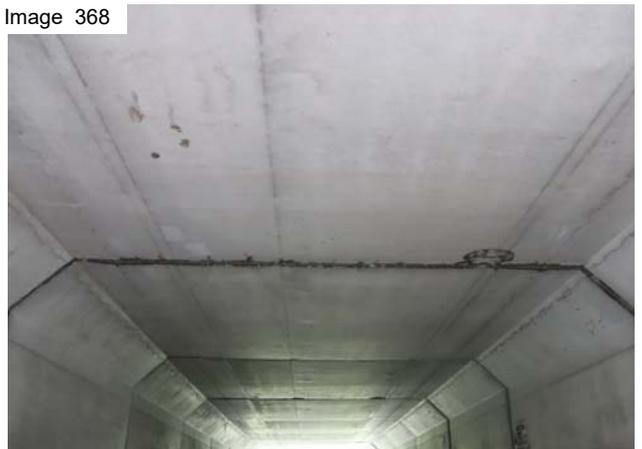
Image 368

Soffit

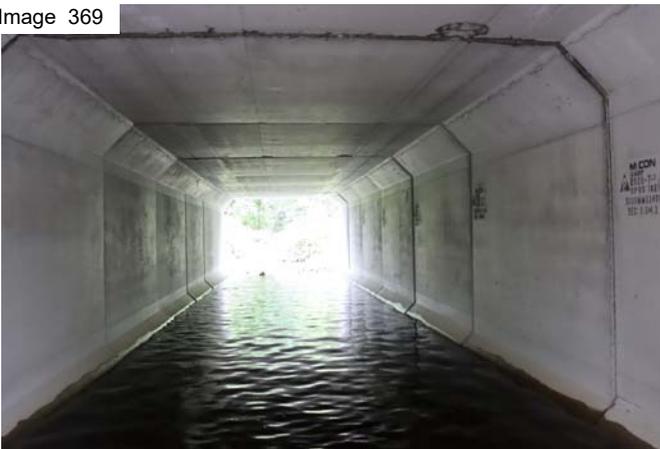
Image 369

Through from south

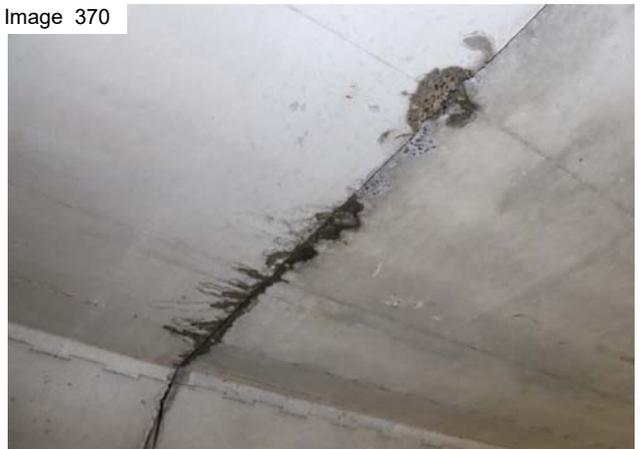
Image 370

Leaking at joints

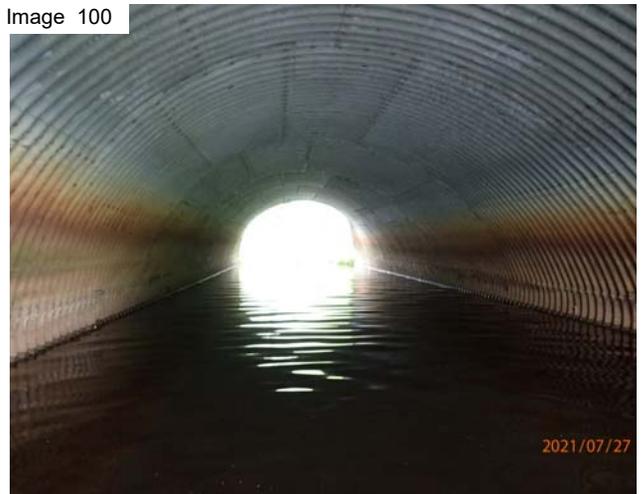
Image 100

Through barrel from west

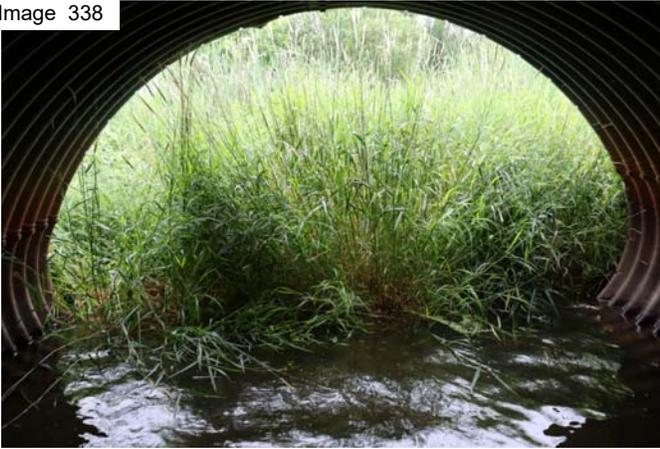
Image 338

Vegetation at south end

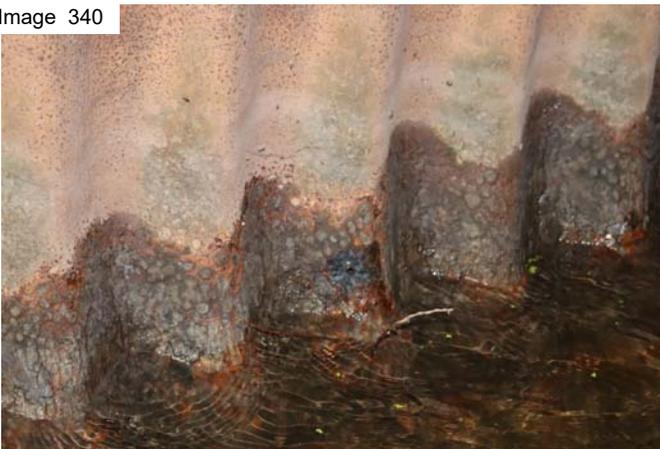
Image 340

This culvert has an obvious crimp line along lower barrel walls, walls are easily penetrated with pick hammer in this area. Programming for replacement of this culvert should be started. Plan on replacing this culvert within two years.

Perforation at waterline west side

This culvert has an obvious crimp line along lower barrel walls, walls are easily penetrated with pick hammer in this area. Programming for replacement of this culvert should be started. Plan on replacing this culvert within two years.

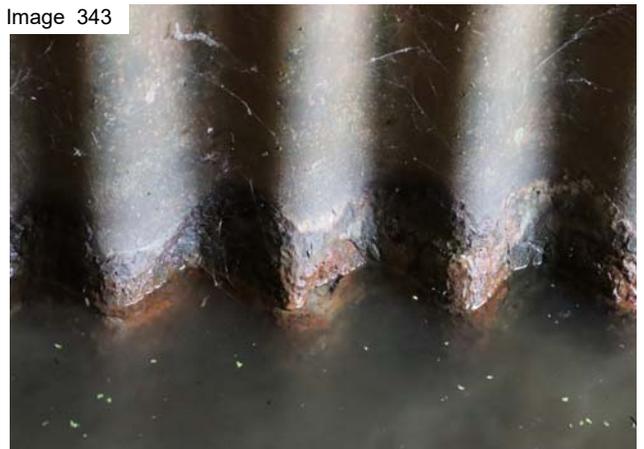
Image 343

Perforation at waterline east side

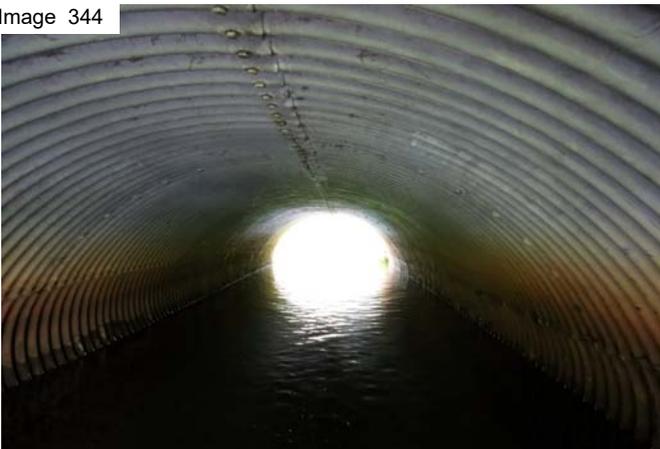
Image 344

Through from south

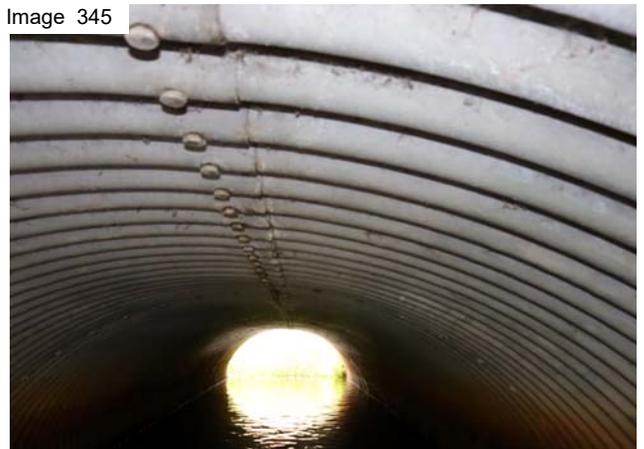
Image 345

Sagging in invert

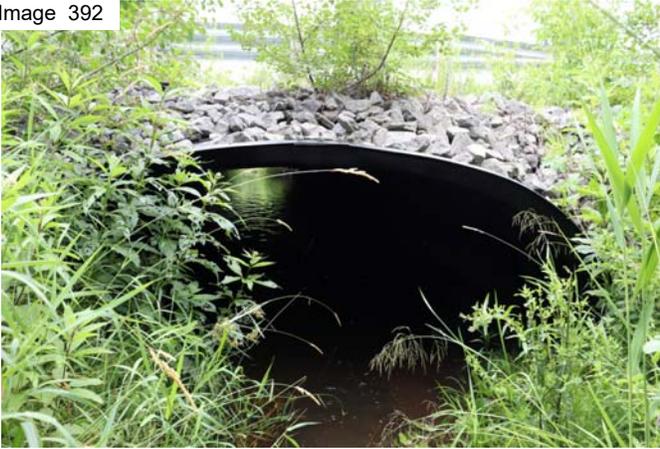
Image 392

North elevation

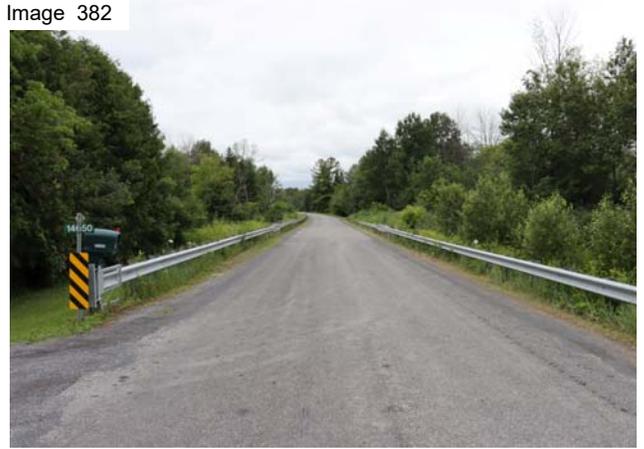
Image 382

East approach

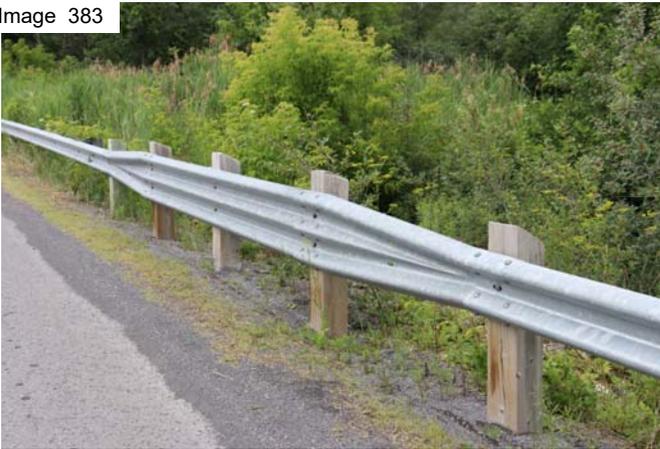
Image 383

North guide rail (typical)

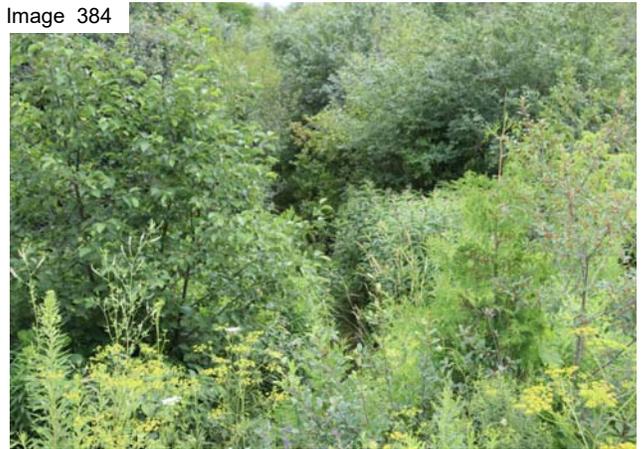
Image 384

South channel

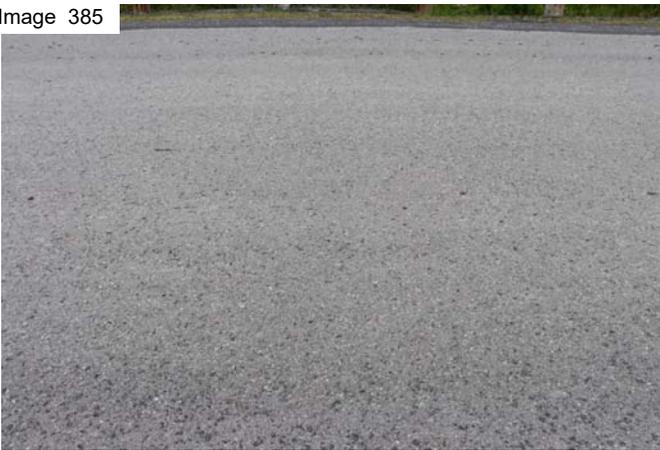
Image 385

Asphalt overtop

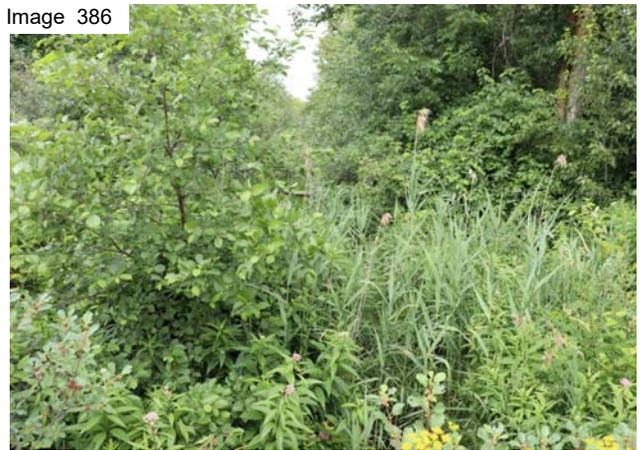
Image 386

North channel upstream

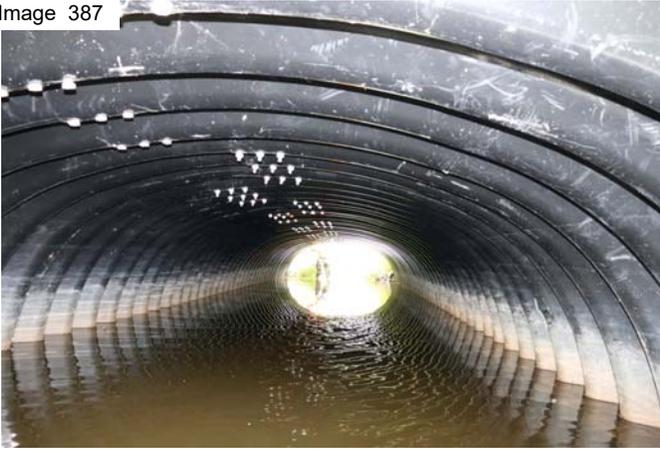
Image 387

Through barrel from north

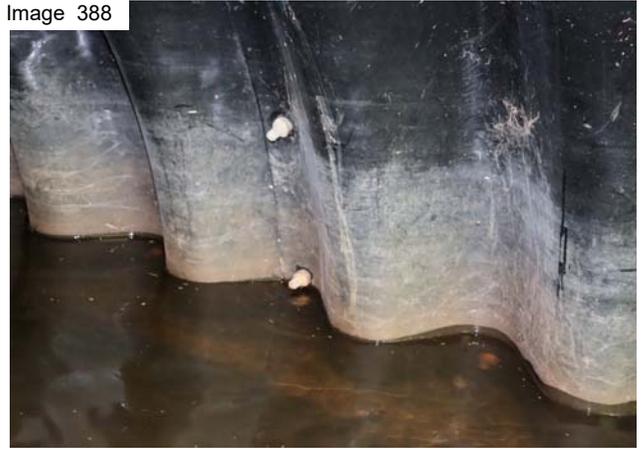
Image 388

Waterline condition at west

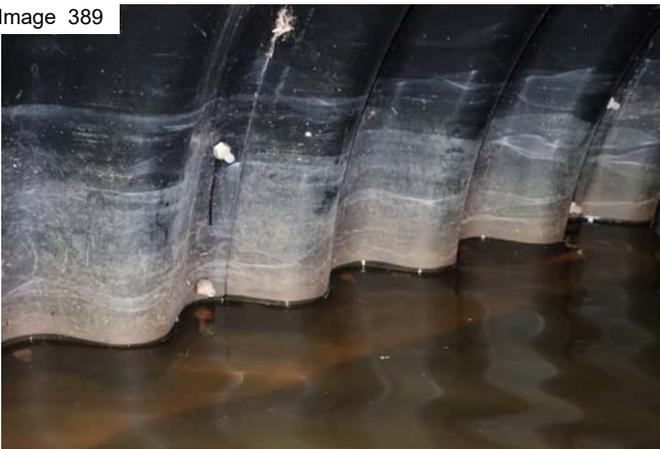
Image 389

Waterline condition at east

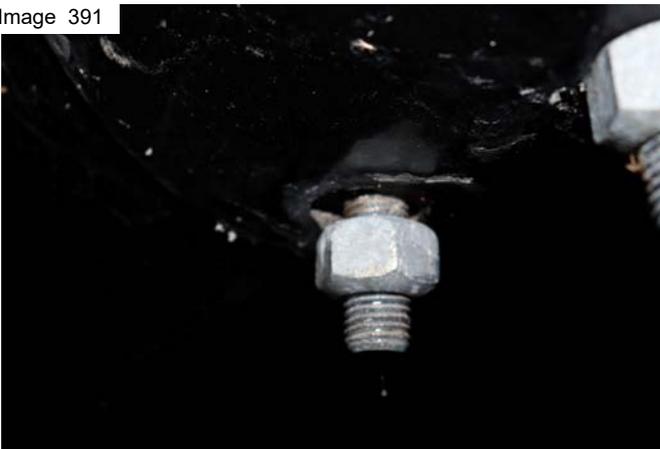
Image 391

Loose nut in obvert

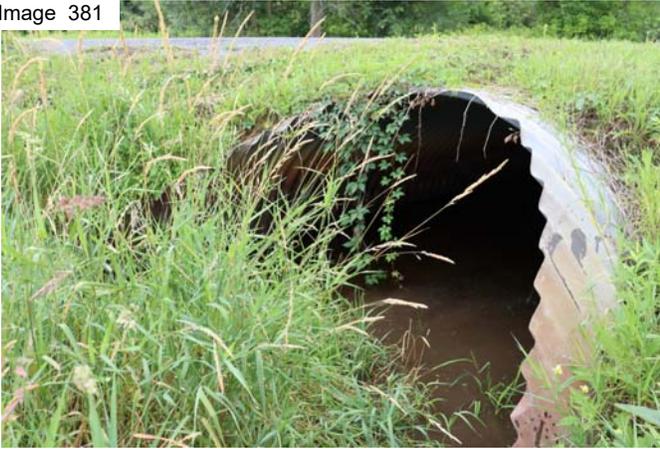
Image 381

North elevation

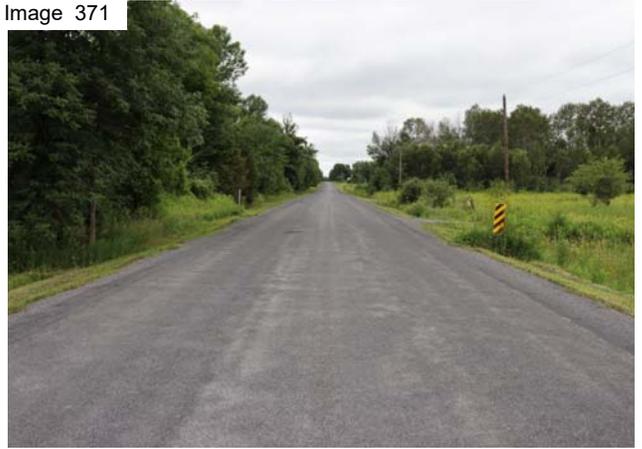
Image 371

East approach

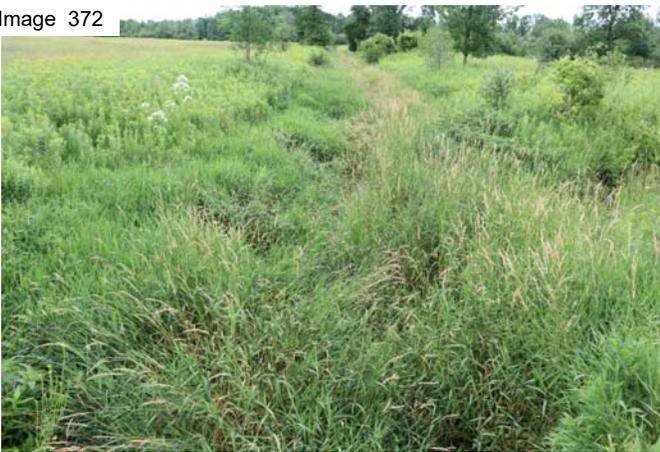
Image 372

North channel

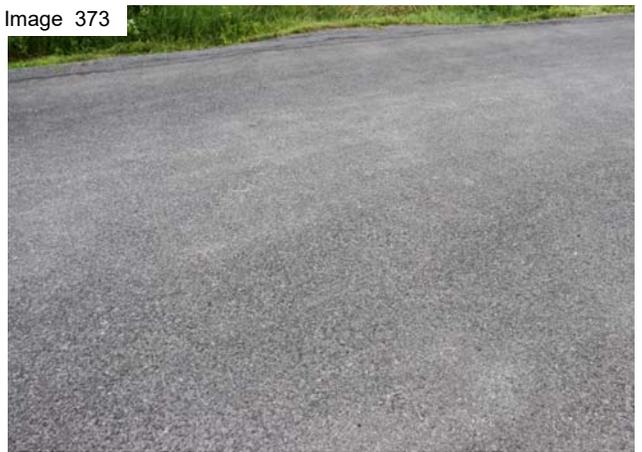
Image 373

Asphalt overtop

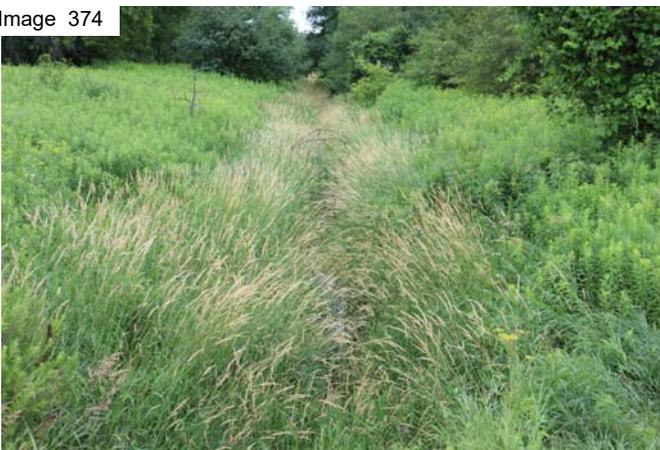
Image 374

South channel

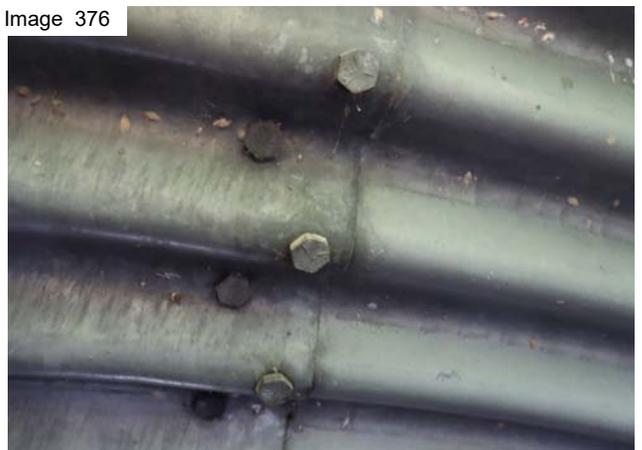
Image 376

Incorrect plate lap

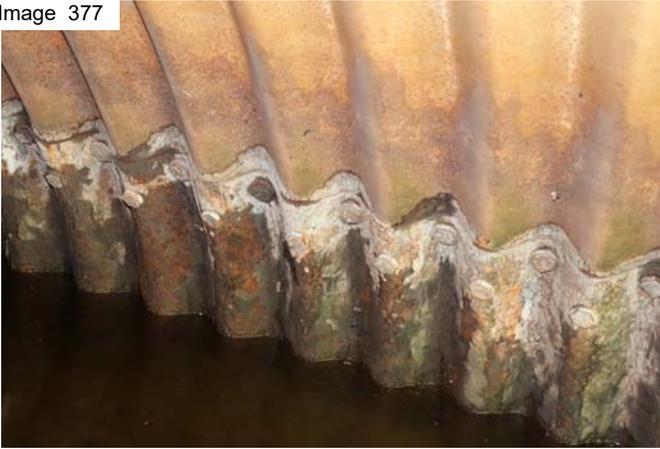
Image 377

Construction year was estimated at 1980. Current condition is satisfactory to poor. Lower half of barrel walls has moderate to severe section loss, culvert has approximately 5 years of remaining service life.

Waterline corrosion at west

New Conc Culvert

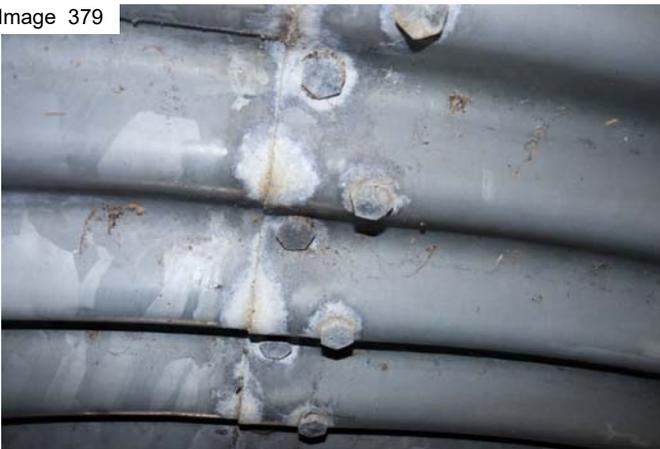
Image 379

Leaching at seam

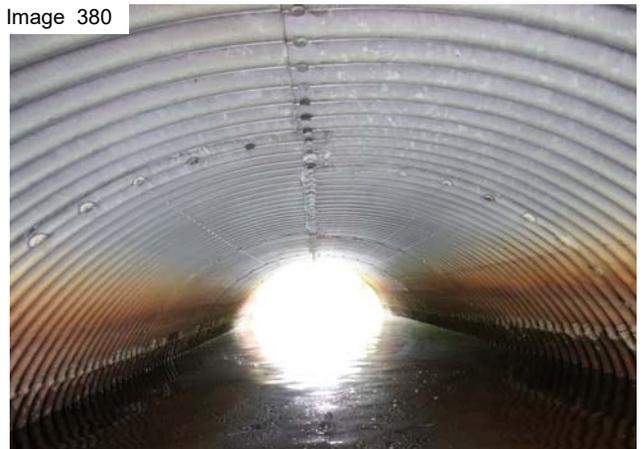
Image 380

Through barrel from north

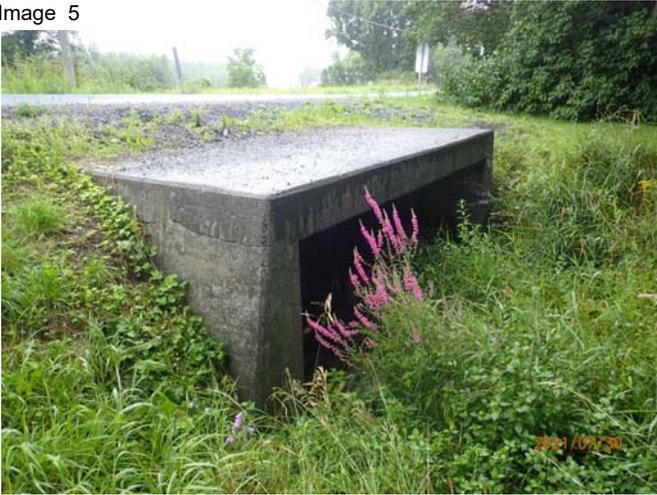
Image 5

North elevation

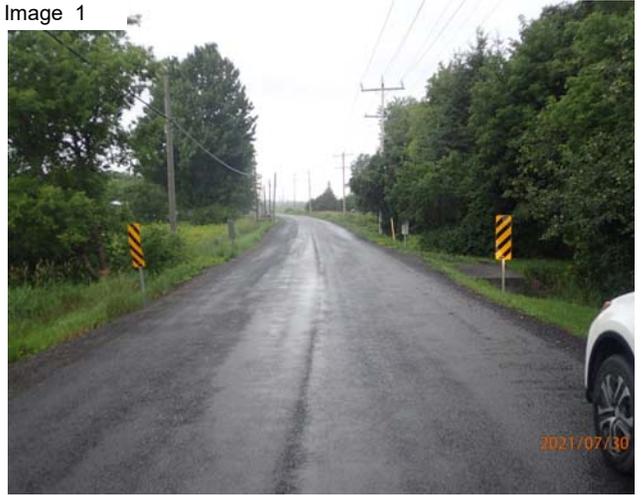
Image 1

East approach

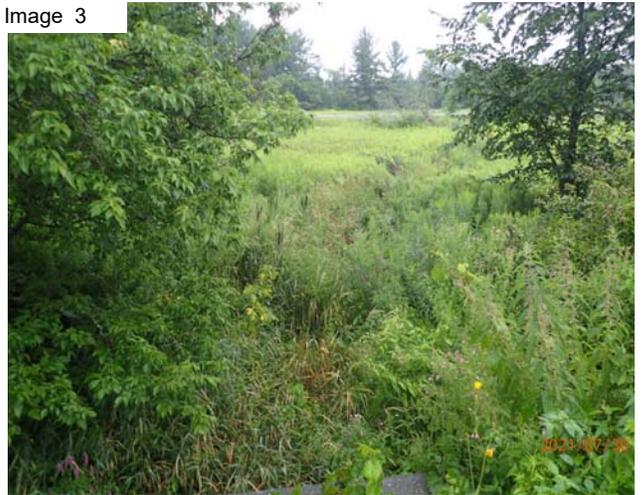
Image 3

South channel

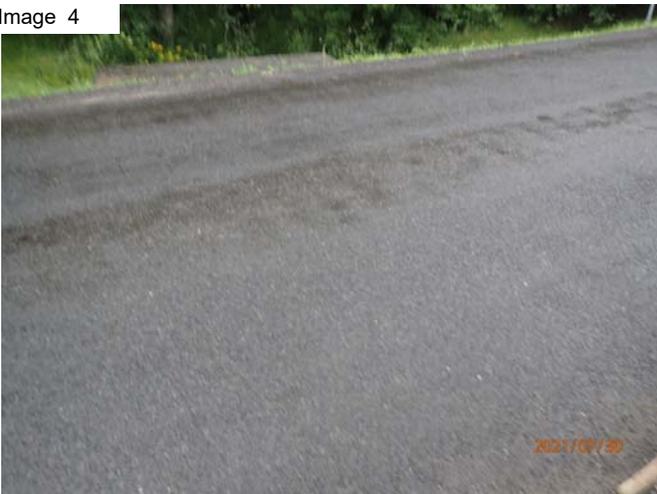
Image 4

Asphalt over culvert

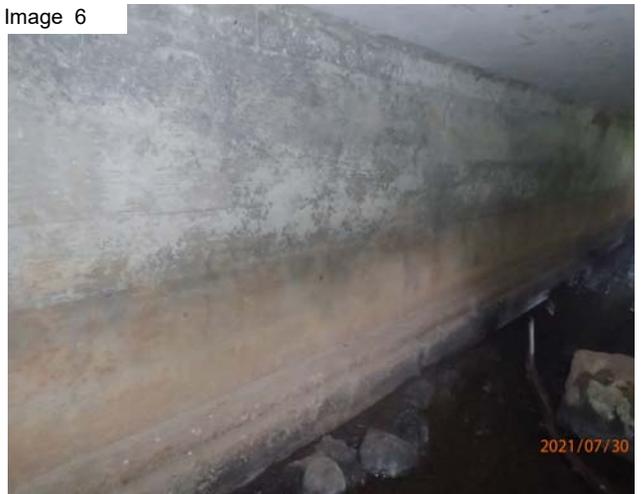
Image 6

East wall

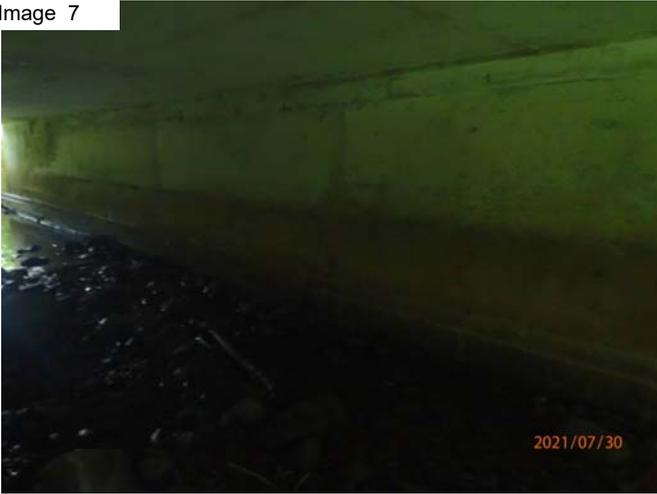
Image 7

West wall

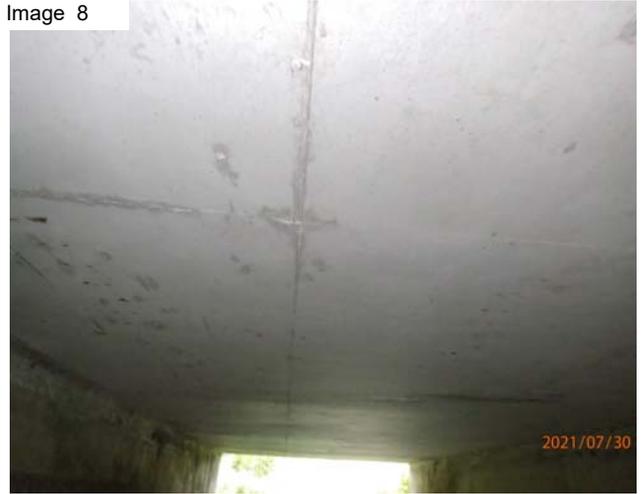
Image 8

Soffit

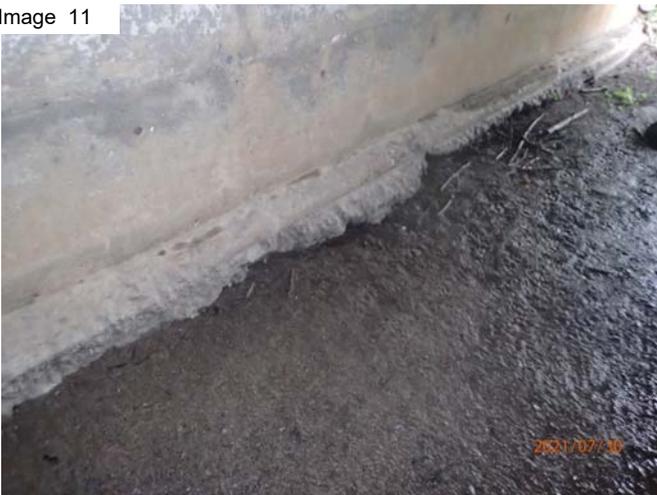
Image 11

East footing disintegration

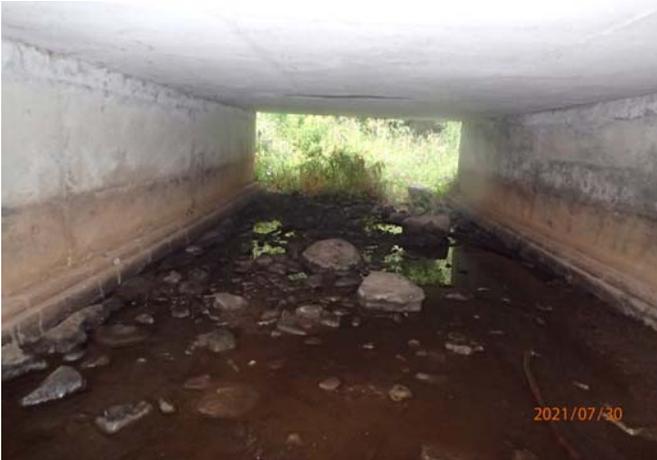
Image 13

Through culvert

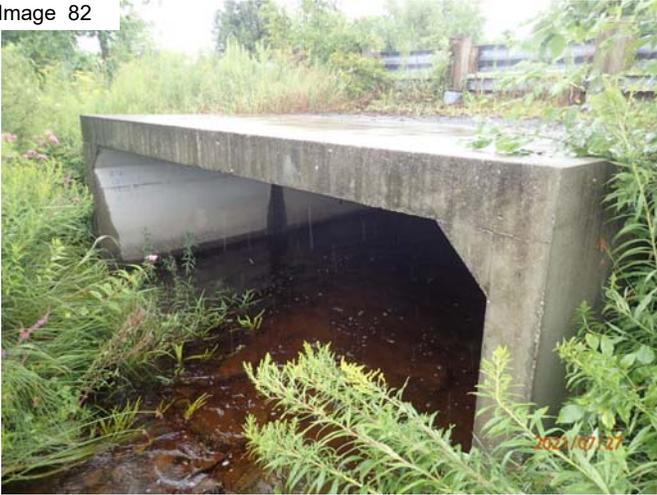
Image 82

North elevation

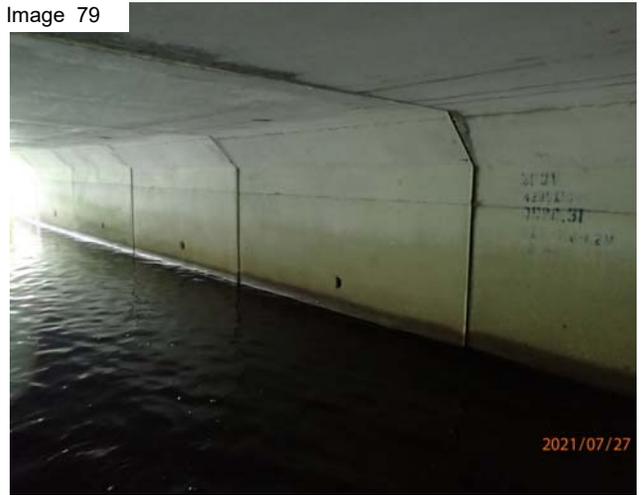
Image 79

Leaky joint at north

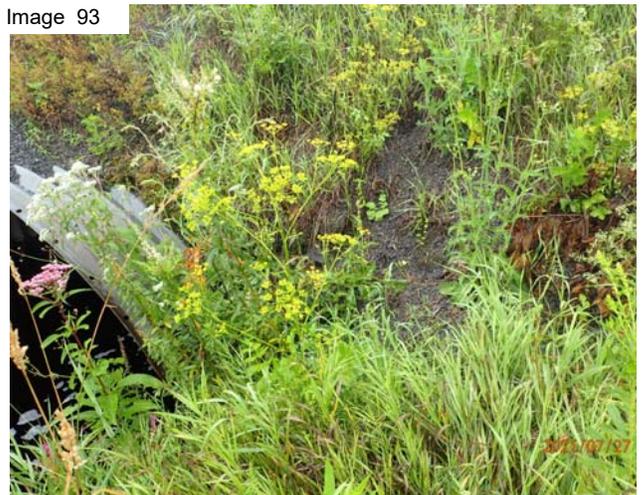
Image 93

Embankment (4) Embankment	Defects 5.0% Minor Erosion Damage 0.0% Maintenance Remove Brush/Trees Capital Rec. None Perf Def: Toxic Weeds <i>Steep embankments, erosion in the NW corner. Retaining walls may be warranted due to the short length culvert. Wild parsnip present.</i>

Embankment erosion in NW

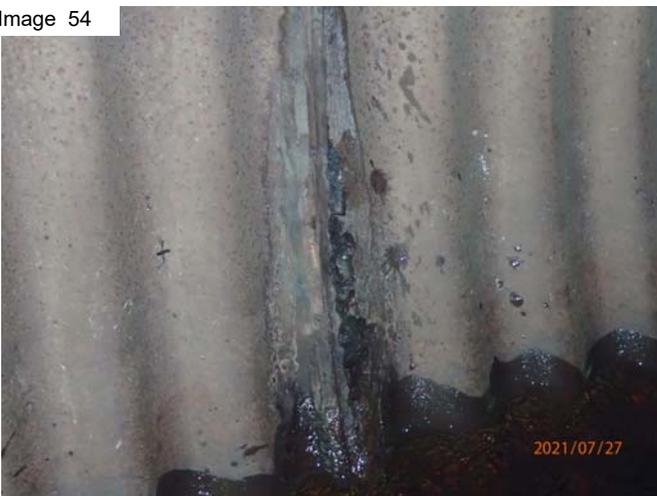
Image 54

Construction year was estimated at 1985. Perforations were noted in the barrel walls and floor. A concrete floor liner may be an appropriate repair strategy for this culvert due to the perforations being low in floor or walls. Without liner this culvert will need replacement within in a 5-7 year timeframe. Floor liner would add 20 years to life of culvert.

Small perforation at north

Concrete floor liner

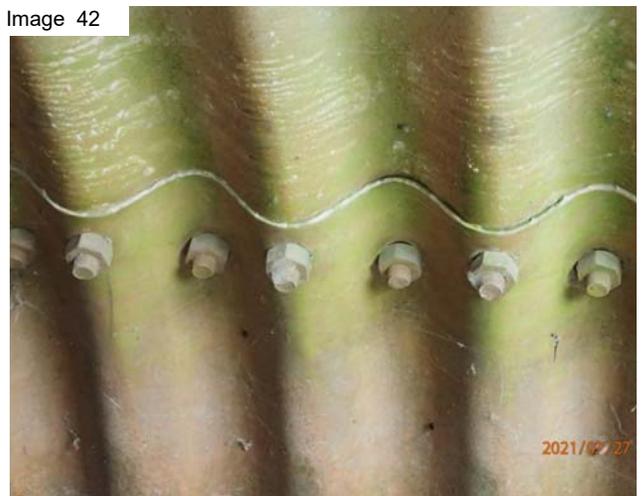
Image 42

Incorrect plate lapping

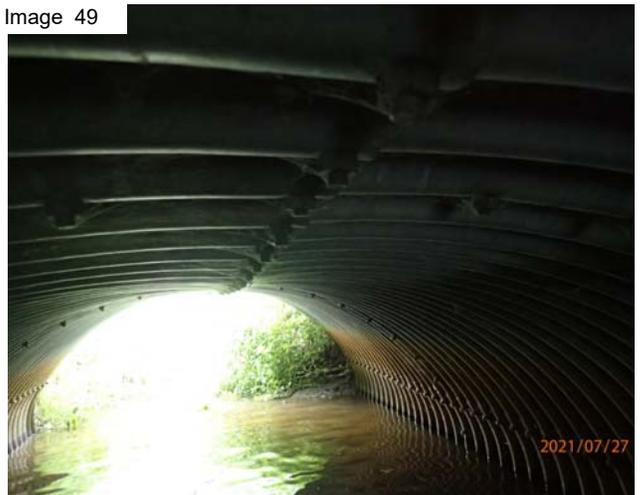
Image 49

Construction year was estimated at 1990. Delineators should be installed to identify the culvert location. Cusping is a concern that poses risk of a failure. Additional vigilance recommended.

Reverse curvature (cussing) in obvert

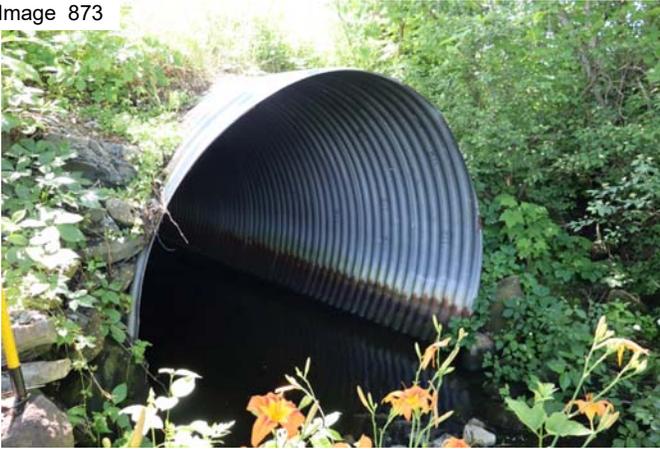
Image 873

West elevation

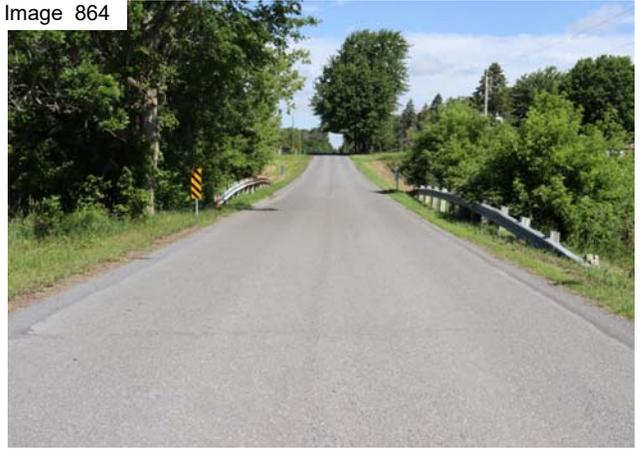
Image 864

South approach

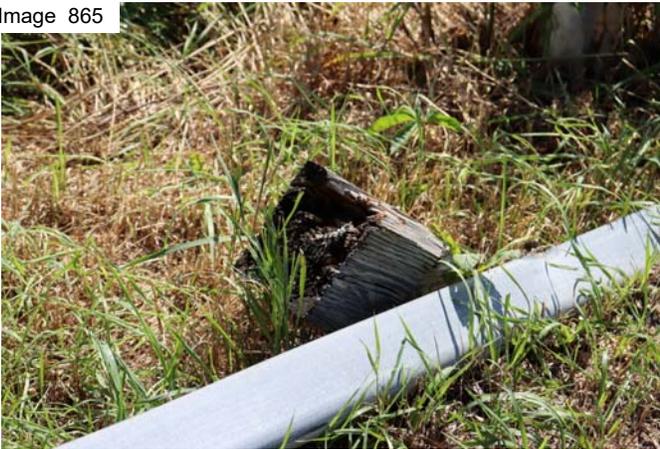
Image 865

Post damage at SE

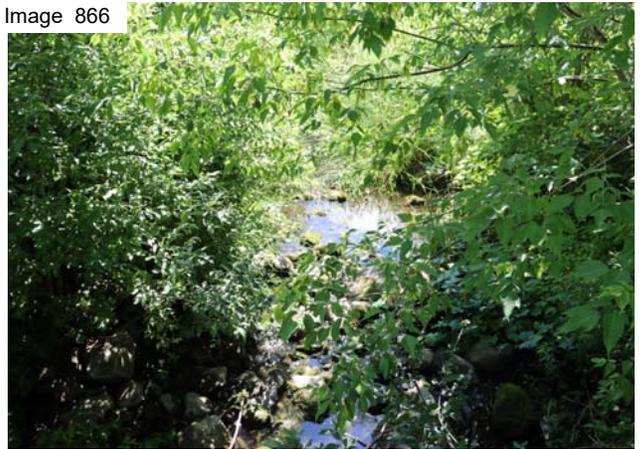
Image 866

East channel downstream

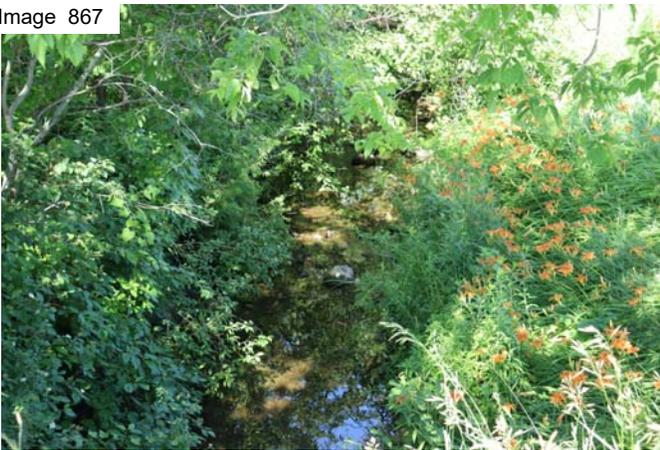
Image 867

West channel upstream

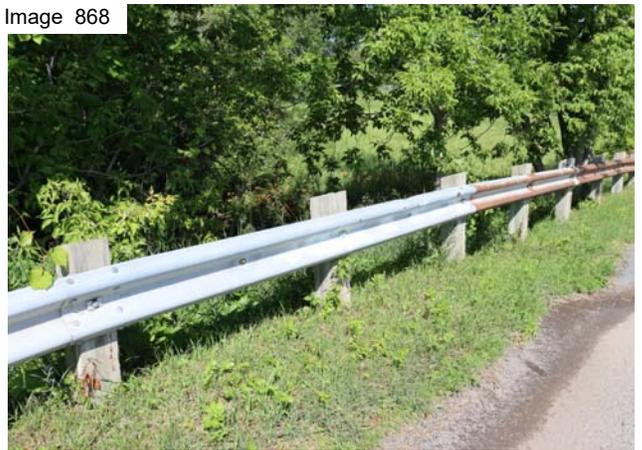
Image 868

Circular CS Pipe (1) Conduit Length: 17.2 m Width: 3.2 m Height: 2.1 m	Defects 40.0% Moderate Corrosion, Major Corrosion Damage 3.0% Minor Section Loss, Moderate Section Loss Maintenance None Capital Rec. None <i>Date of construction should be verified, unlikely this culvert was constructed in 1975. Bottom third of culvert has moderate to major corrosion with some minor section loss. No perforations detected.</i>
Asphalt Wear Surf (1) Wear Surface Length: 3.2 m Width: 5.5 m Height:	Defects 2.0% Minor Ravelling Damage 0.0% Maintenance None Capital Rec. None <i>Satisfactory condition. Minor ravelling.</i>
Steel Beam on Wood Post (Guide Rail Length: 30.5 m Width: Height: 0.8 m	Defects 5.0% Minor Checking Damage 5.0% Major Decay, Moderate Impact Maintenance Spot post replacement, Local repair Capital Rec. Replace in 2 years Perf Def: Does'nt Meet New Standard <i>Many posts have major decay. Ends are not properly buried and don't meet current standard. Post in the SE is damaged. Sections of flex beam badly corroded. Guide rail system requires renewal.</i>

West guide rail (typical)

Age of this culvert should be verified, more likely constructed in 90's not 1975. Culvert is in satisfactory condition at this time. Current guide rail protection should be updated within 2 years.

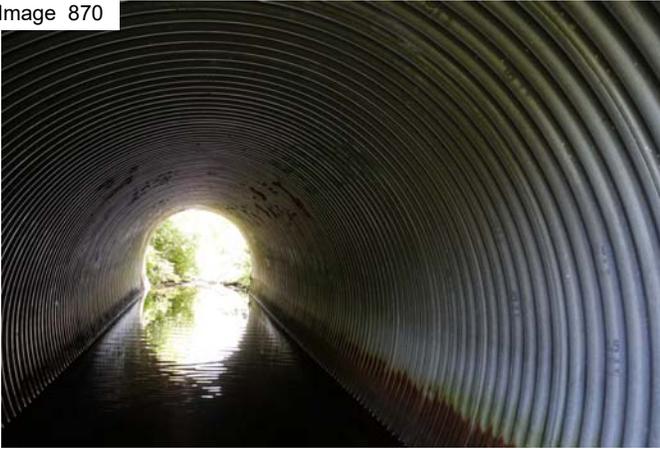
Image 870

Through barrel from west

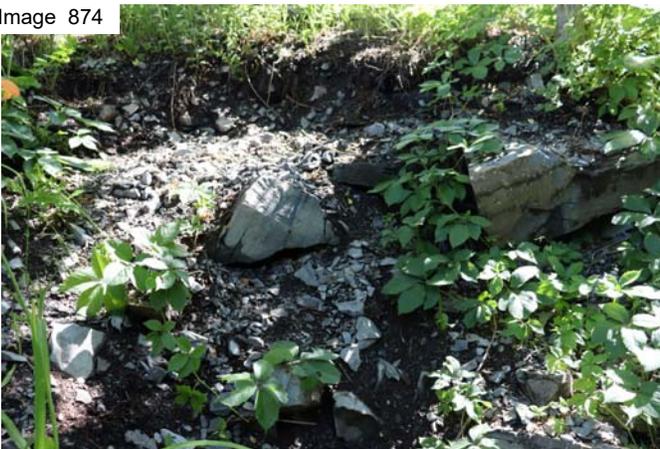
Image 874

NW embankment

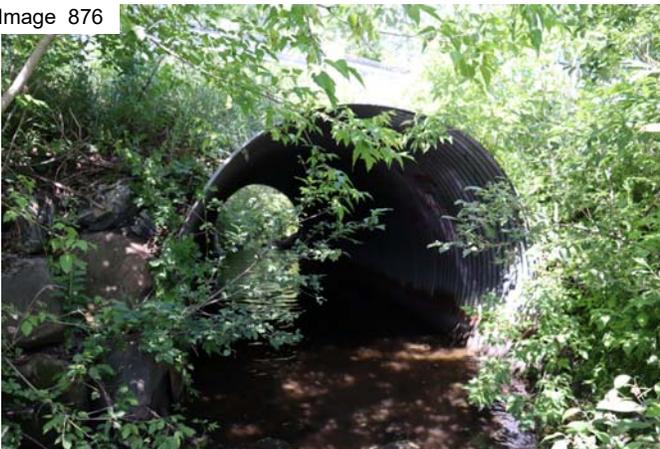
Image 876

East elevation
