2019 BIENNIAL STRUCTURE INSPECTION PROGRAM

Township of South Stormont – September 2019

Keystone Bridge Management Corp.

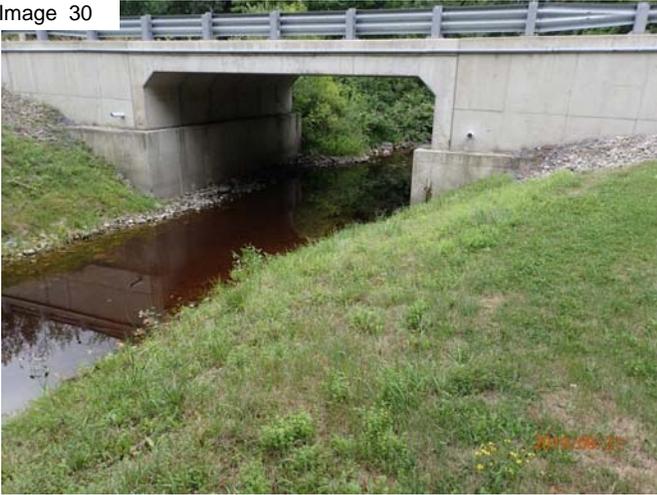
Image 30

North elevation

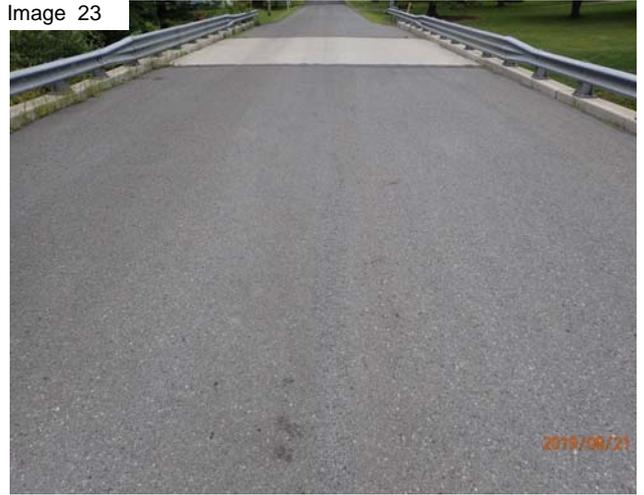
Image 23

East approach

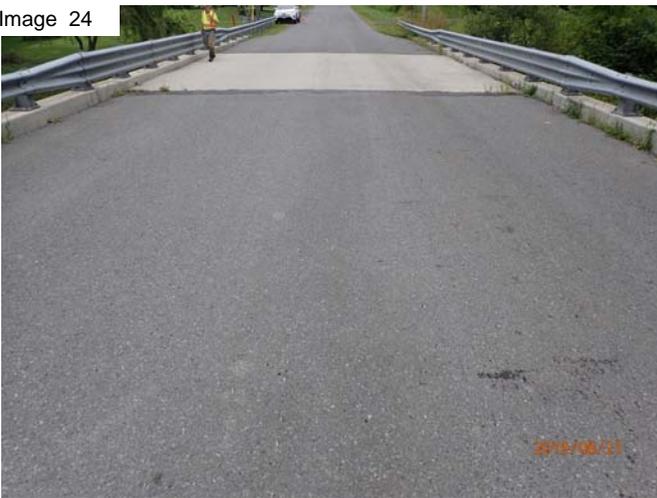
Image 24

West approach

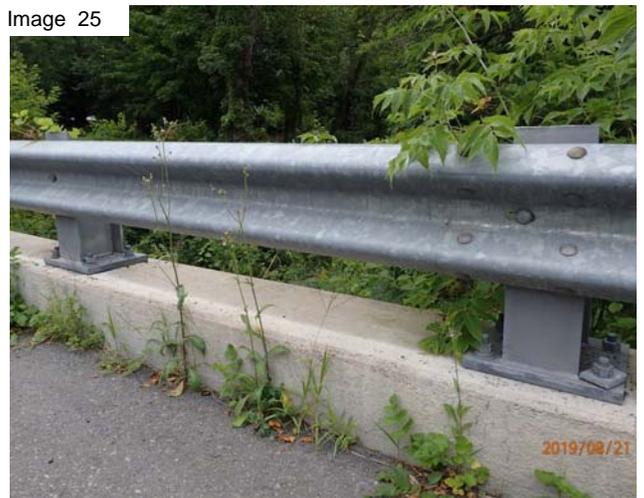
Image 25

Guide rail on wing walls

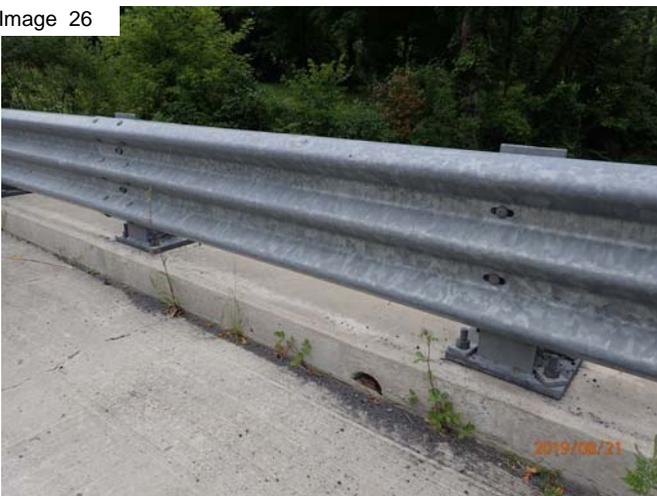
Image 26

Thrie beam on deck

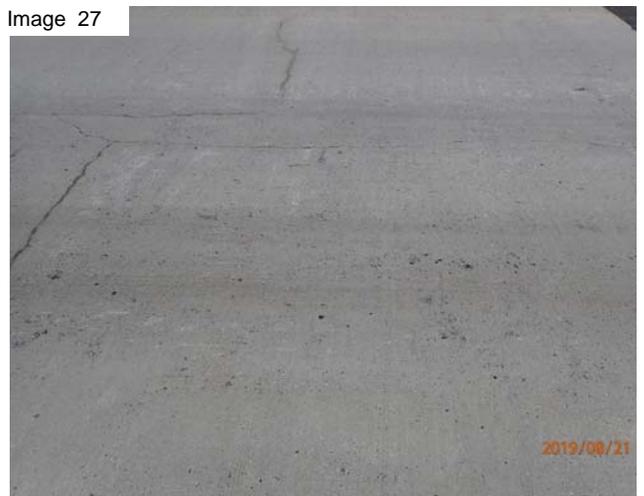
Image 27

Exposed concrete deck

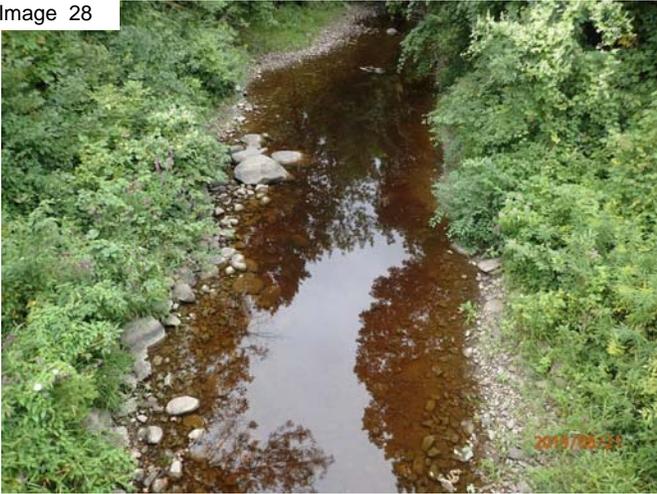
Image 28

South channel

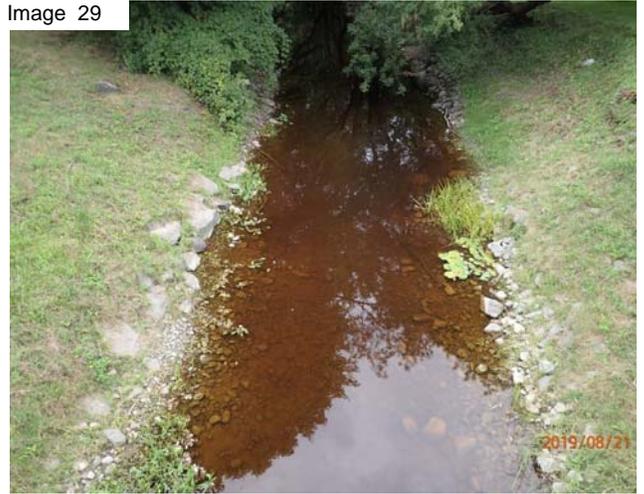
Image 29

North channel

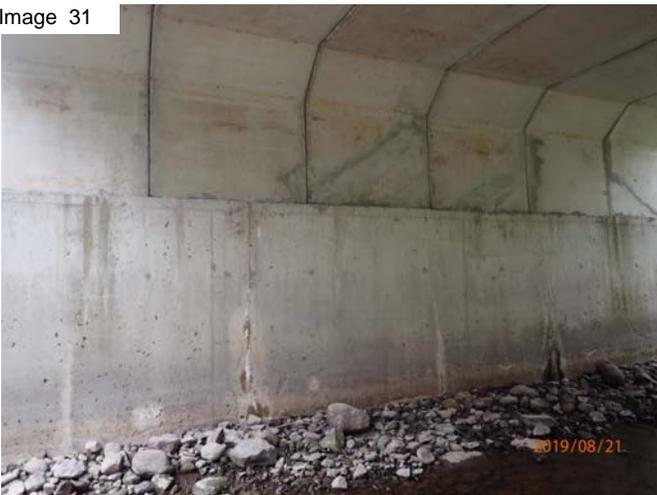
Image 31

East abutment wall

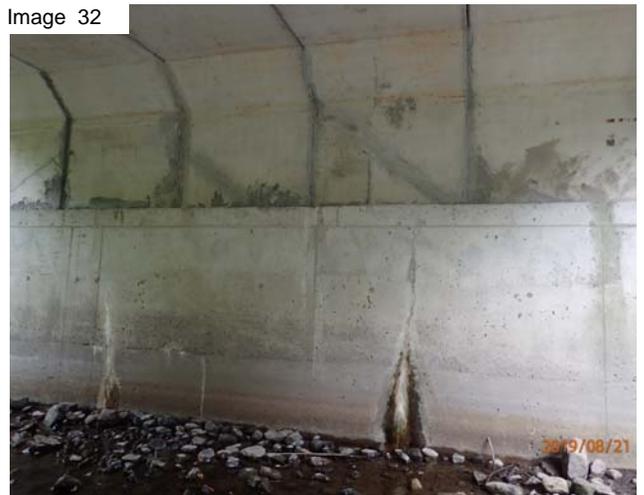
Image 32

West abutment wall

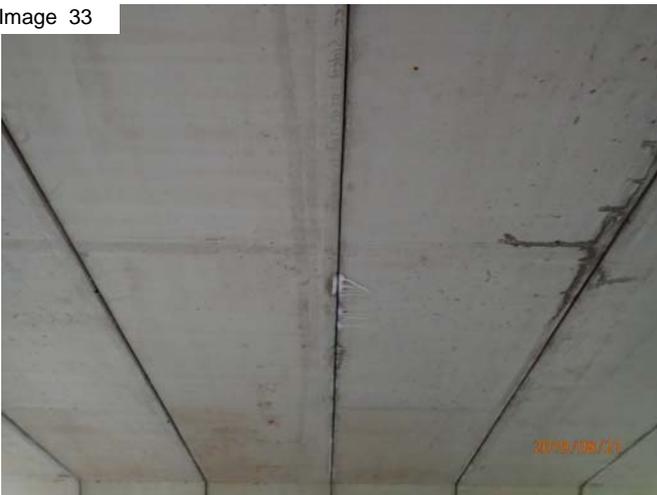
Image 33

Soffit (typical)

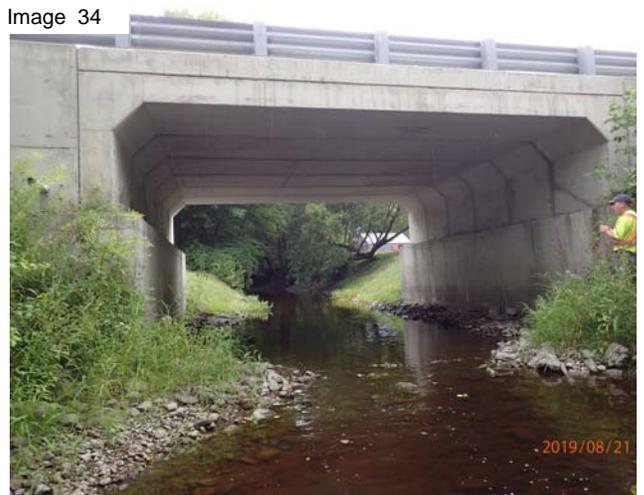
Image 34

South elevation

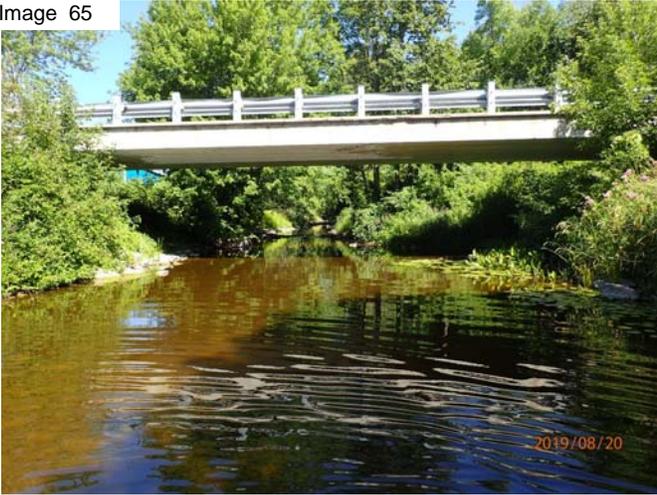
Image 65

South elevation

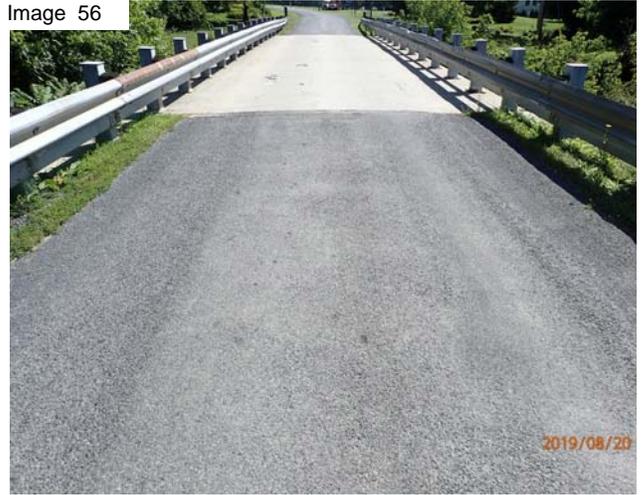
Image 56

West approach

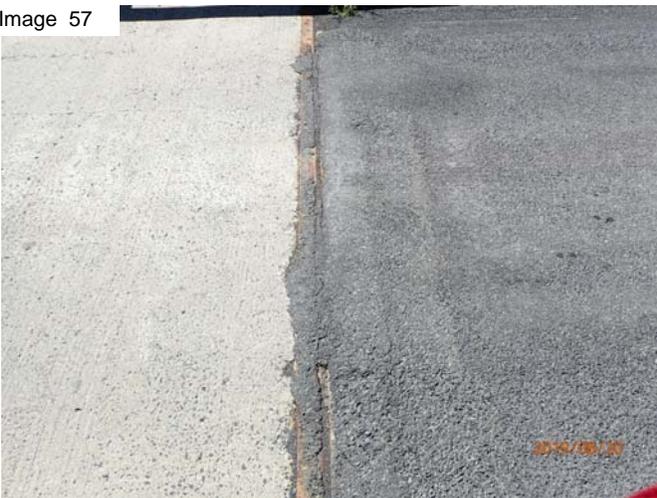
Image 57

West expansion joint

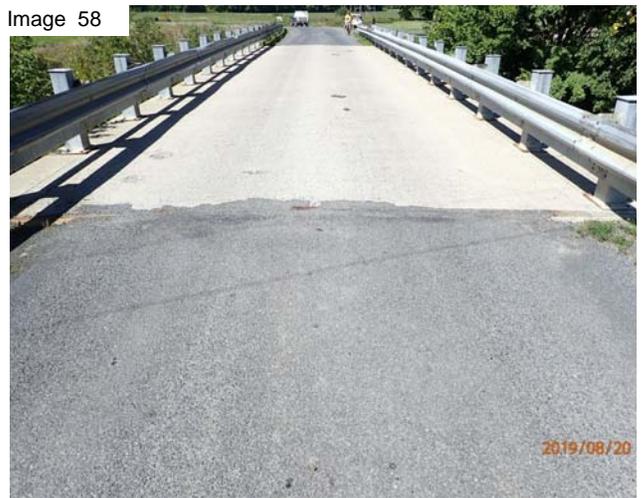
Image 58

East approach

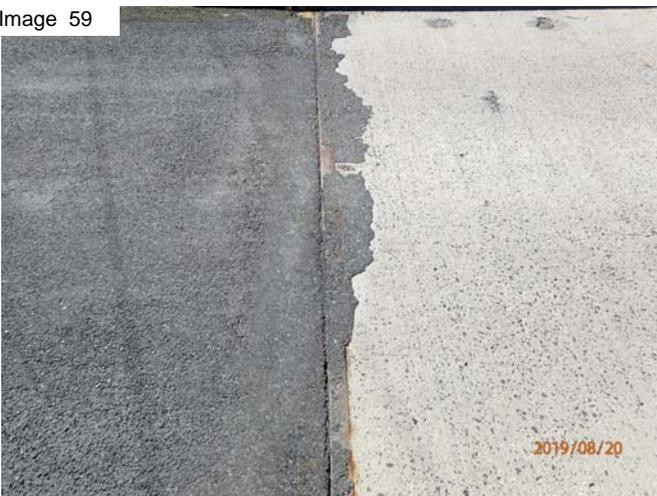
Image 59

East expansion joint

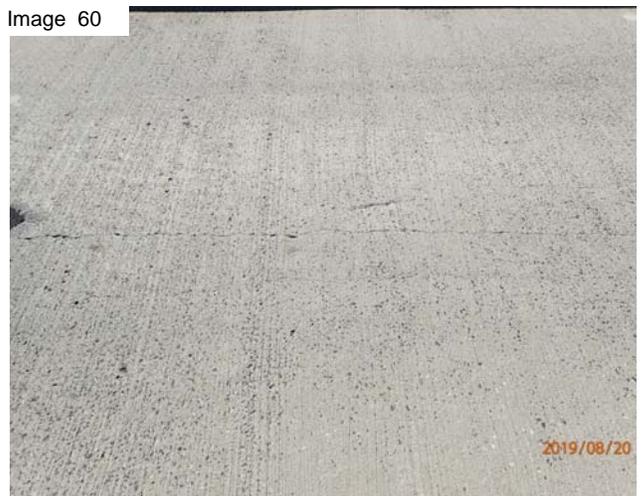
Image 60

Deck surface

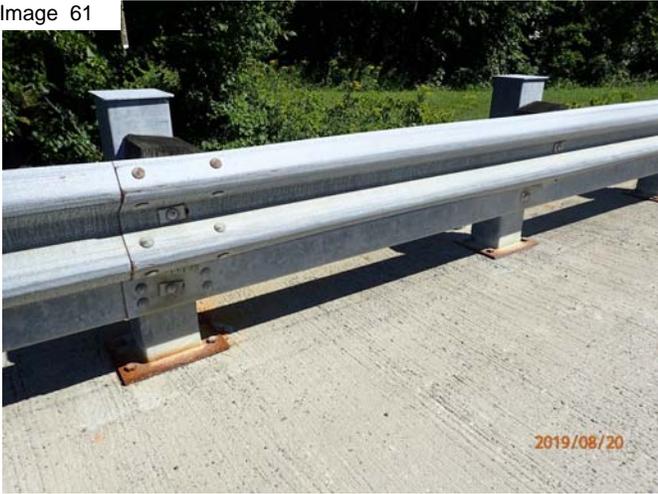
Image 61

North guide rail on deck

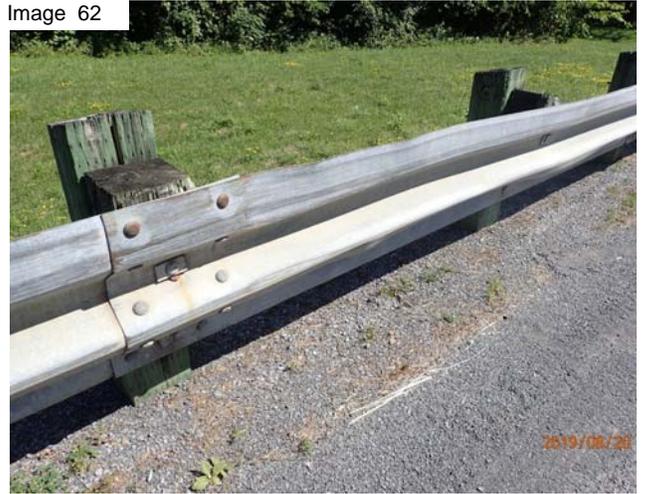
Image 62

NE guide rail on approach

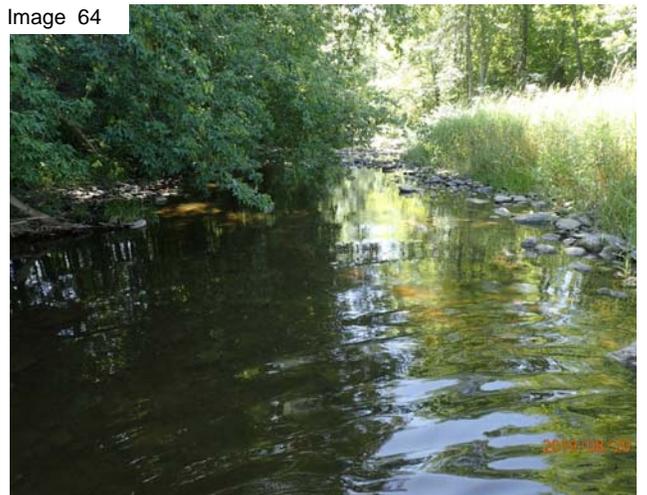
Image 64

South channel

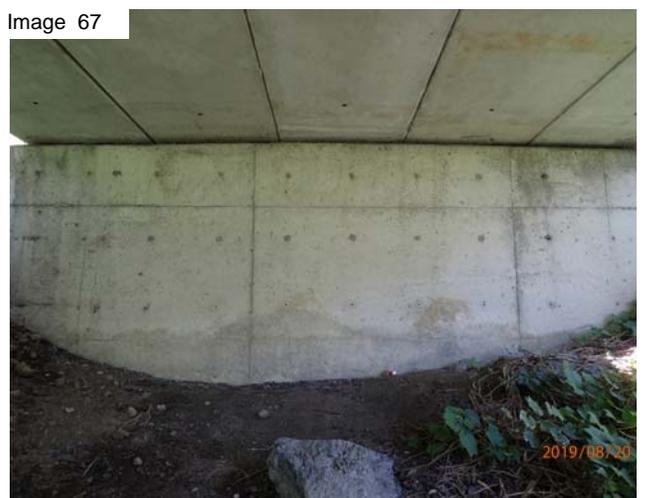
Image 67

East abutment wall

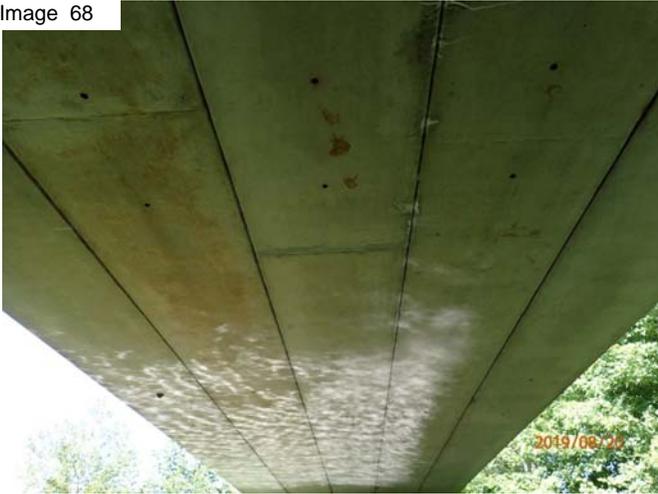
Image 68

Soffit typ (girder bottoms)

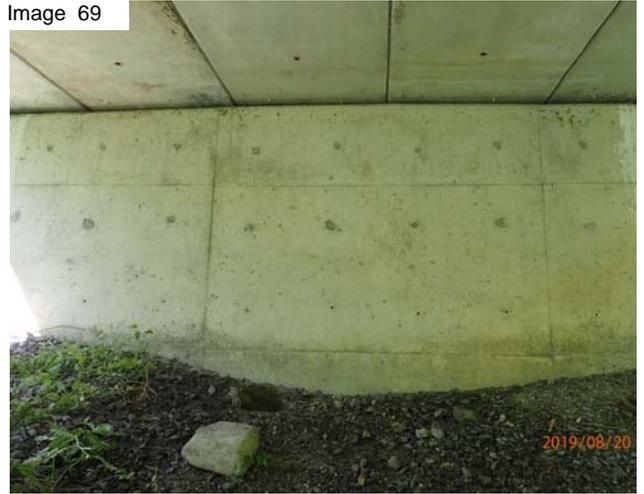
Image 69

West abutment wall

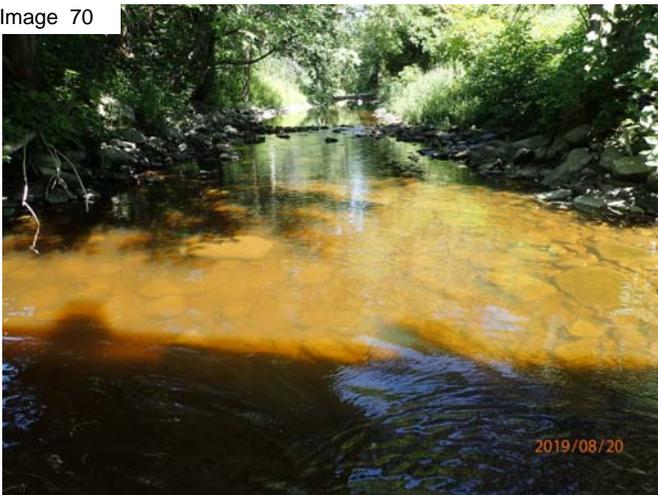
Image 70

North channel

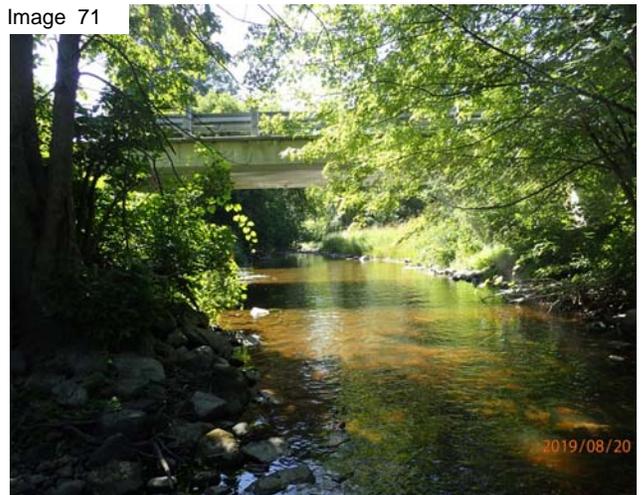
Image 71

North elevation

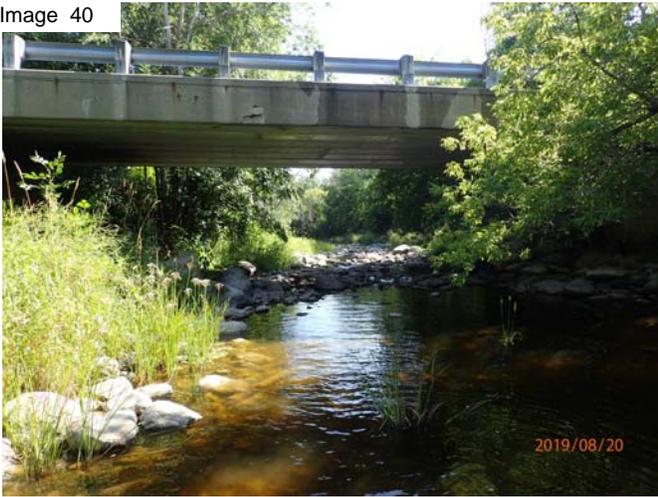
Image 40

West elevation

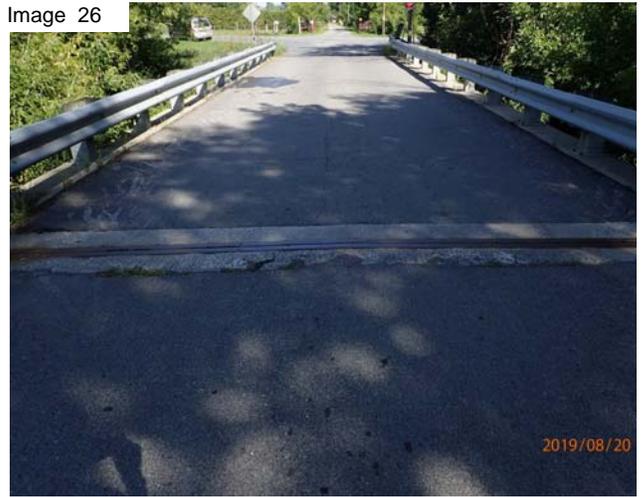
Image 26

South approach

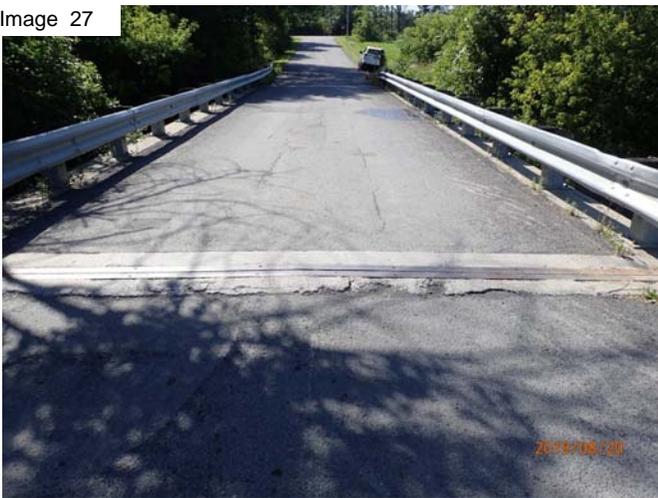
Image 27

North approach

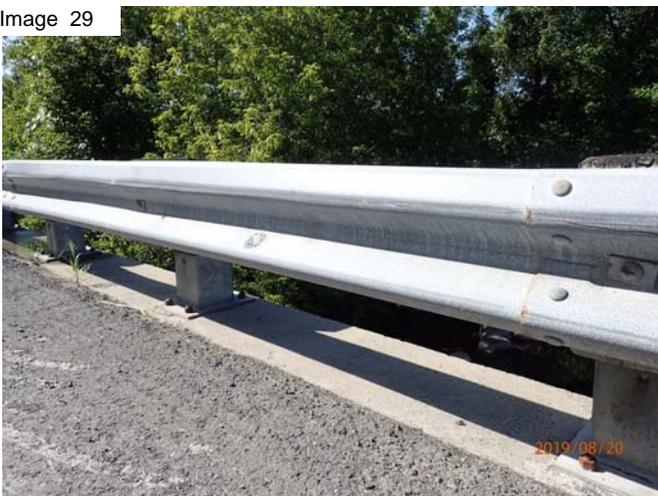
Image 29

West guide rail on deck

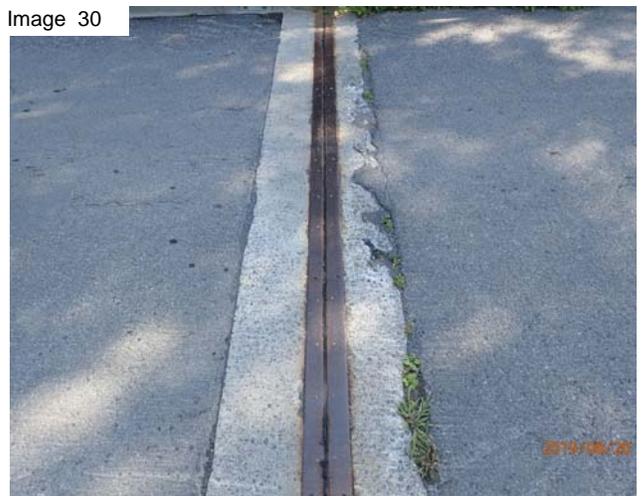
Image 30

Length: 6.4 m	Maintenance None	
Width:	Capital Rec. Replace in 2 years	
Height:	<i>Joint seals are over compressed. Tops of both ballast walls have major damage from winter plow. Armouring also has minor plow scrapes.</i>	
Steel Beam on Wood Post (Defects 0.0%	
Guide Rail	Damage 10.0%	Major Decay, Moderate Impact
Length: 42.5 m	Maintenance None	
Width:	Capital Rec. Replace in 2 years	Perf Def: Weakened
Height: 0.72 m	<i>Guide rail has many collision scrapes. One post is completely severed at NE end. 47 m (E) + 38 m (W)</i>	
RC Box (7)	Defects 5.0%	Moderate Staining, Minor Rust Staining
Girders	Damage 1.0%	Minor Delamination, Minor Fire Spalls
Length: 19.6 m	Maintenance None	
Width: 0.9 m	Capital Rec. None	
Height: 0.7 m	<i>Delaminated area on bottom of west girder. Spall on exterior of west girder. Lack of drainage from deck is causing damage to exterior girders. Staining on underside of girders at north end evident of camp fires under bridge.</i>

South expansion joint

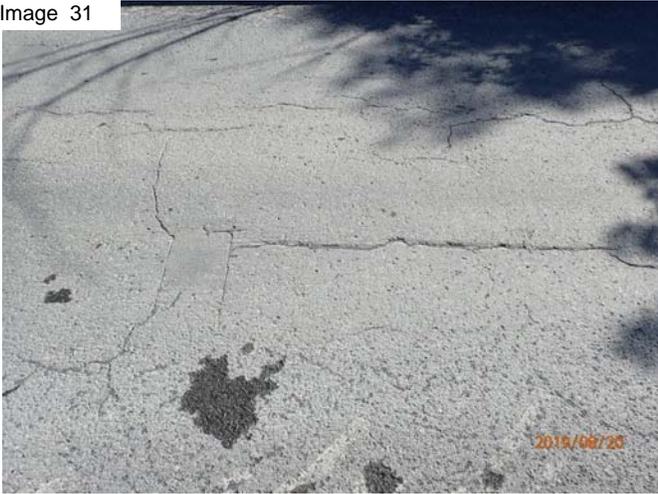
Image 31

Asphalt on deck

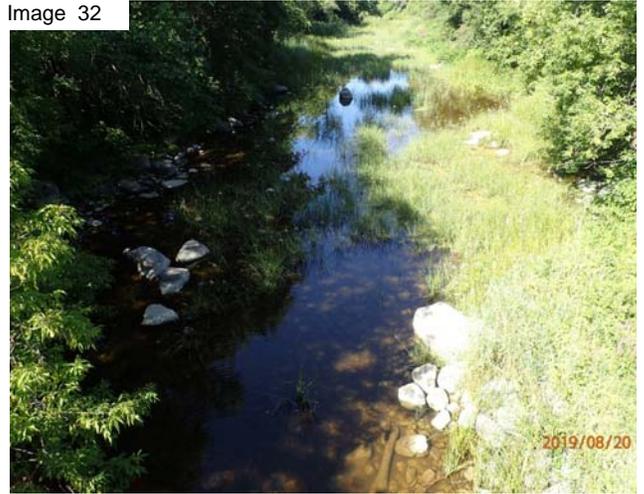
Image 32

West channel

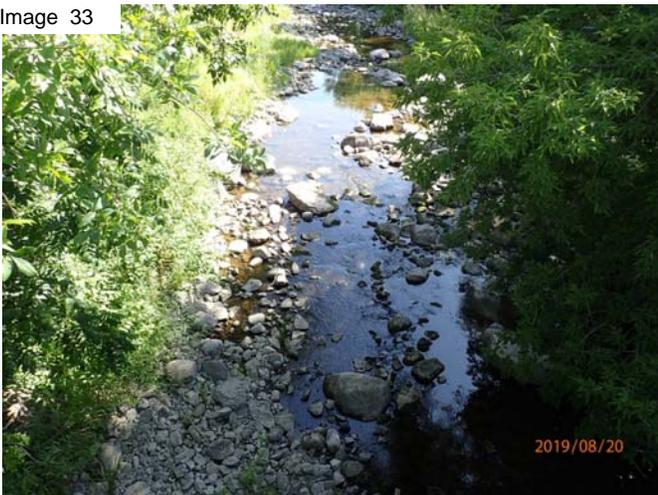
Image 33

East channel

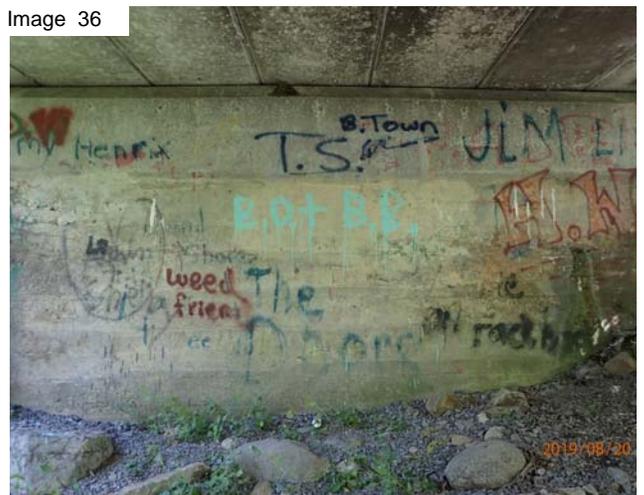
Image 36

North abutment wall

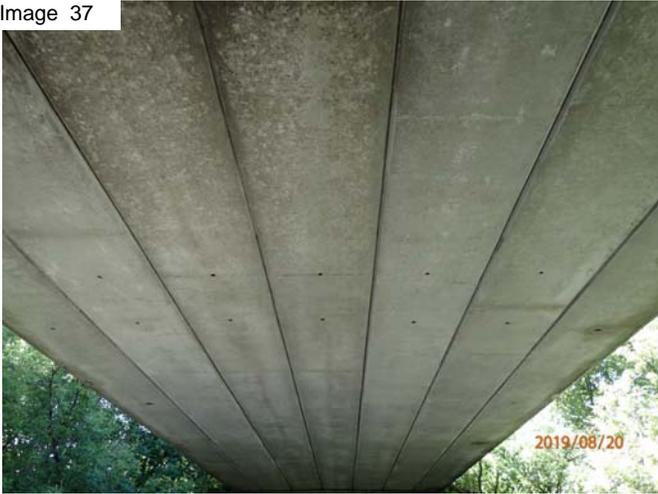
Image 37

Soffit typ (girder bottoms)

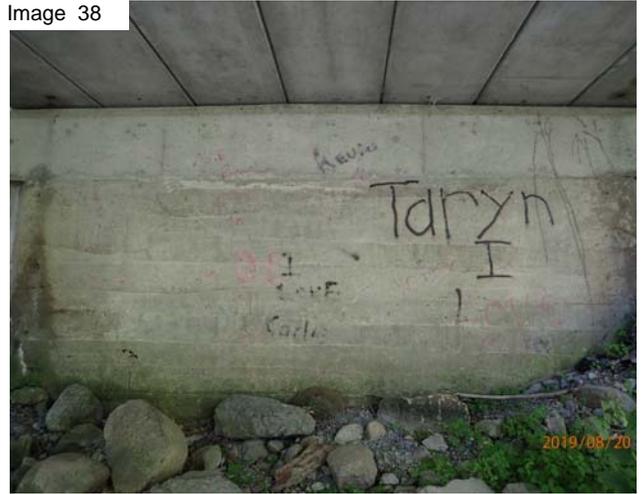
Image 38

South abutment wall

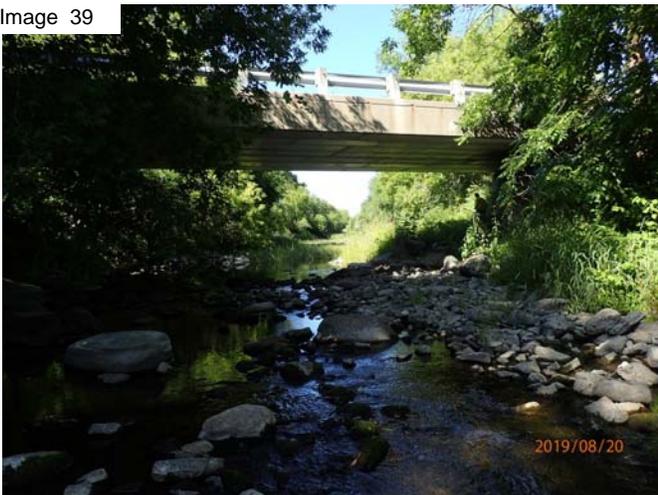
Image 39

East elevation

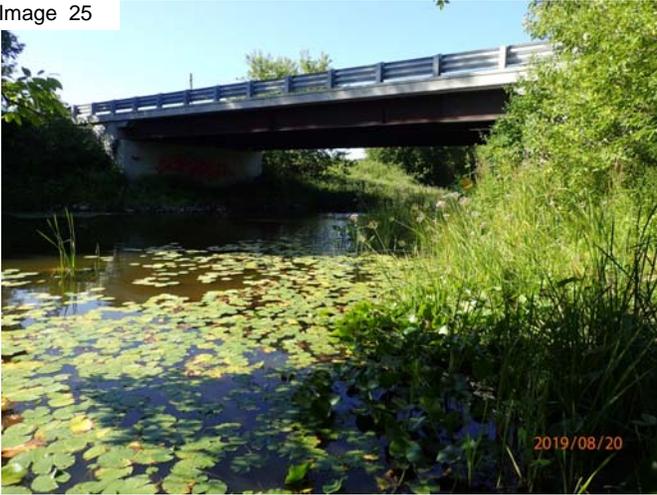
Image 25

East elevation

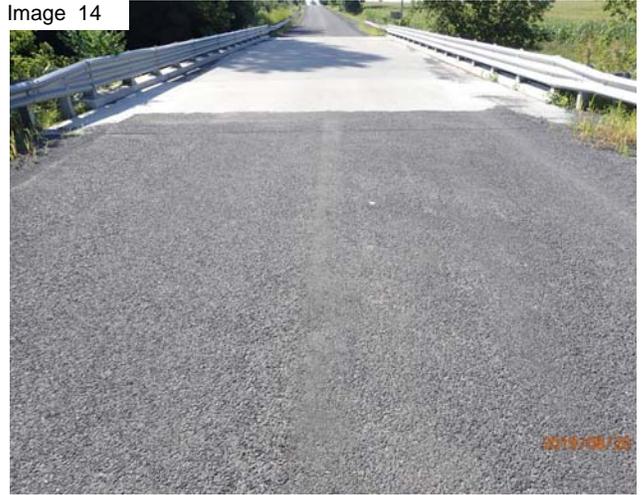
Image 14

North approach

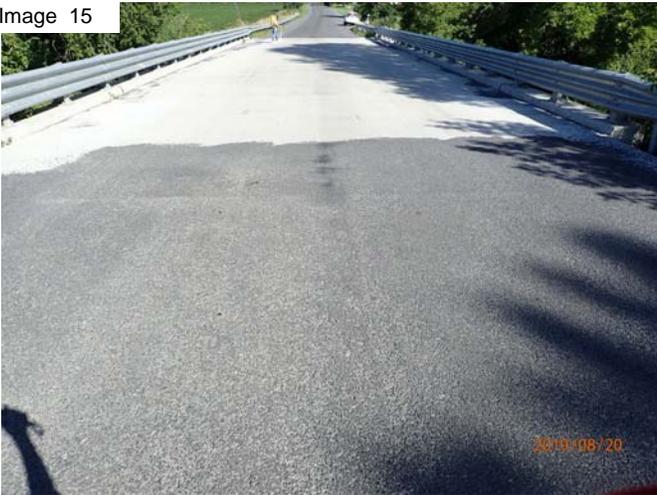
Image 15

South approach

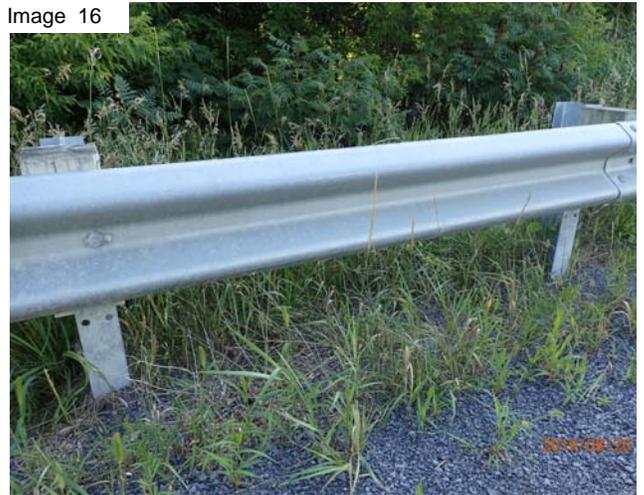
Image 16

SE guide rail on approach

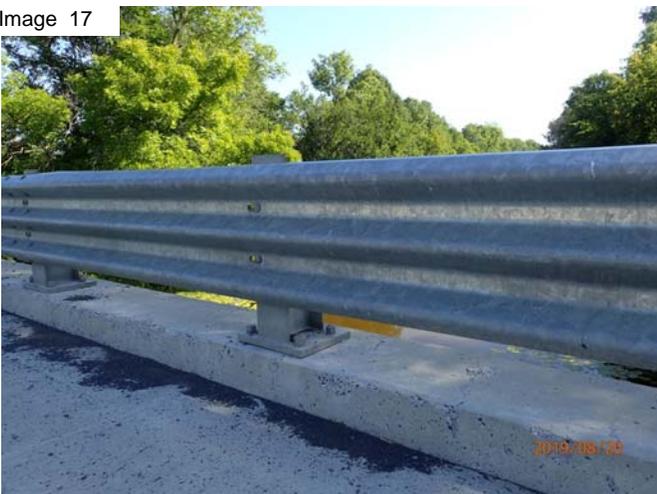
Image 17

East thrie beam on deck

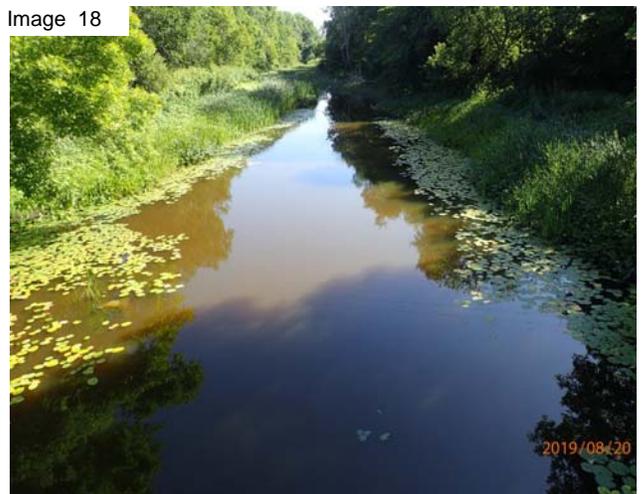
Image 18

East channel

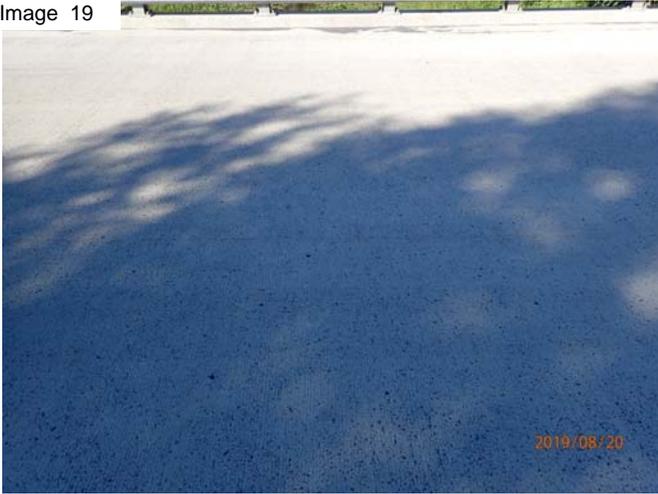
Image 19

Deck surface

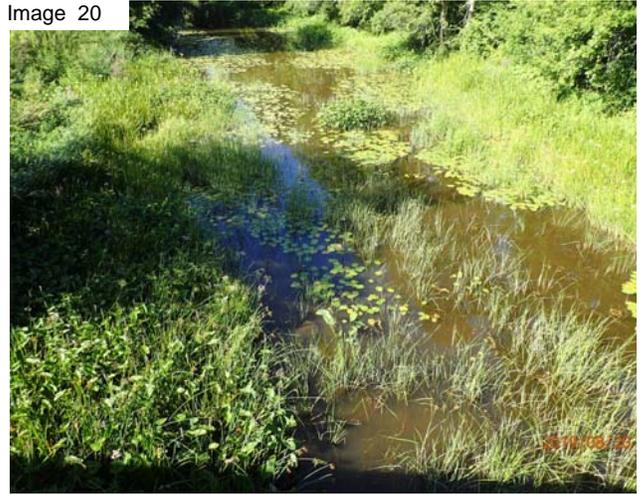
Image 20

West channel

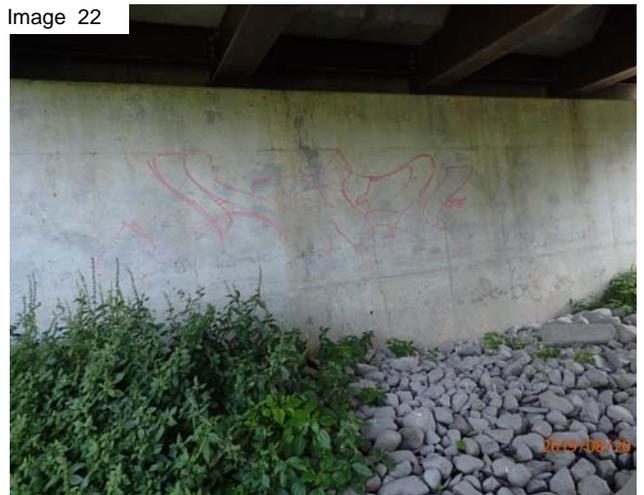
Image 22

North abutment wall

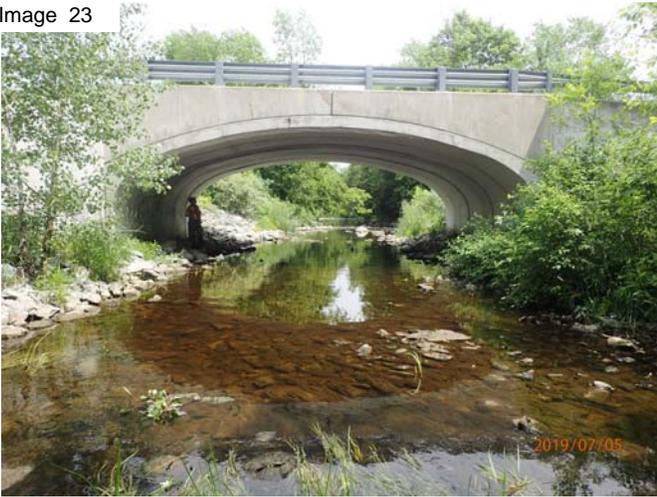
Image 23

West elevation

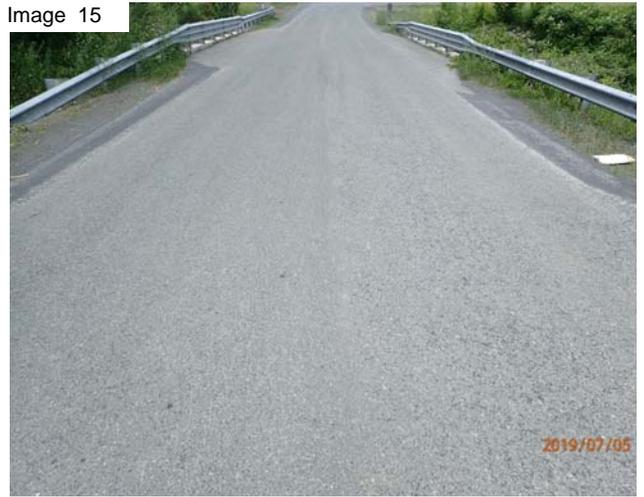
Image 15

South approach

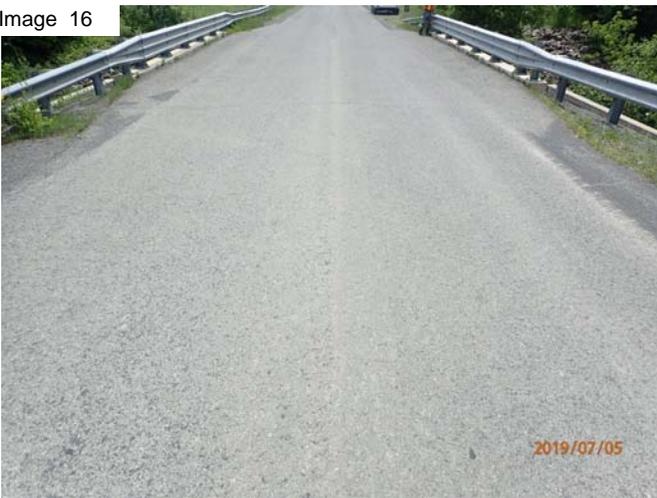
Image 16

North approach

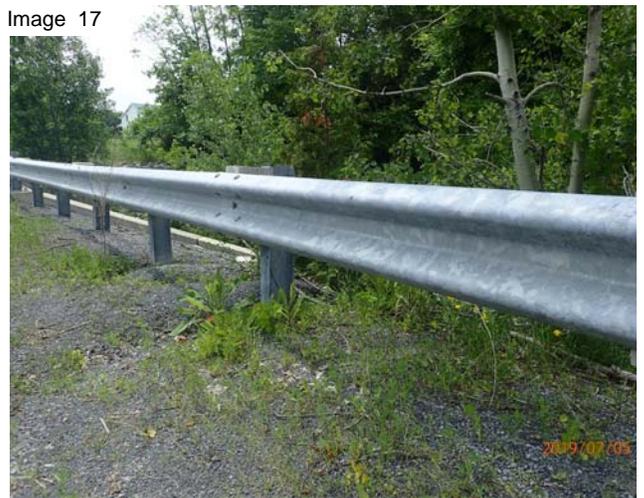
Image 17

NW guide rail system

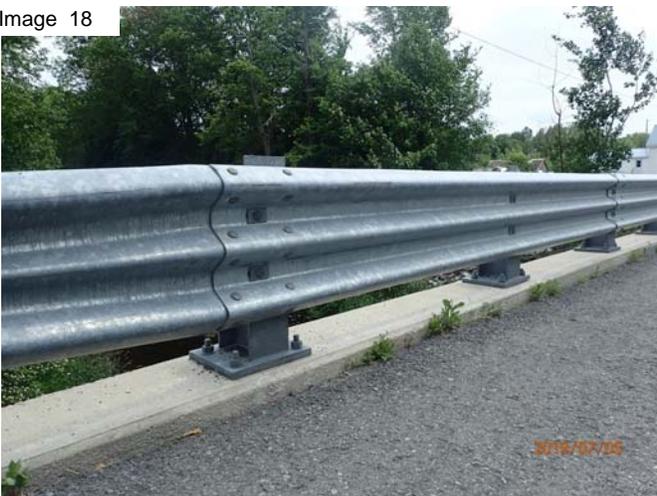
Image 18

Thrie beam over bridge typ

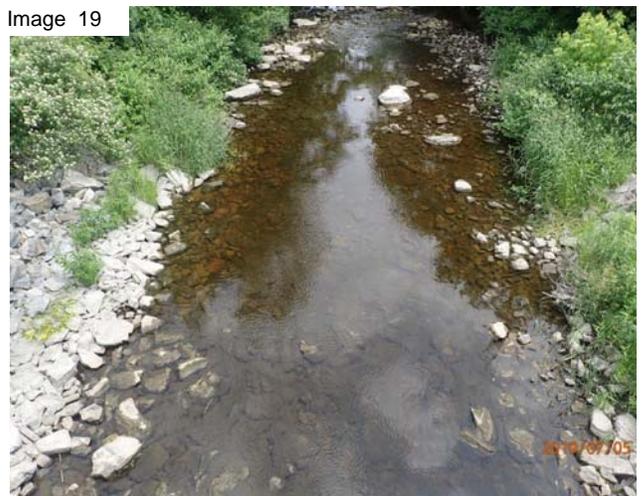
Image 19

East channel

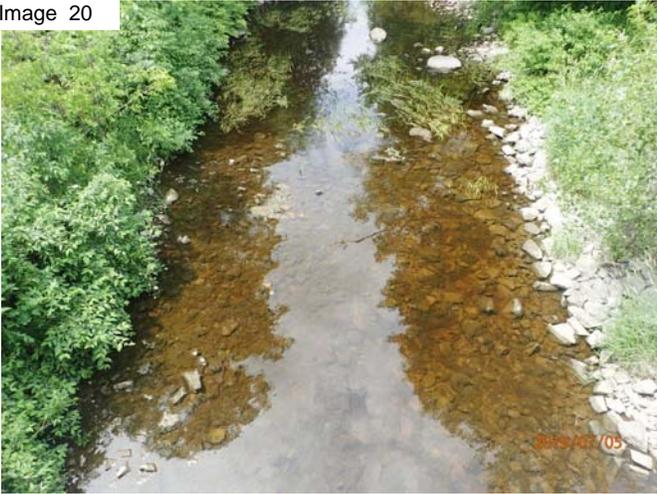
Image 20

West channel

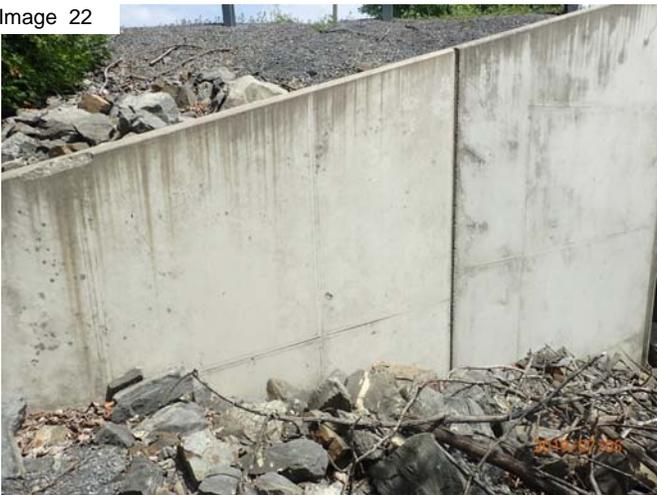
Image 22

NW wing wall typ

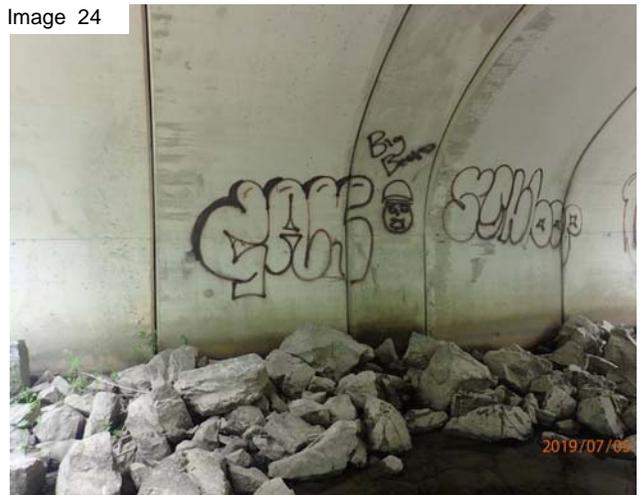
Image 24

North abutment wall

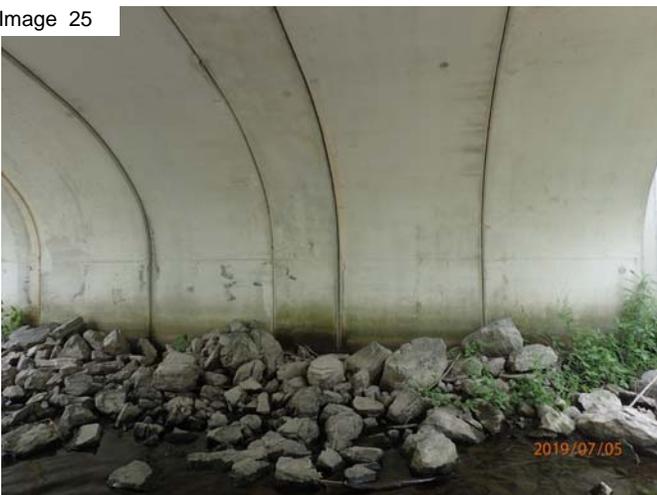
Image 25

South abutment wall

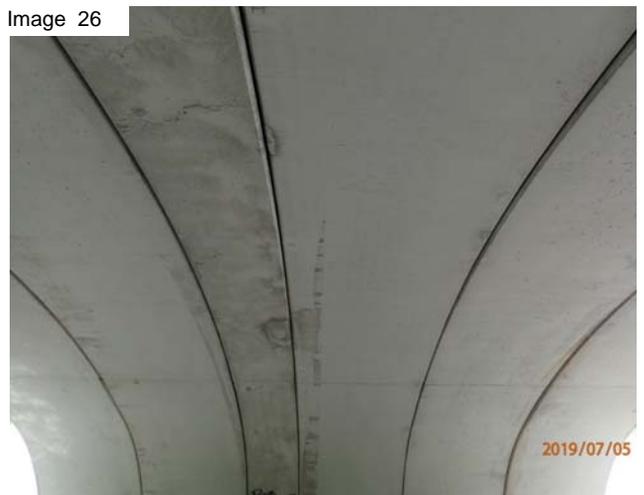
Image 26

Soffit (typical)

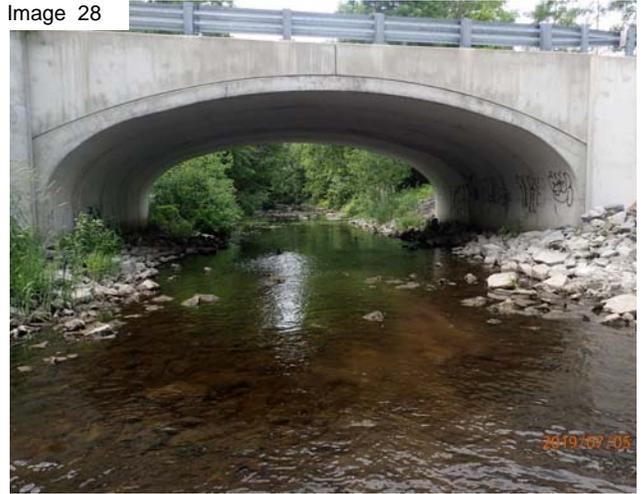
Image 28

East elevation

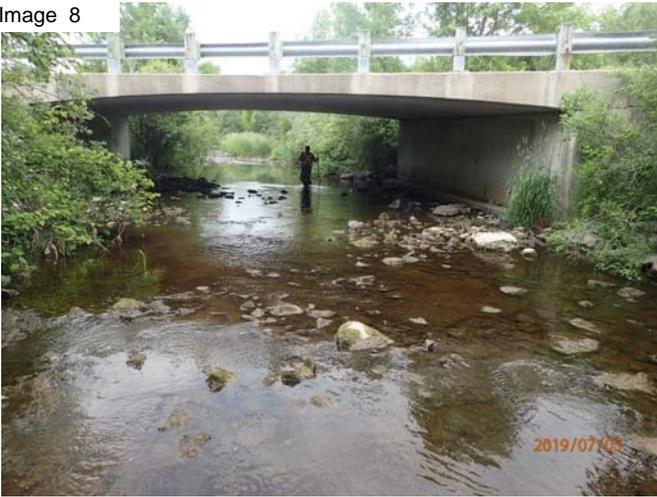
Image 8

South elevation

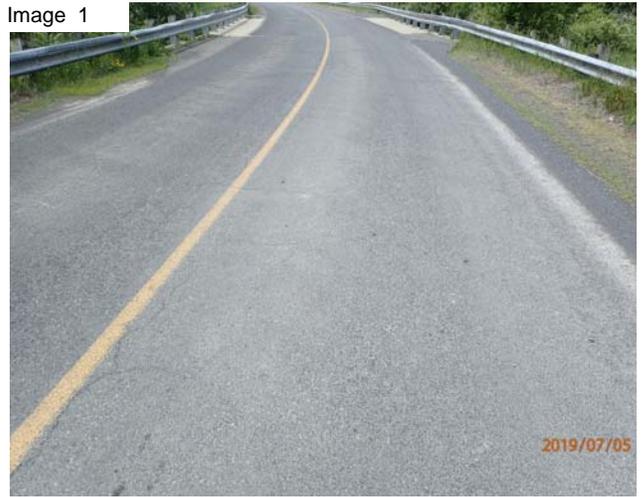
Image 1

East approach

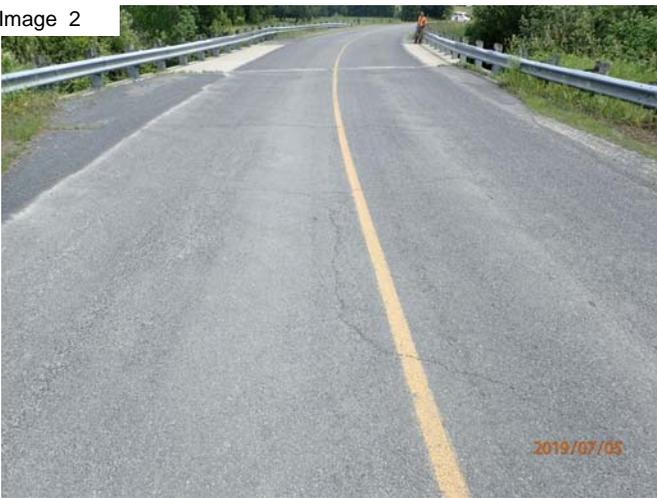
Image 2

West approach

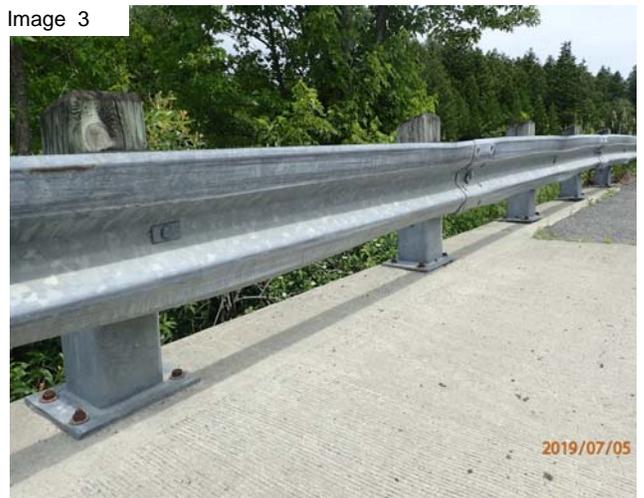
Image 3

Barrier system north side

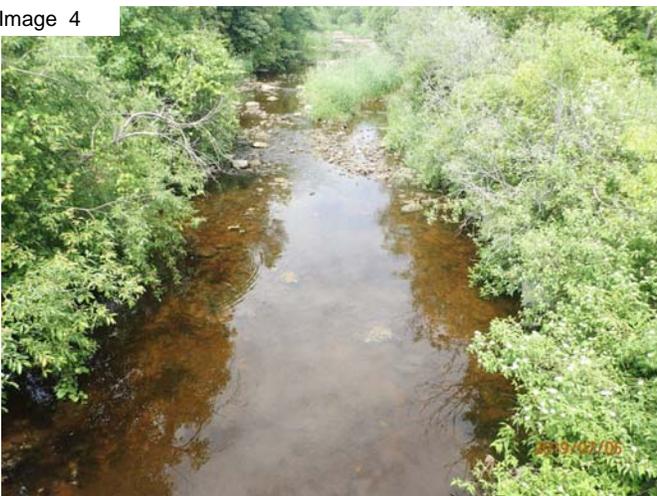
Image 4

North channel

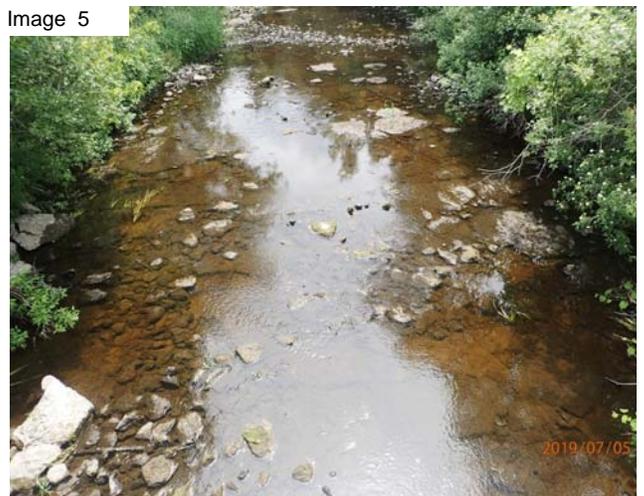
Image 5

South channel

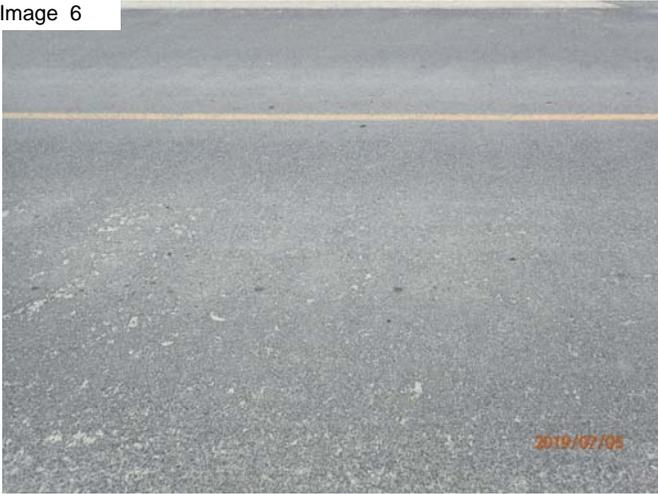
Image 6

Asphalt on deck

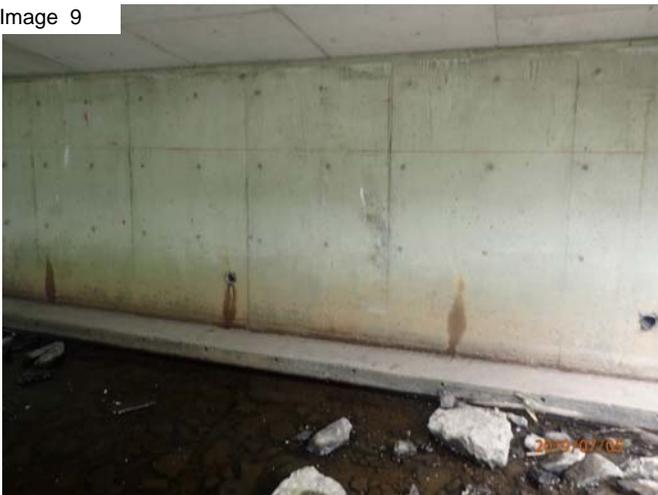
Image 9

East abutment wall

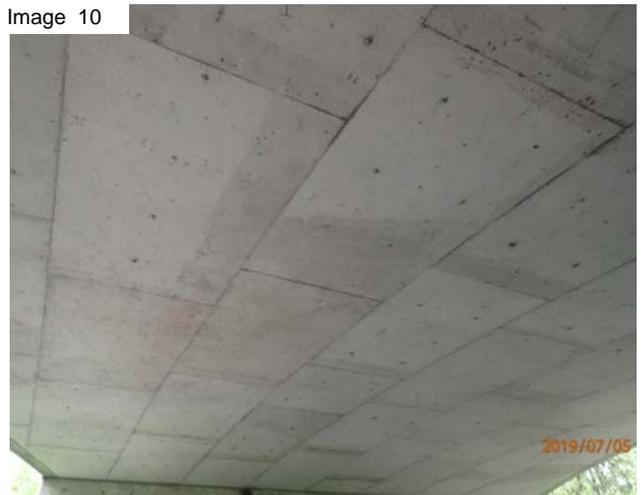
Image 10

Soffit (typical)

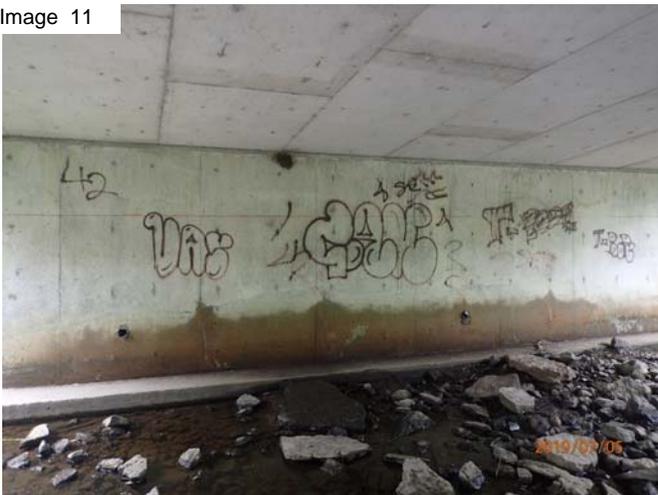
Image 11

West abutment wall

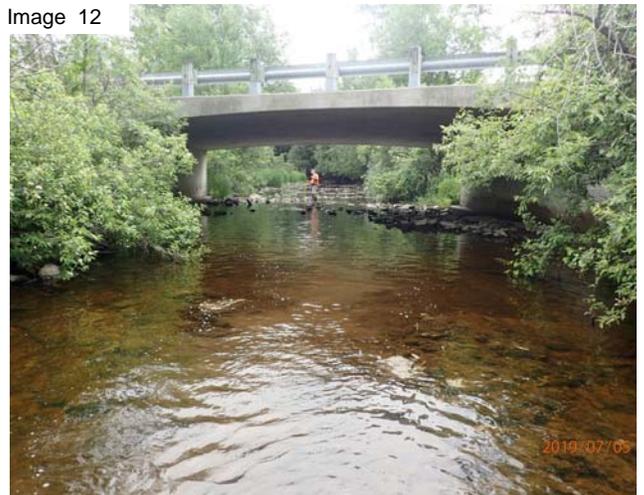
Image 12

North elevation
