2019 BIENNIAL STRUCTURE INSPECTION PROGRAM

Township of South Stormont – September 2019

Keystone Bridge Management Corp.

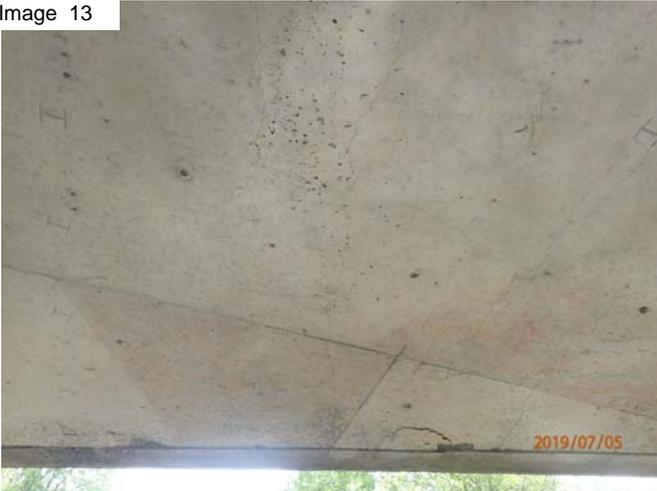
Image 13

Delams soffit south side

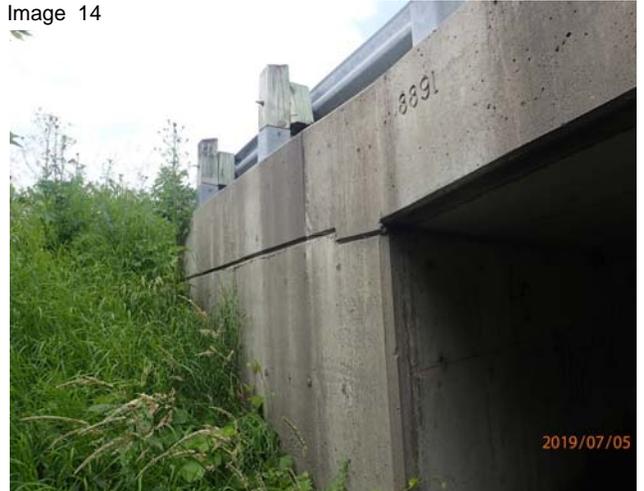
Image 14

SW corner detail

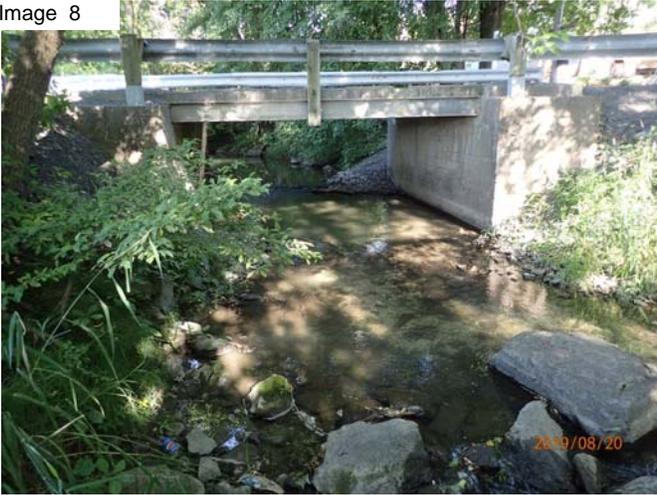
Image 8

East elevation

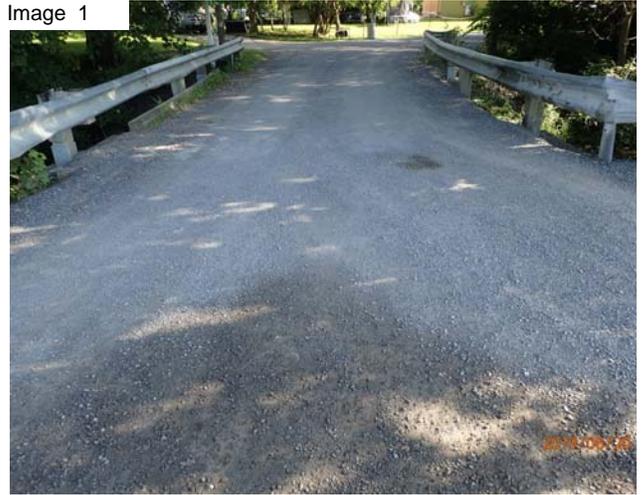
Image 1

South approach

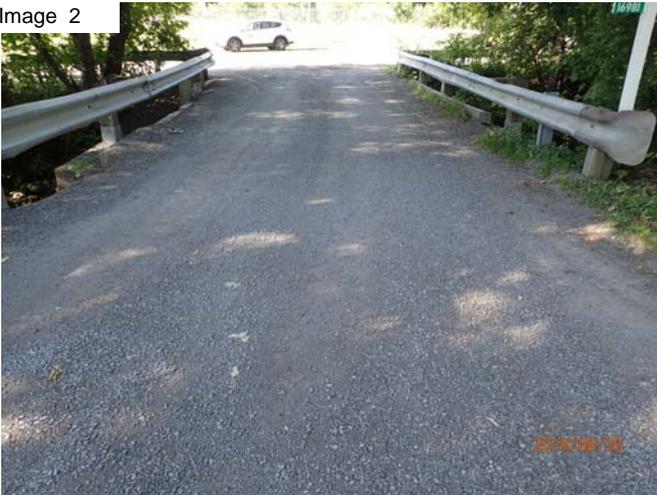
Image 2

North approach

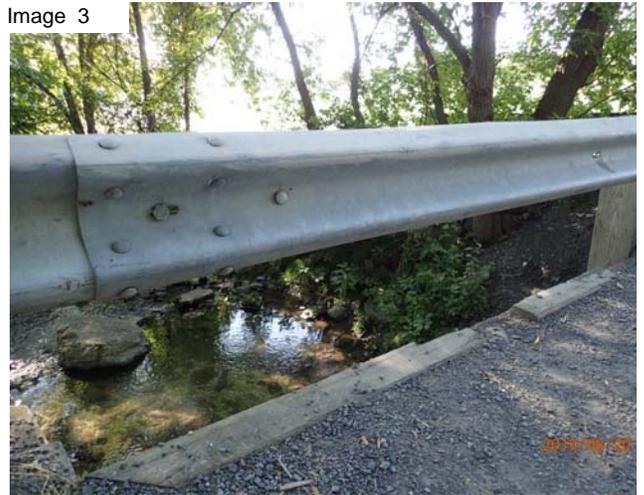
Image 3

East guide rail on bridge

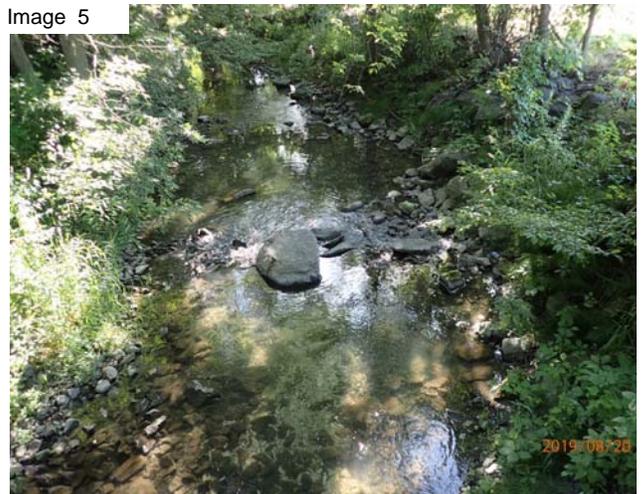
Image 5

East channel

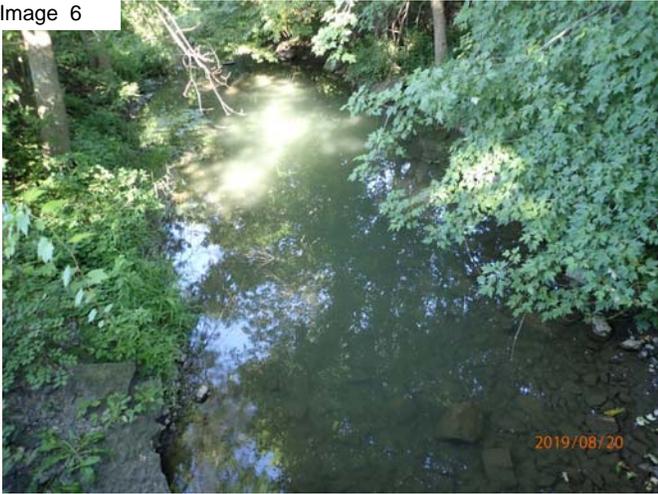
Image 6

West channel

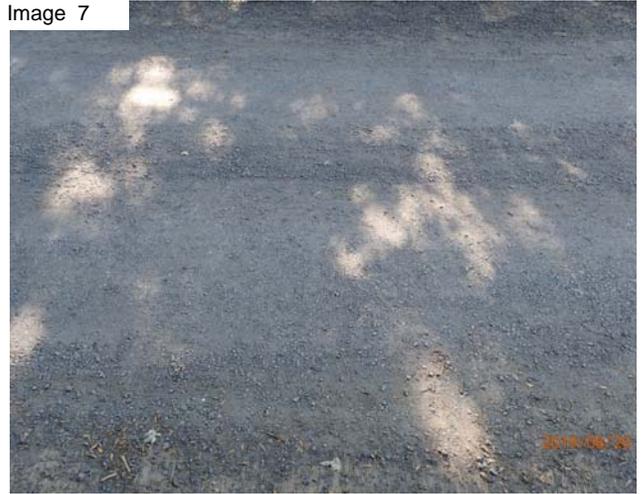
Image 7

Gravel on timber deck

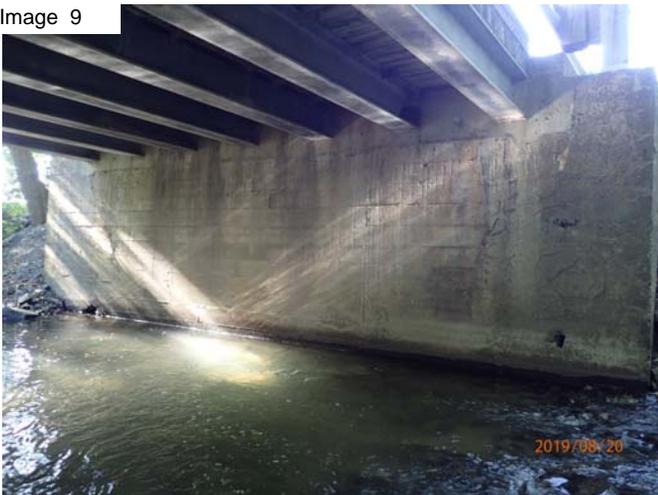
Image 9

South abutment wall

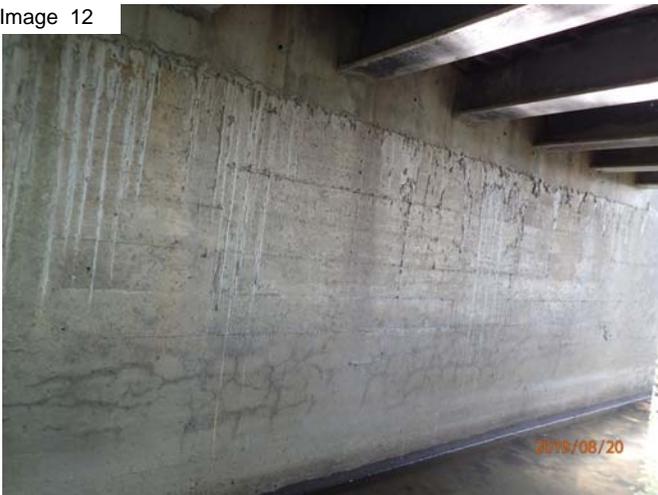
Image 12

North abutment wall

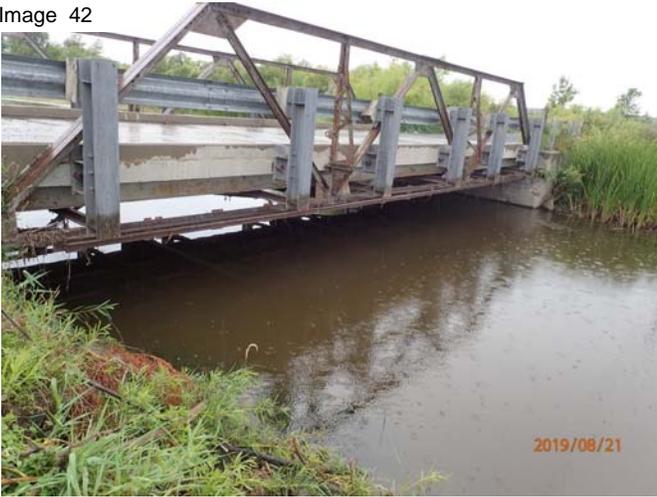
Image 42

East elevation

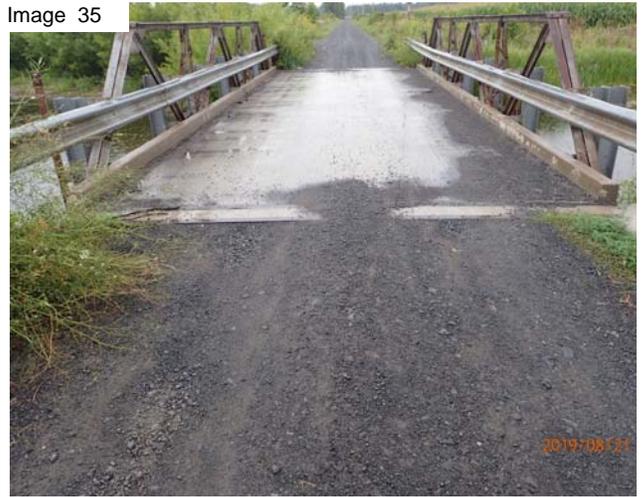
Image 35

South approach

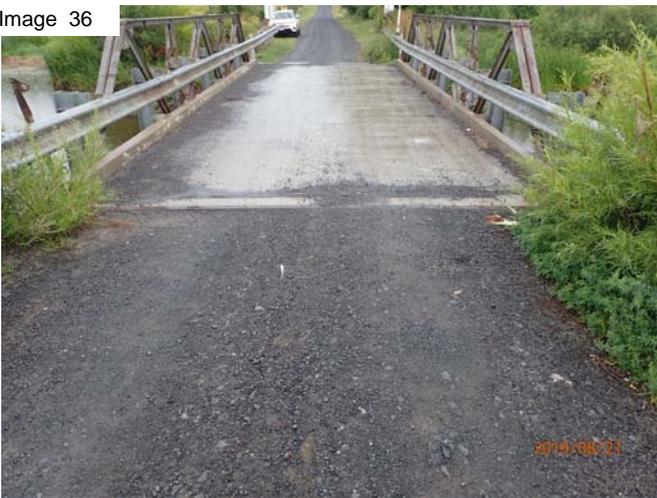
Image 36

North approach

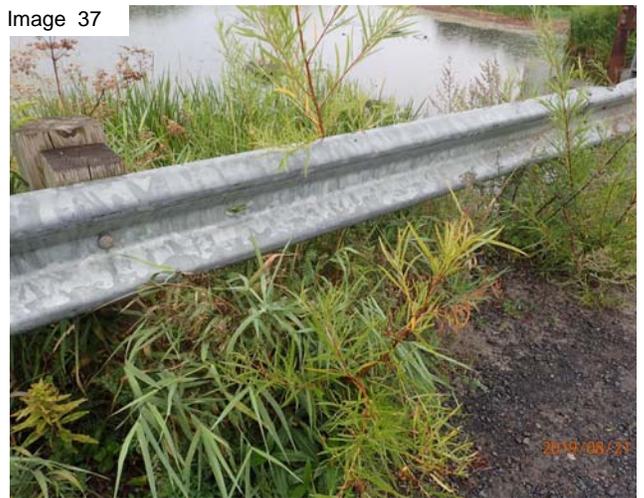
Image 37

NE guide rail

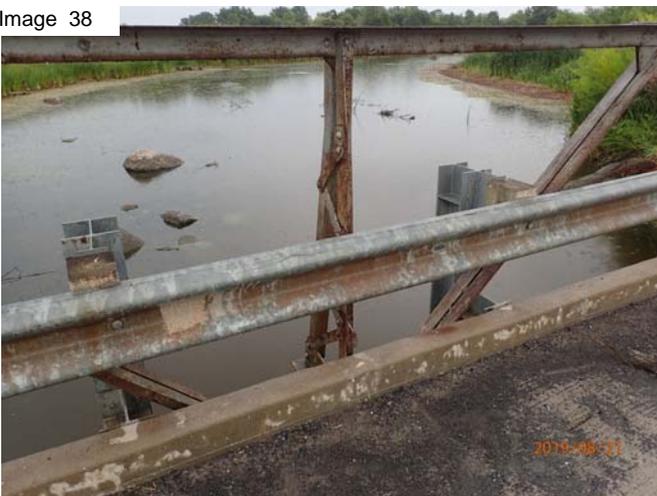
Image 38

East side truss panel

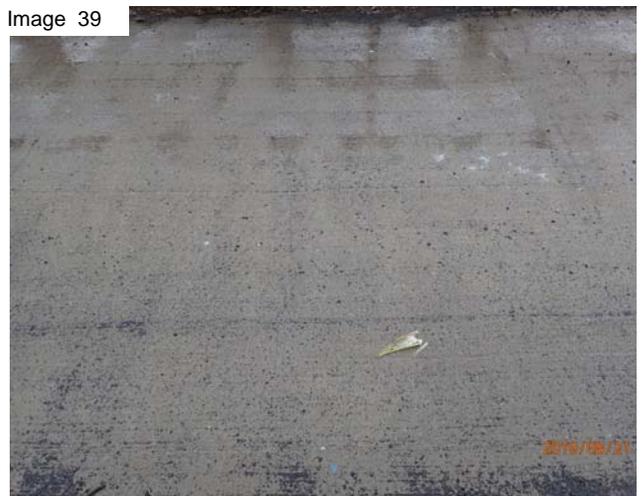
Image 39

Exposed concrete deck

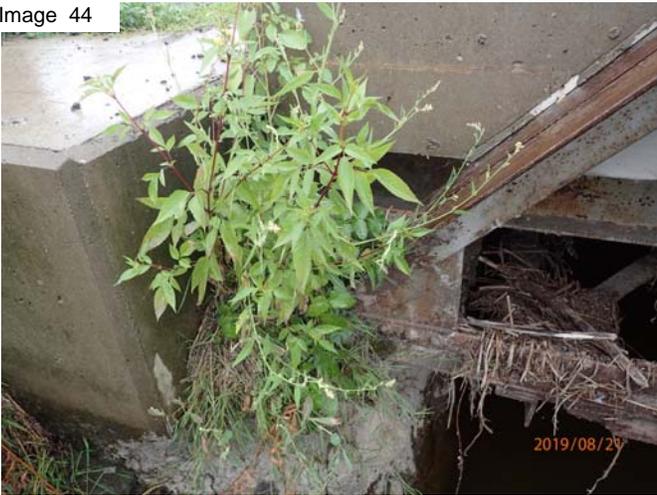
Image 44

SE bearing

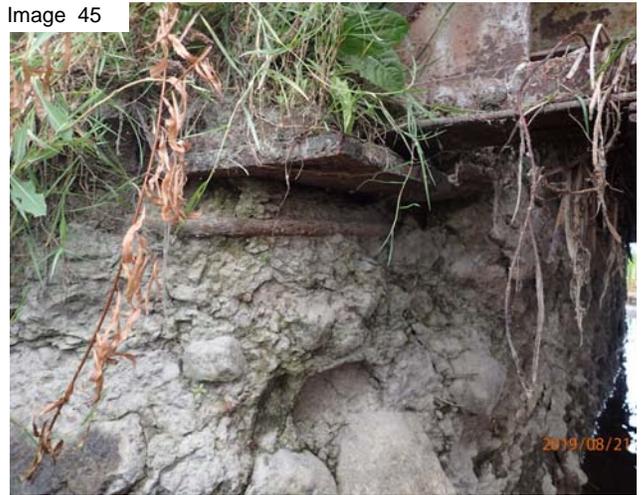
Image 45

SE bearing loss support

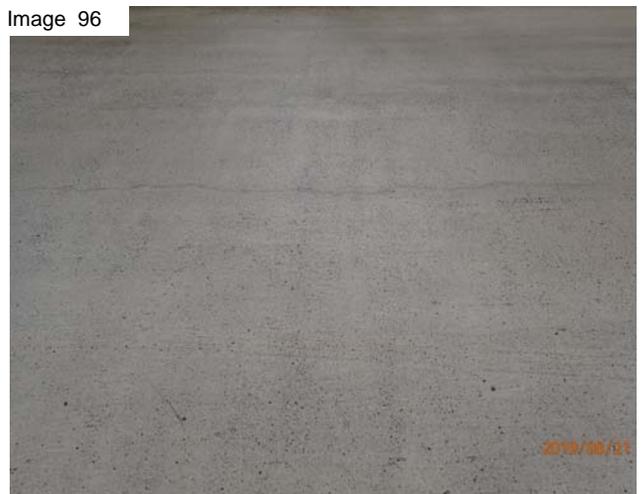
Image 96

Exposed concrete deck

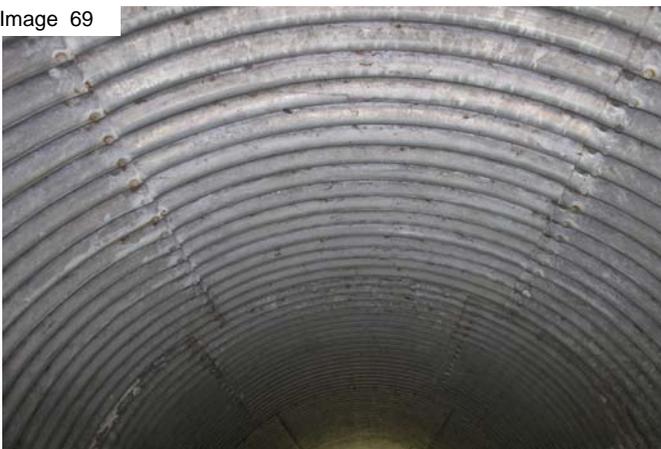
Image 69

Length: 16.5 m	Maintenance None	
Width: 3.7 m	Capital Rec. Replace in 1 year	Perf Def: Settlement
Height: 3.7 m	<i>Bottom of culvert has severe perforations along most of its length.</i>	
Asphalt Wear Surf (1)	Defects 0.0%	
Wear Surface	Damage 0.0%	
Length: 3.7 m	Maintenance None	
Width: 6 m	Capital Rec. None	
Height:	<i>Two transverse cracks along sides of culvert suggest road settlement from failing culvert.</i>	
Water Channel (1)	Defects 0.0%	
Outlet Channel	Damage 0.0%	
	Maintenance None	
	Capital Rec. None	
	<i>Part of agricultural drain with uniform bottom width of about 3.5 to 4 m and 1.5:1 side slopes.</i>	
Water Channel (1)	Defects 0.0%	
Conduit Channel	Damage 0.0%	
	Maintenance None	
	Capital Rec. None	
	<i>Clear.</i>	
Water Channel (1)	Defects 0.0%	
Inlet Channel	Damage 0.0%

Culvert invert

Comments:
Culvert is severely perforated and starting to fail. Should be replaced on an urgent basis.

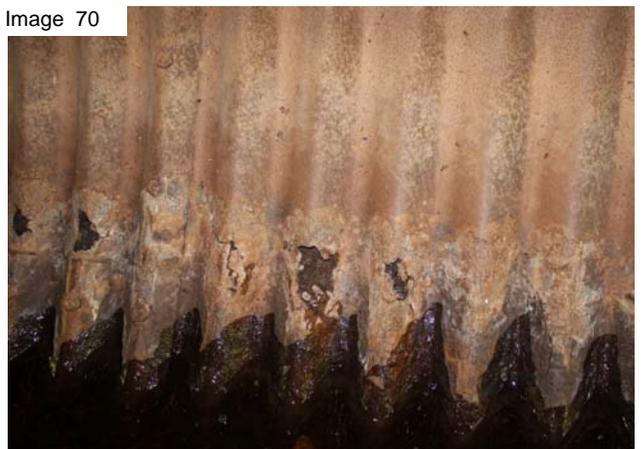
Image 70

West wall perforation

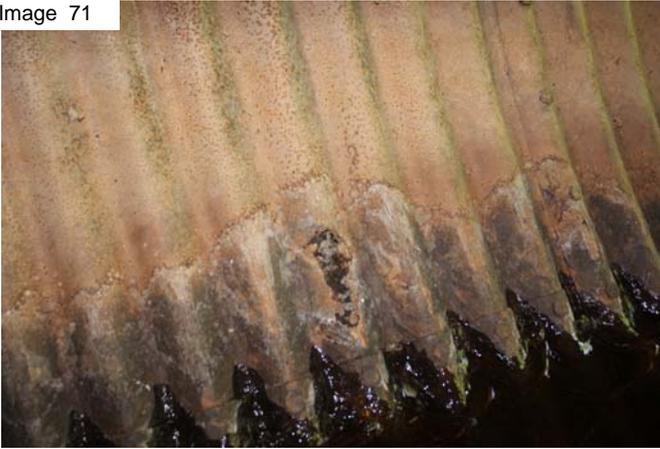
Image 71

East wall perforation

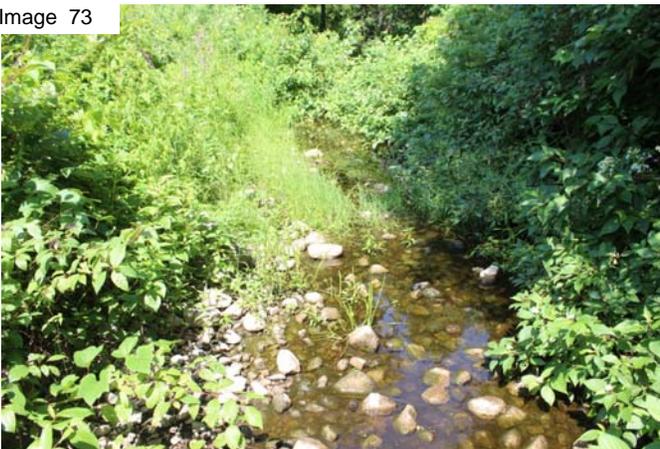
Image 73

West wall perforation south inlet

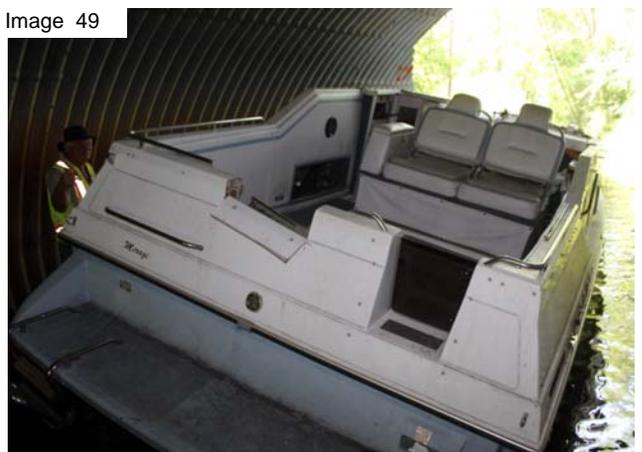
Image 49

West inlet boat

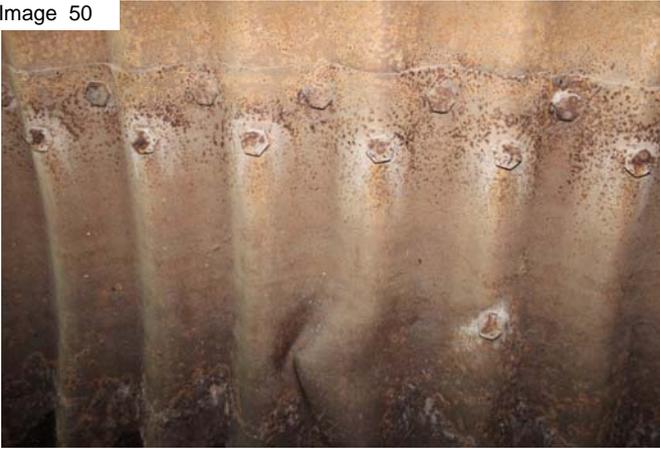
Image 50

North wall bulge

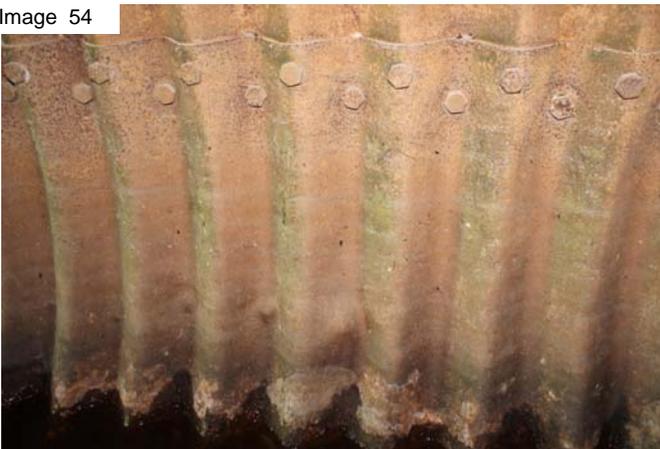
Image 54

South wall bulge

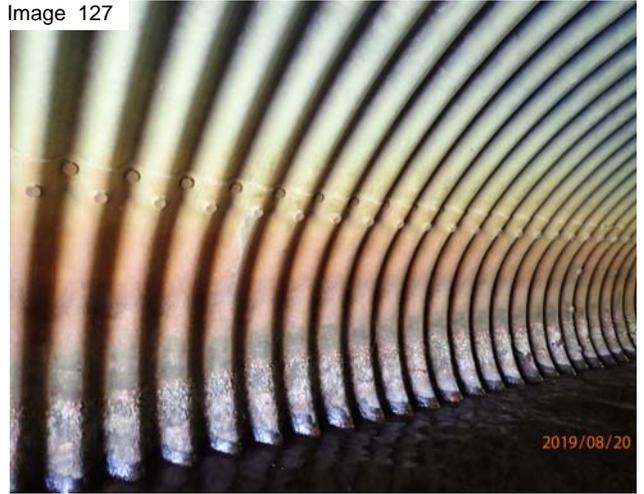
Image 127

West wall

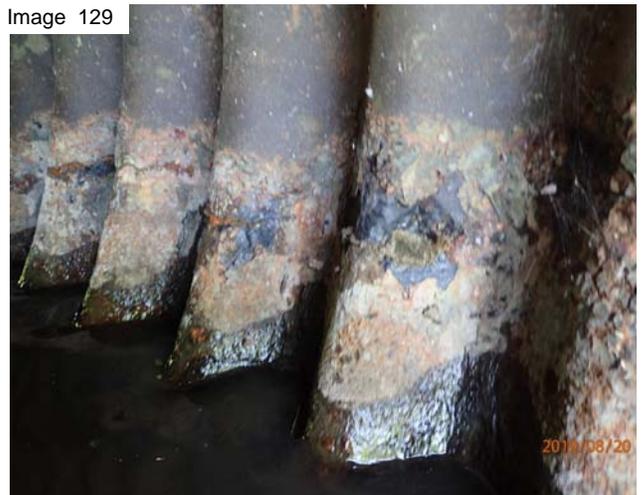
Image 129

Date of construction is likely 1990's not 1976. This culvert has an obvious crimp line along lower barrel walls, walls are easily penetrated with pick hammer in this area. Programming for replacement of this culvert should be started. Plan on replacing this culvert within two years.

Crimping with perforations wall

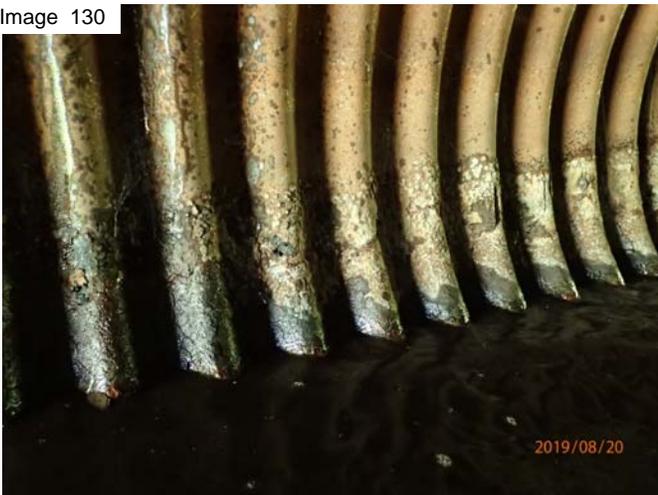
Image 130

West wall defined crimping & perforations

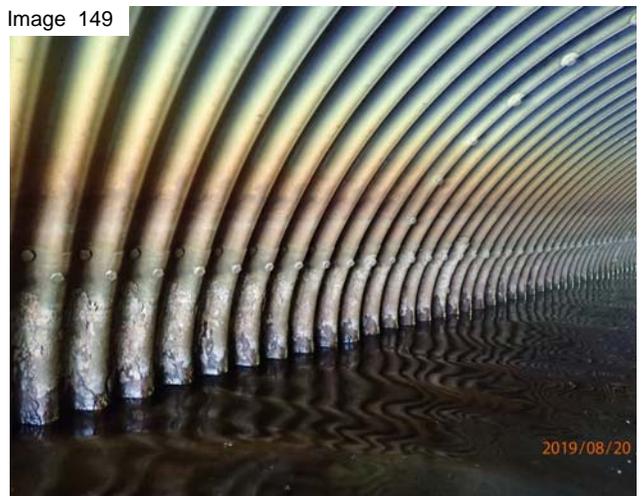
Image 149

Construction year was estimated at 1980. Current condition is satisfactory. Lower half of barrel walls has moderate to severe section loss, culvert has approximately 5 years of remaining service life.

East wall

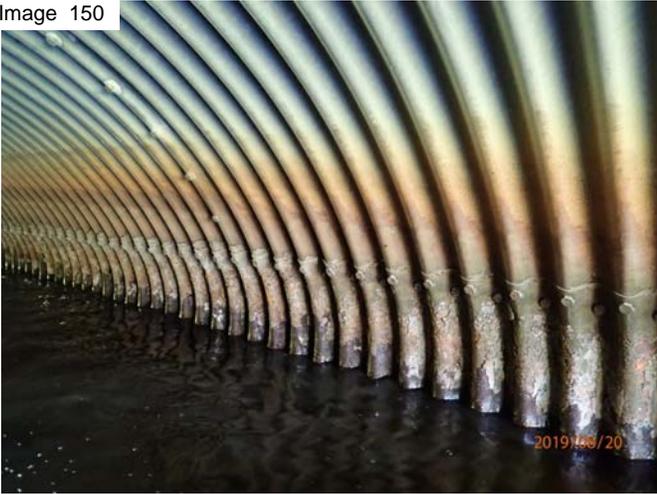
Image 150

West wall

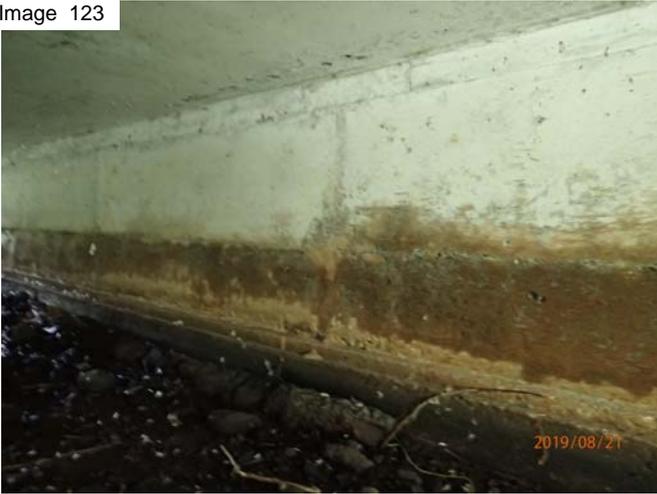
Image 123

West wall

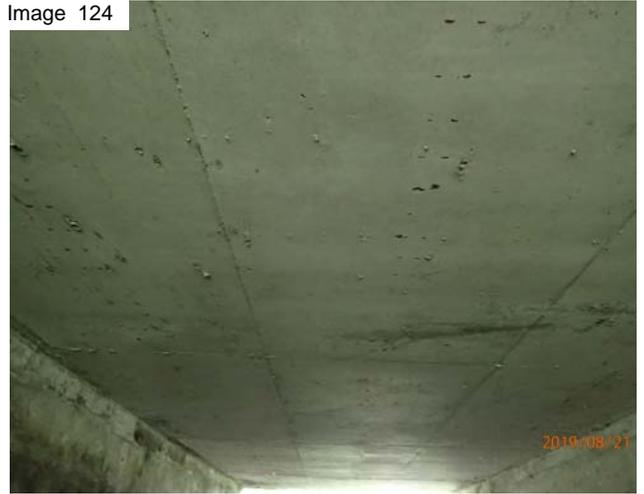
Image 124

Soffit (typical)

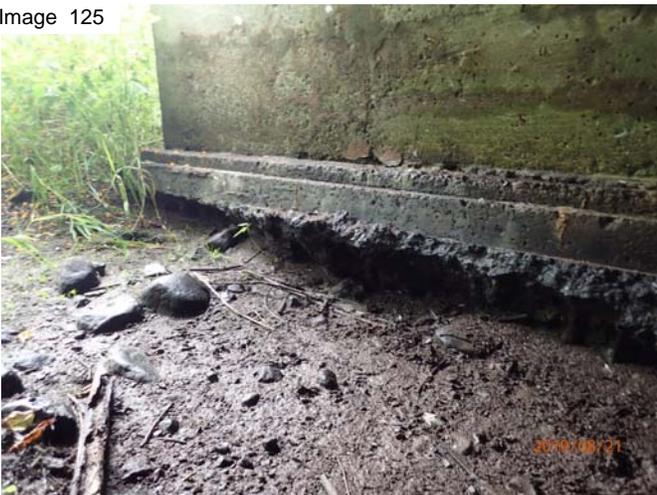
Image 125

SW corner footing under cut

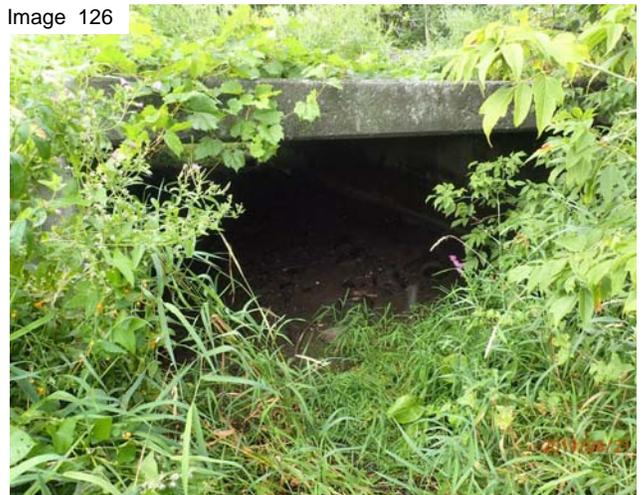
Image 126

South elevation

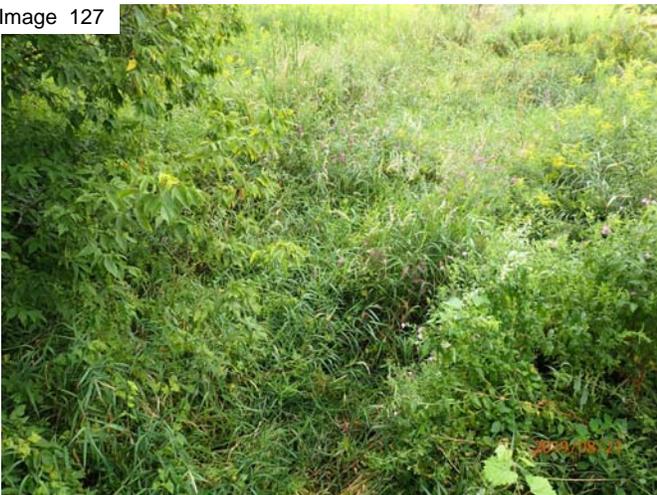
Image 127

South channel

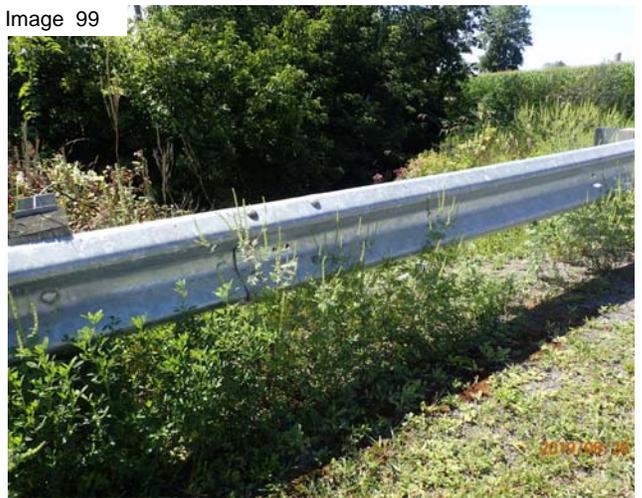
Image 99

West guide rail

Comments:
This culvert is in good condition. Guide rail over culvert is due for replacement.

Recommended Capital Works:
Guide Rail

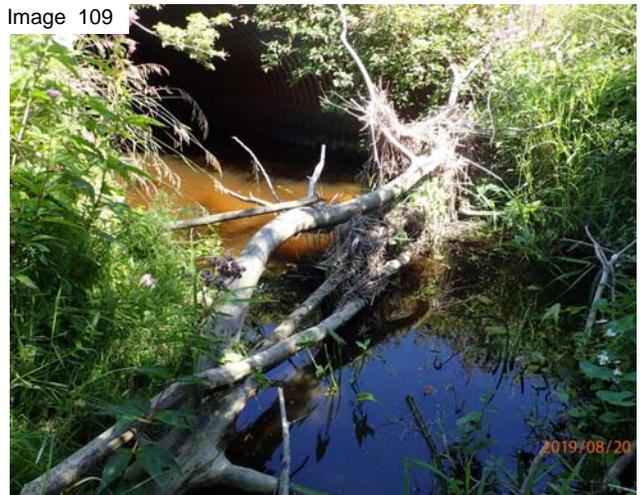
Image 109

West inlet debris

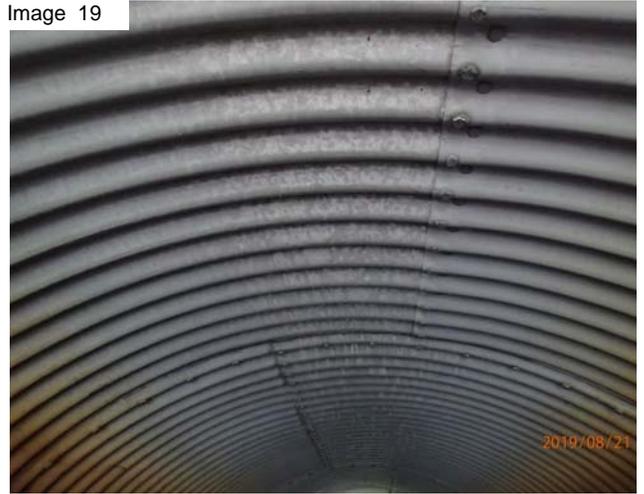
Image 19

East wall

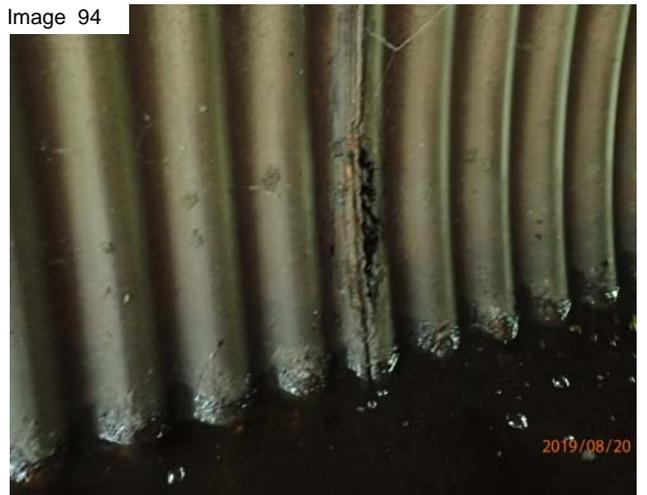
Image 94

Construction year was estimated at 1995. Perforations were noted in barrel wall and floor. A concrete floor liner may be an appropriate repair strategy for this culvert due to the perforations being low in floor or walls. Without liner this culvert will need replacement in 5 - 10 year timeframe. Floor liner would add 20 years to life of culvert.

North wall mid length wall perforations

Recommended Capital Works:
Concrete floor liner

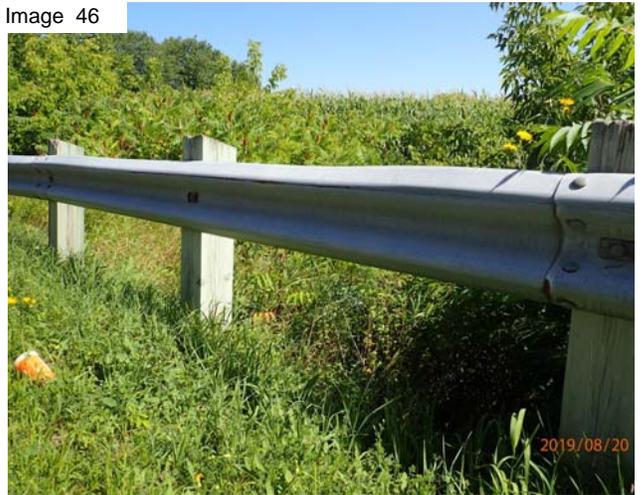
Image 46

Age of this culvert should be verified, more likely constructed in 90's not 1975. Culvert is in satisfactory condition at this time. Guide rail protection should be updated within 2 years.

East guide rail

Guide rail

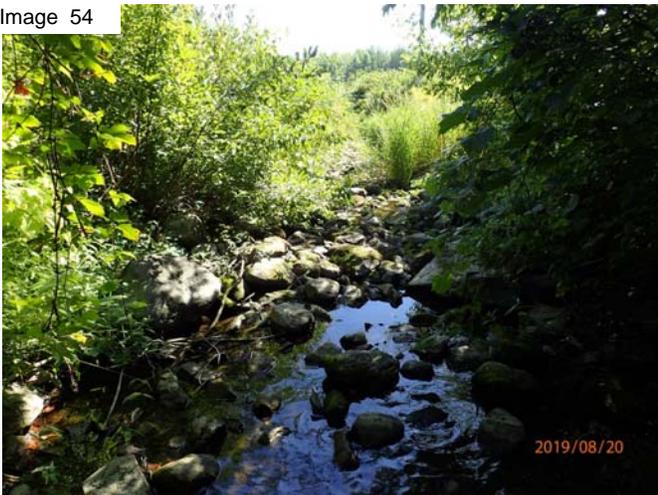
Image 54

East channel

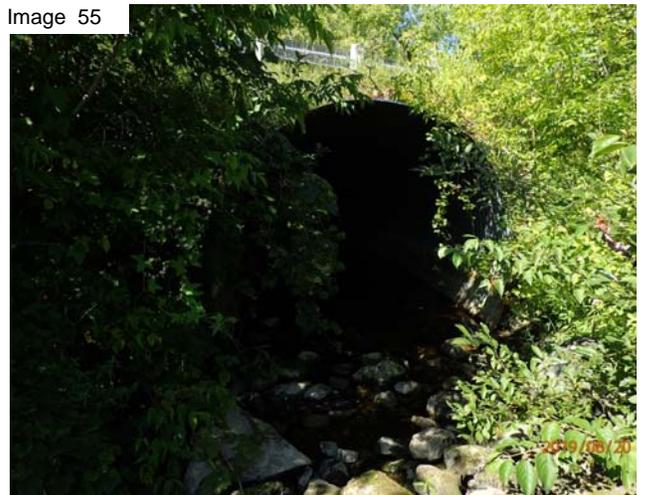
Image 55

East elevation
